RECOMMENDED SERVICE BULLETIN RSB 42-139 RSB 42NG-081

Replacement of rudder T-yoke axle with improved design.

WORK INSTRUCTION WI-RSB 42-139 WI-RSB 42NG-081

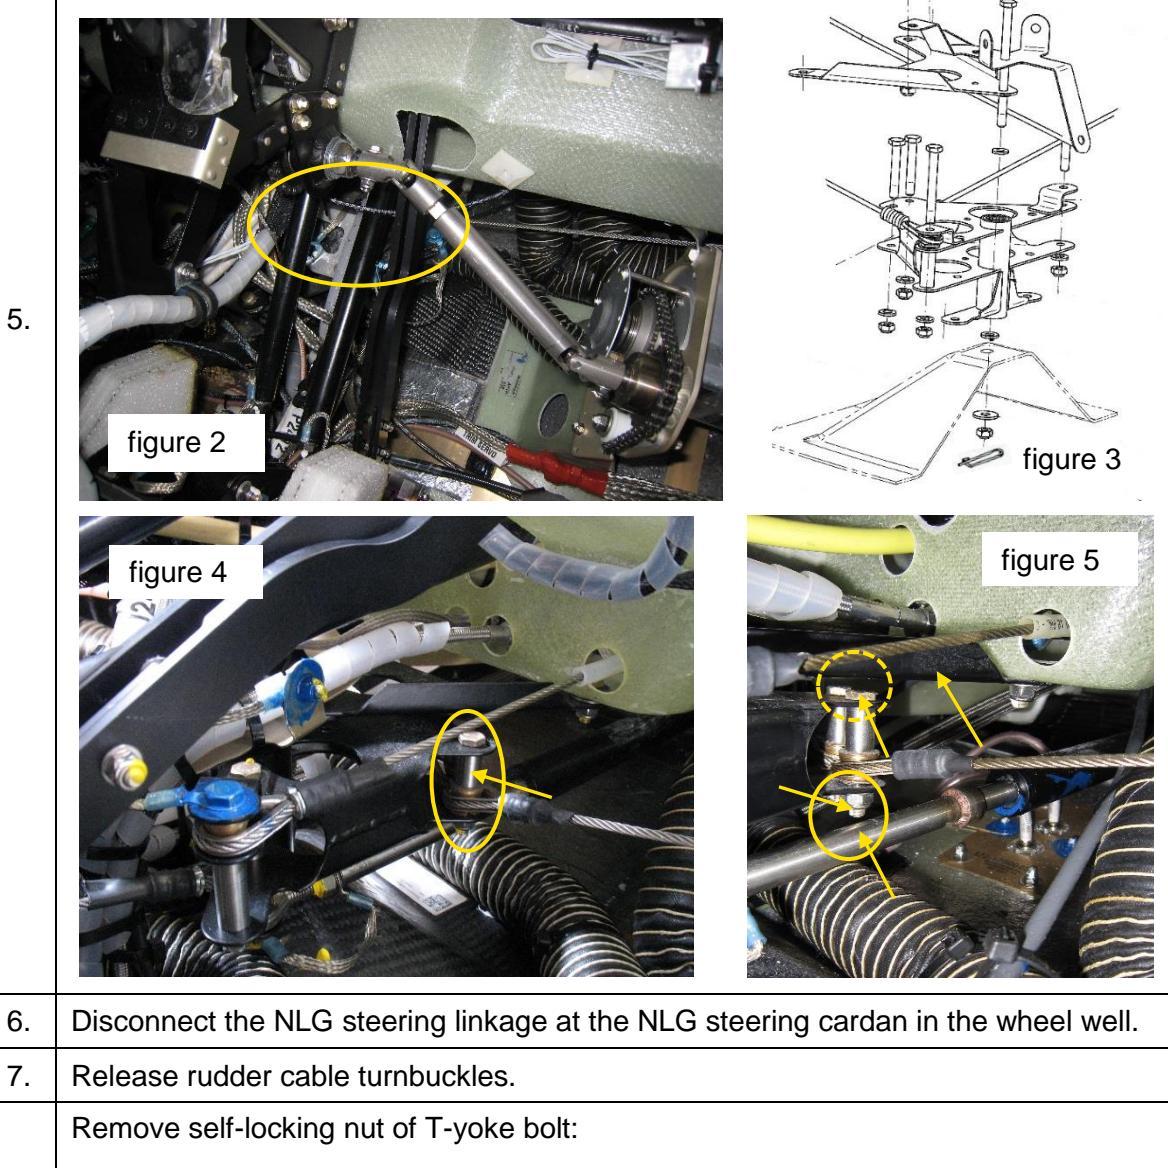
- between end of T-yoke bolts for copilot's right rudder cable & pilot's left rudder cable and nose landing gear (NLG) steering rod (continuous circle in figure 5)
- and between head of T-yoke bolts for copilot's right rudder cable & pilot's left rudder cable and mounting bracket (dashed circle in figure 5).

Record the measured clearances. Each clearance must be greater than 2 mm (0.08 in).

Figures 2 – 5 show the affected area.

If any of the clearances is not greater than 2 mm (0.08 in), reposition the T-yoke in accordance with Work Instruction of MSB 42-087 / MSB 42NG-016, Section III.3, latest effective issue.
