# MANDATORY SERVICE BULLETIN NO. MSB-42-021

Type: DA 42

Inspection of clearance of exhaust pipe.

# WI-MSB-42-021

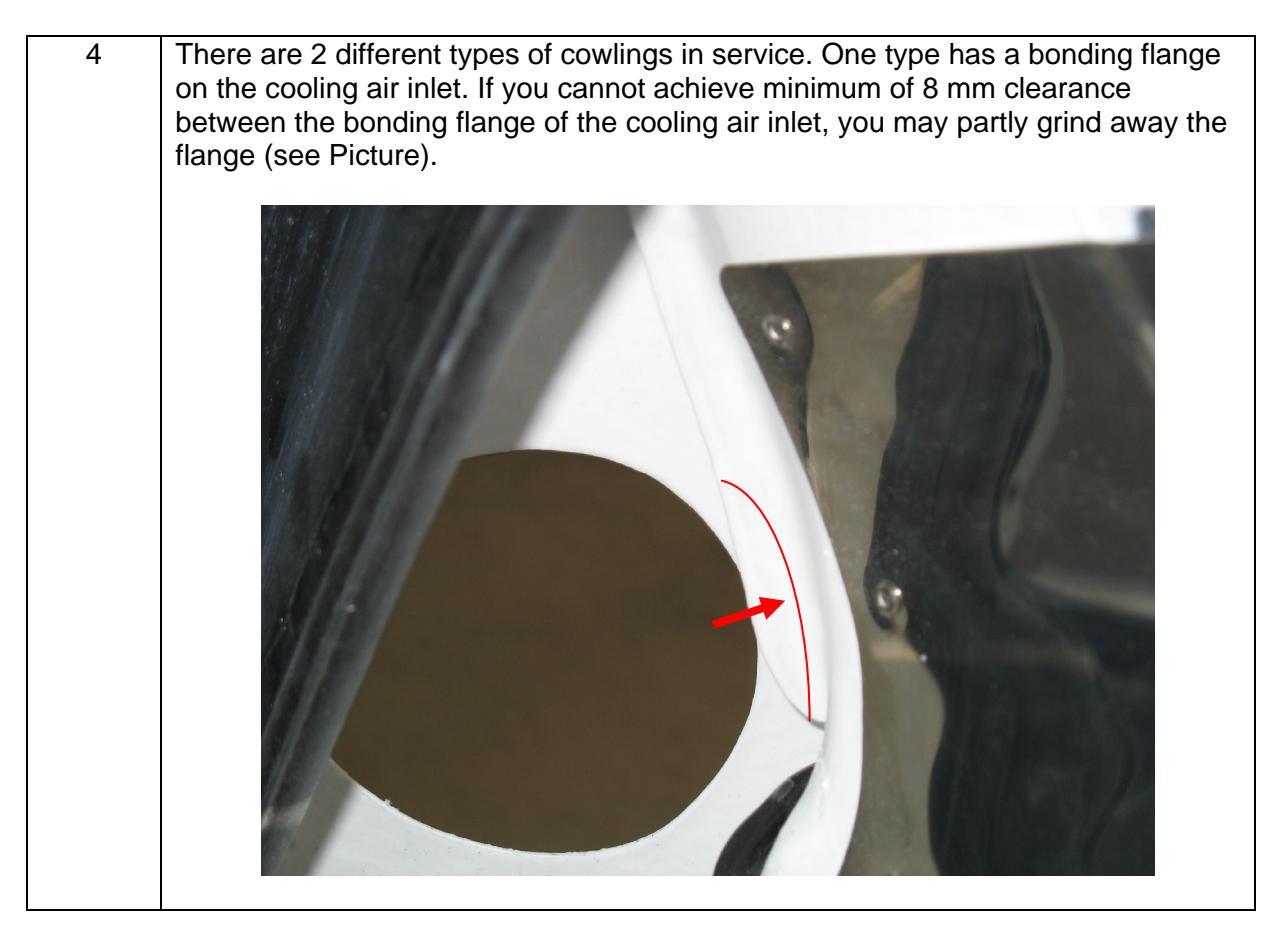
Poorly aligned exhaust pipes in combination with too tight cut outs in the cowling cause too less clearance between the exhaust pipes and the cowling. This leads to additional constraint forces onto the pipes leading to cracks in the exhaust pipes near the flange.

1	Remove top cowlings in accordance with the AMM Section 71-10
2	Check clearance of exhaust pipe to all components.
3	If the exhaust pipe is not centered properly, loosen the nuts on the flange and try to rearrange the pipe so that the clearance to all components is a maximum.

5	Widen the cutout where the pipe leads through the cowling, clearance 8 to 12
	mm.
6	Clean working area and check for foreign objects.
7	Perform functional check of altered, repaired and new parts.
8	Test all systems in working area for function.
9	Install top cowlings in accordance with the AMM Section 71-10
10	Repeat procedure (step 1 to 8) for the 2 <sup>nd</sup> engine.
11	Make necessary entries in the aircraft logs.
