# MANDATORY SERVICE BULLETIN NO. MSB-42-070/1 SUPERSEDES MSB-42-070

#### I.5 Subject

# WORK INSTRUCTION WI-MSB 42-070 "Inspection of NLG Pivot"

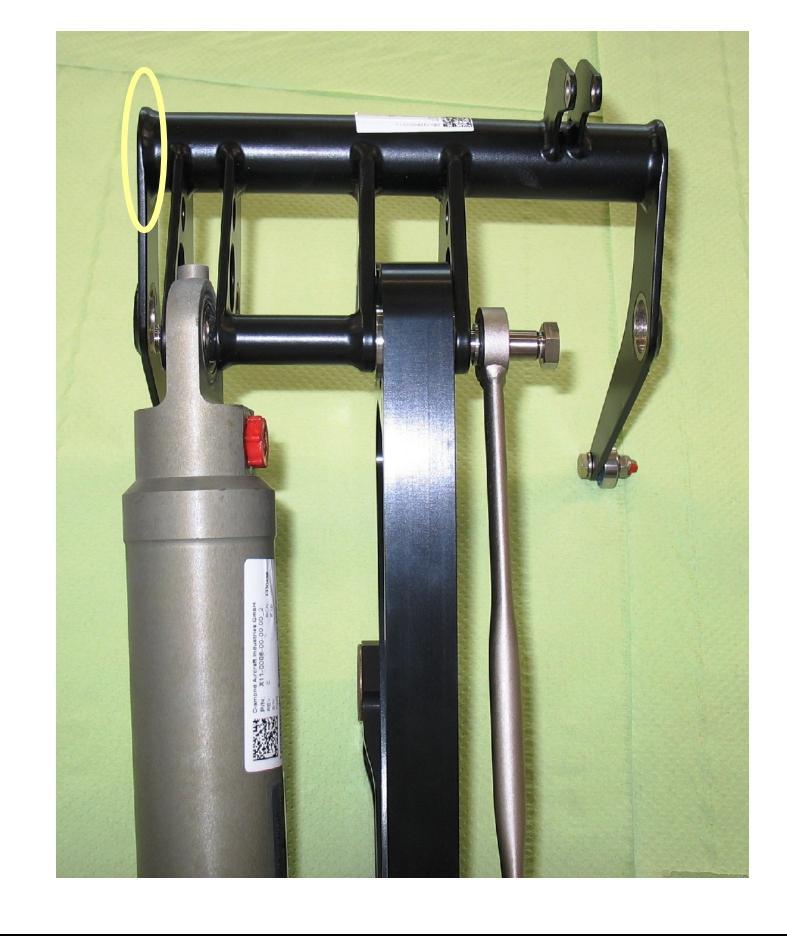
Inspect Brace Bearing (P/N D60-3233-12-00) for cracks on the left hand outer weld seam between lever arm and tube. If cracks are visible in the powder coating replace the Brace Bearing in accordance with AMM Section 32-20. In case of doubt use die penetration methods.
