MANDATORY SERVICE BULLETIN NO. MSB 42-074/3

Reinforcement of the supporting structure in NLG-Box (ATA-Code: 53).

WORK INSTRUCTION WI-MSB 42-074 "NLG-Box Reinforcement"

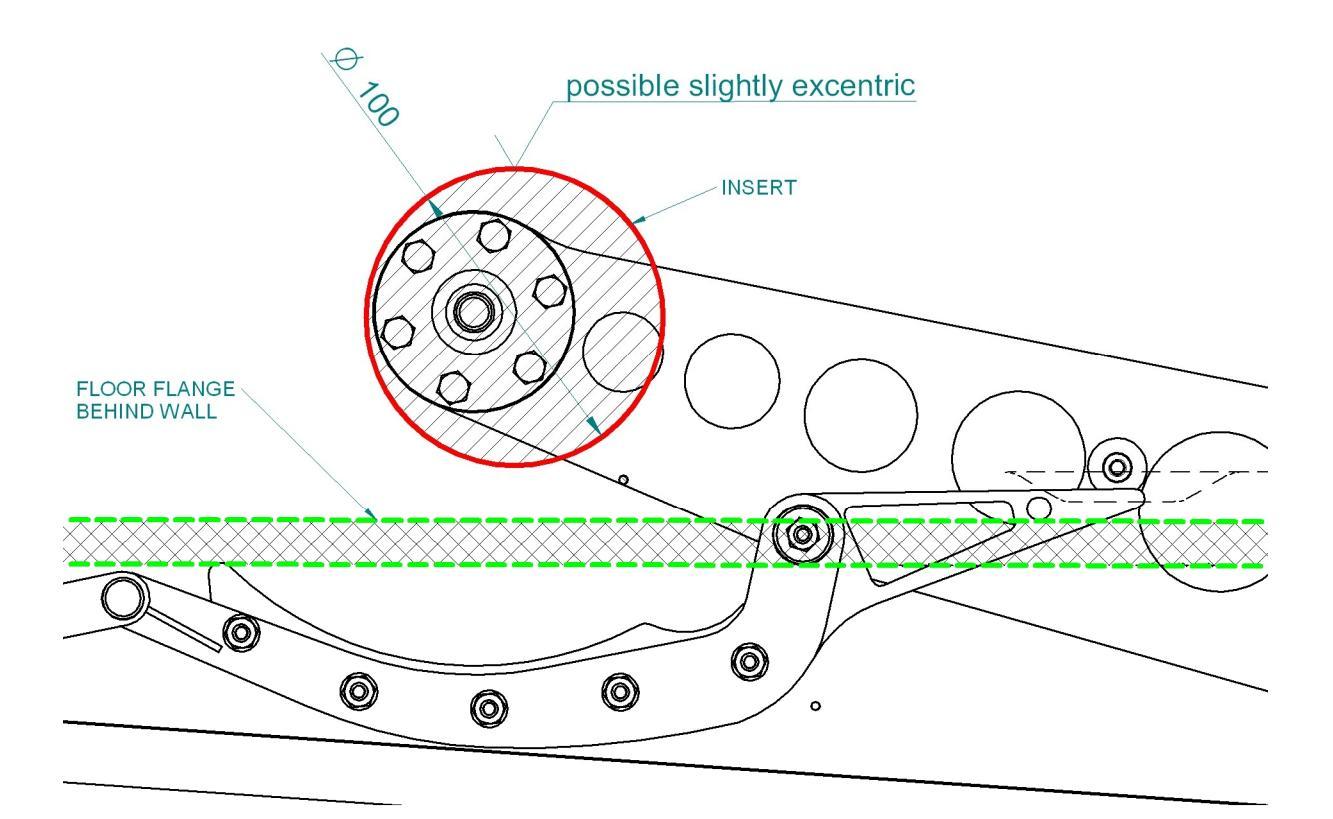
SKETCH 1: ACOUSTIC ZONING RH WALL - NLG Box

3.	Perform Tap Test on inside of NLG-Box around RH brace in acc. with AMM (Chapter 51).
	Note: Use Acoustic Zoning Sheet interpretation of Tap Test results (Sketch 1).

4.	If a delamination is detected and
	 can be covered by a circle with diameter smaller than 25mm (1in) -> acceptable damage
	 cannot be covered by a circle with diameter smaller than 25mm (1in) -> repair in acc. with AMM
