## SERVICE INFORMATION NO. SI 20E-007

Rotax Service Bulletin No. SB-912i-009 Replacement of oil filter

# Replacement of oil filter for ROTAX® Engine Type 912 i, 912 and 914 (Series)

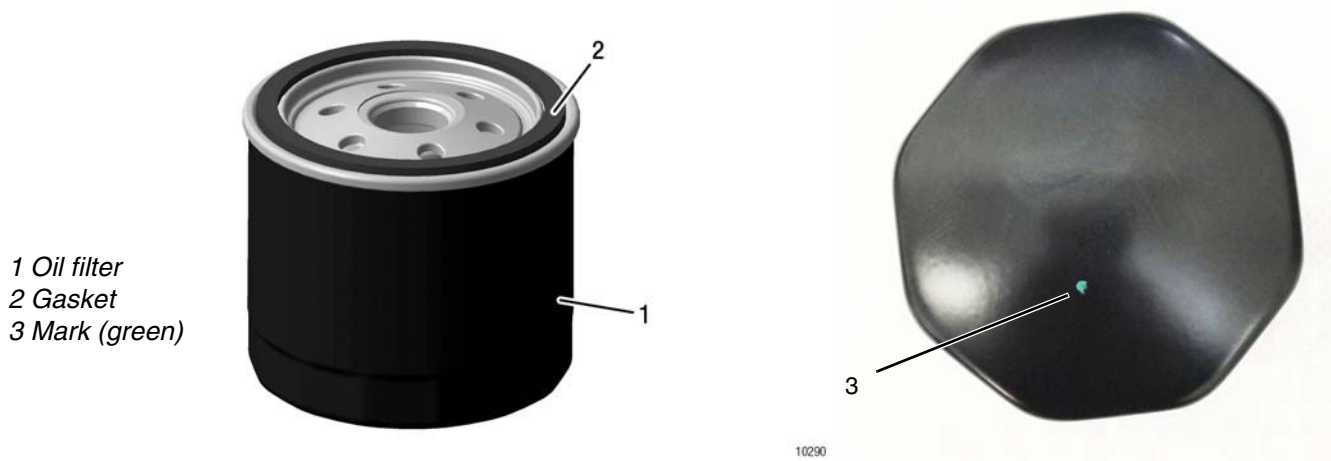
Fig. 1  
Oil filter

The above engines have been fitted by the manufacturer with an oil filter part no. 825016 with a production date code 10/17 up to 38/17 and have no green mark see Fig. 1).

All engines are affected, which have been equipped with an oil filter part no. 825016 (with a production date code from 10/17 up to 38/17) during engine repair, maintenance or general overhaul as of June 8<sup>th</sup>, 2017 to October 31<sup>st</sup>, 2017 and have no green mark. see Fig. 1).

Step	Procedure
1	Check the engine logbook and maintenance documentation or shipping documents to see if this Service Bulletin has already been accomplished.
2	<p>Check whether the affected oil filter shows a green mark on the crown of oil filter (as illustrated in Fig. 1) (same area as production date code).</p> <ul style="list-style-type: none"> <li>- green mark is present: this oil filter is OK as it has already been tested by the supplier and can be used even though the production date code is from 10/17 to 38/17. No further actions are required.</li> <li>- green mark NOT present: this oil filter is NOT OK, please follow the instructions in section 3.2).</li> </ul> <p>NOTE: If production date code is not easy to read, use a proper means of light (e.g. flashlight directed at a proper angle onto the oil filter crown etc.) for better visibility of the coding imprint.</p>

See Fig. 1.

Step	Procedure
1	Remove the affected oil filter according to the Maintenance Manual Line.
2	Install the new oil filter according to the Maintenance Manual Line.

See [Fig. 1](#).

Step	Procedure
1	Quarantine and/or remove affected filters from your inventory. Mark as unserviceable and return F.O.B. to your ROTAX® Authorized Distributor or their independent Service Centers.
