SERVICE INFORMATION LETTER NO. SI40NG-080

EASA AD 2021-0143-E and Austro Engine Mandatory Service Bulletin MSB-E4-031 - Oil Pump Replacement.

MANDATORY SERVICE BULLETIN

Oil pump replacement

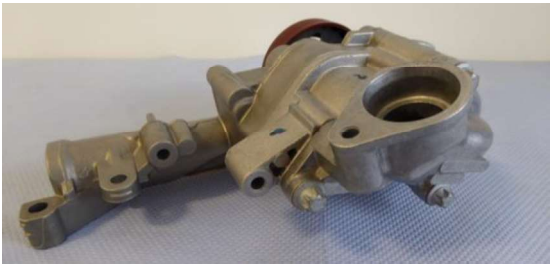
<p>Delivered oil pump</p>

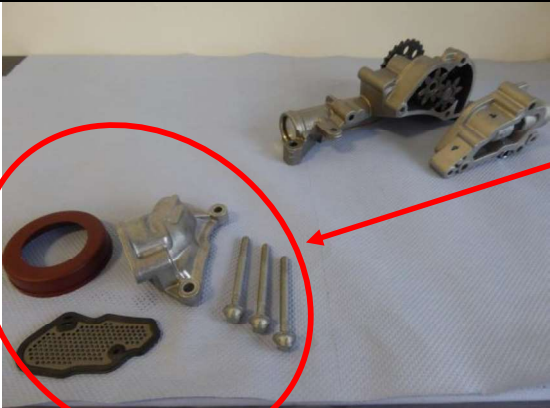
<p>Remove the following parts of the new oil pump:</p> <ul style="list-style-type: none"> - Cover of the chain gear - Original oil suction pipe (including screws and oil strainer) <p><u>Note:</u> Discard the removed parts. The screws can be used as alternative (see step 4, figure 12).</p>

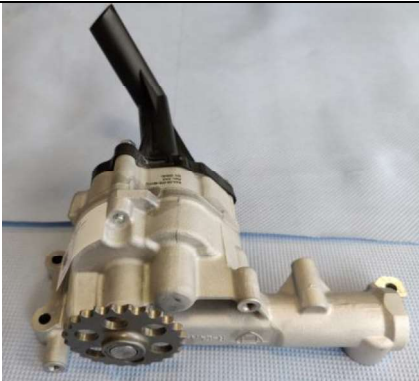
<p>Delivered oil pump</p>
---	---------------------------

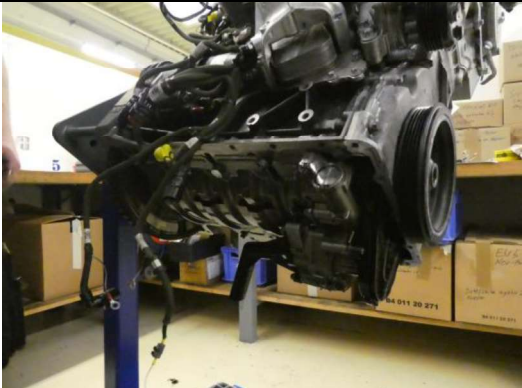
<p>Fig. 3</p>	<p>After removal of the oil sump</p>

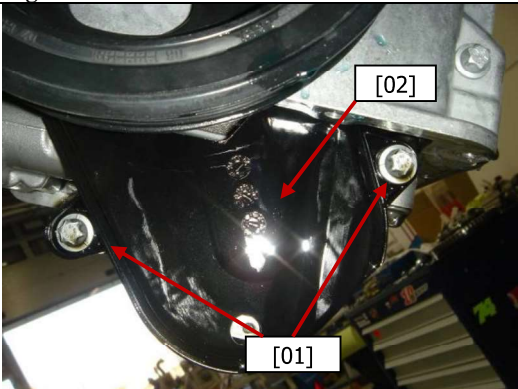
<p>Fig. 4</p>	<p>Loosen two screws [01] that attach the chain cover [02] to the oil pump and remove the chain cover.</p>

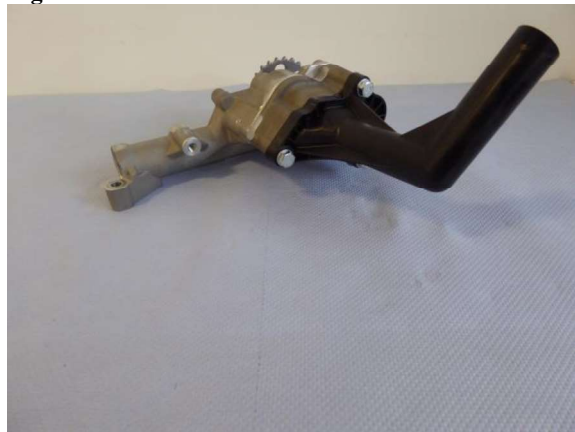
Fig. 10

Loosen the oil pump chain gear from the oil pump chain.
 Remove the oil pump.

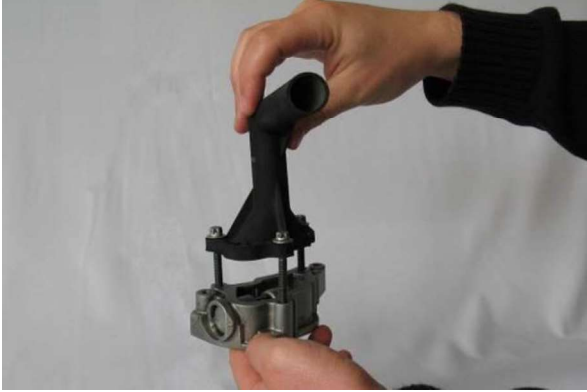
<p>Fig. 12</p>	<p>Fit the oil suction pipe [06] (E4A-50-100-BHY / re-used from the old oil pump) in place on the valve housing (E4A-50-520-000) and then insert the three hexagon screws [05] (ISO_4014-M6xM60-10.9 with washers ISO_7089-6 / alternative MBN 10 143-M6x63-10.9) through the holes.</p>

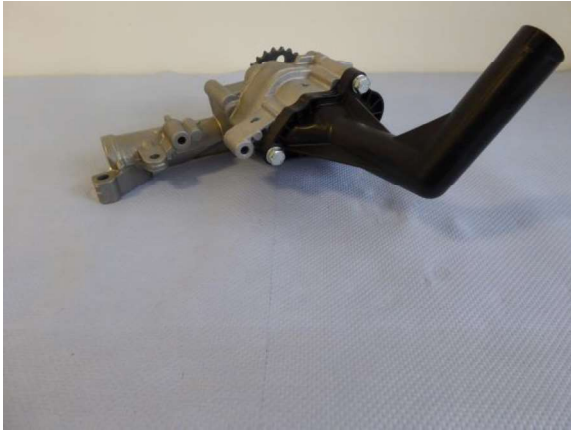
Apply Loctite 278 or Loctite 2701.
 Tighten the oil pump housing with 12 Nm.

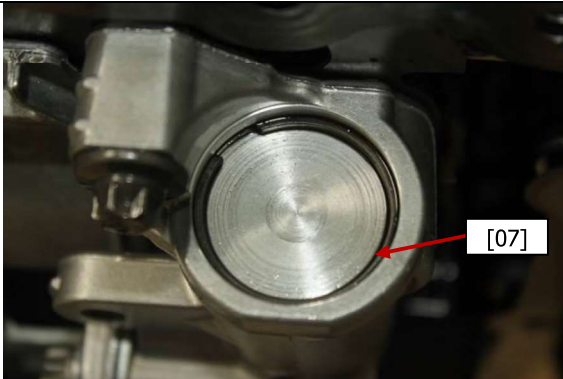
Fig. 13

Make sure that the circlips [07] (E4A-50-300-801) [08] (E4A-50-400-801) used to secure both plugs on the oil pump is in the correct position.

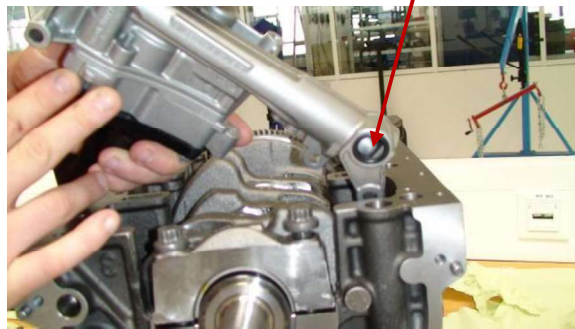
Fig. 16

Discard the O-Ring (OR_16x3-ACM 70) between the oil pump and the crankshaft housing.

Install a new O-Ring.
 Make sure it is correctly fitted.

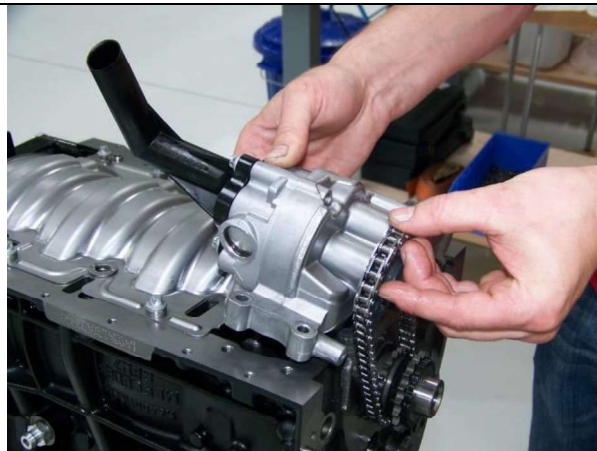
Fig. 17

Install the oil pump chain.
 Apply some approved engine oil (refer to the MM) on the chain before installation.

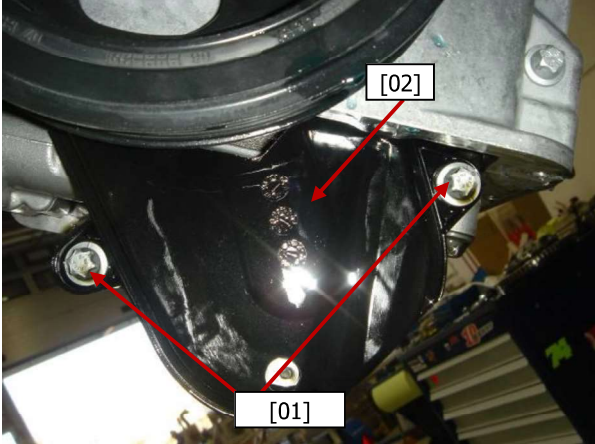
<p>Fig. 21</p>	<p>Install the oil pump chain cover</p> <p>Put the chain cover [02] in place on the oil pump and tighten the screws [01] (ISO8102-M6x20-10.9) (x2) with 12 Nm.</p>
---	--

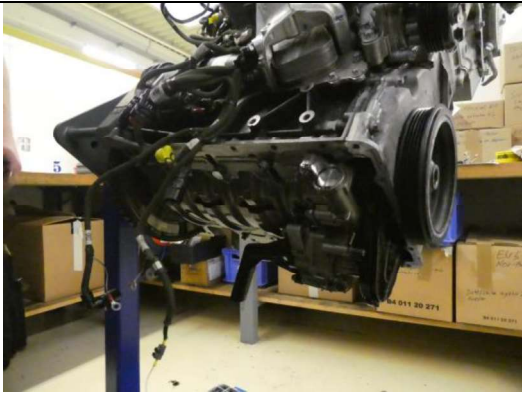
<p>Fig. 3B</p>	<p>After removal of the oil sump</p>

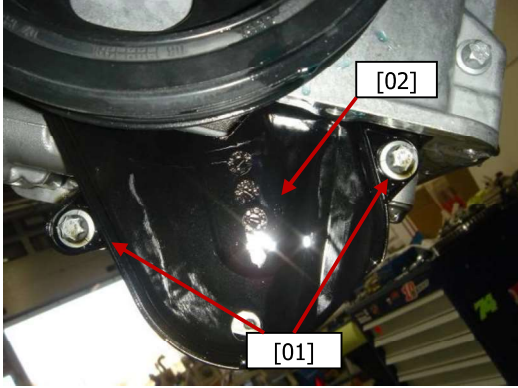
<p>Fig. 4B</p>	<p>Loosen two screws [01] that attach the chain cover [02] to the oil pump and remove the chain cover.</p>

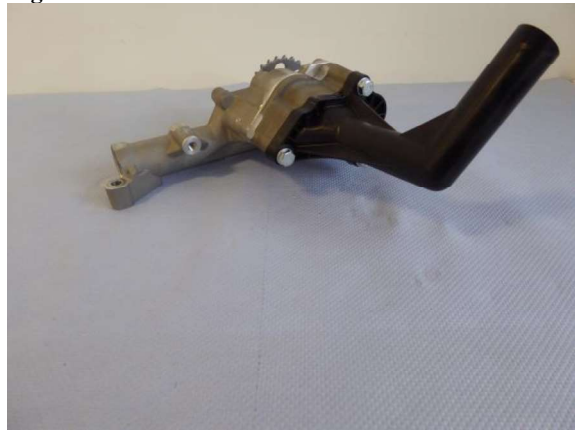
Fig. 10B

Loosen the oil pump chain gear from the oil pump chain.
 Remove the oil pump.

Examine the oil pump for blockage.
 Make sure that the pump gears move freely when turned by hand.

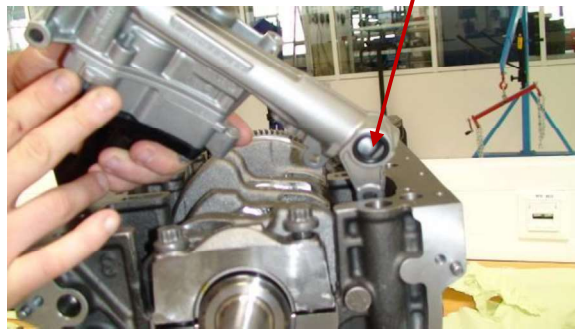
Fig. 14B

Discard the O-Ring (OR_16x3-ACM 70) between the oil pump and the crankshaft housing.

Install a new O-Ring.
 Make sure it is correctly fitted.

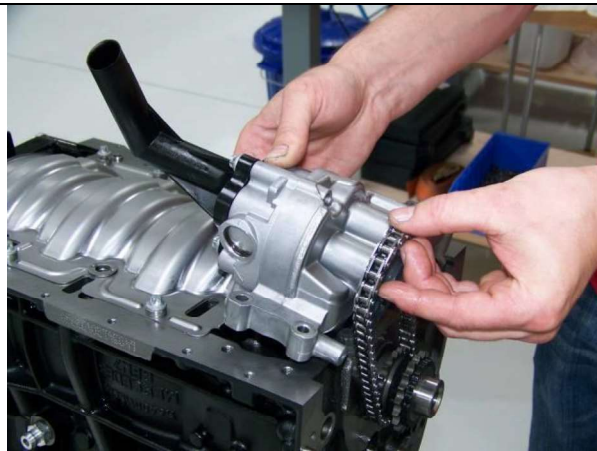
Fig. 15B

Install the oil pump chain.
 Apply some approved engine oil (refer to the MM) on the chain before installation.

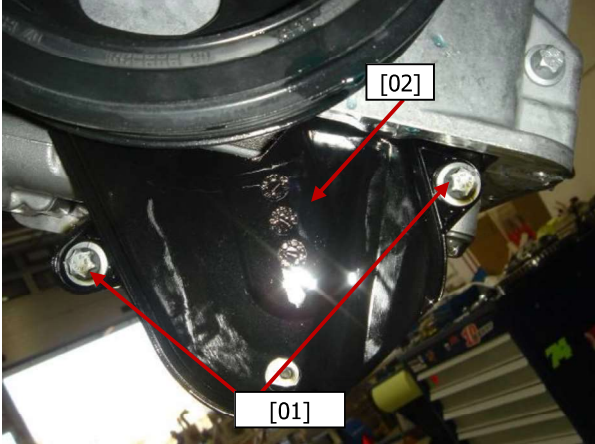
<p>Fig. 19B</p>	<p>Install the oil pump chain cover</p> <p>Put the chain cover [02] in place on the oil pump and tighten the screws [01] (ISO8102-M6x20-10,9) (x2) with 12 Nm.</p>
--	--
