**MANDATORY SERVICE BULLETIN NO. MSB 40NG-064 REV. 2**  
**SUPERSEDES MSB 40NG-064 REV. 1**

Replacement of fuel tank interconnect hose (flexible coupling).

**WORK INSTRUCTION WI-MSB 40NG-064 REV. 0**

Replacement of fuel tank connection hoses (flexible couplings).

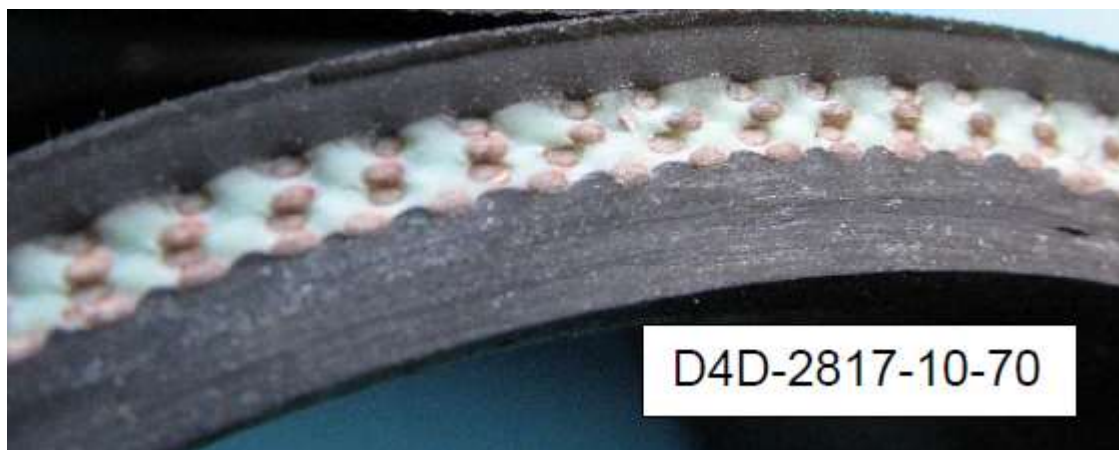
- D4D-2817-10-70, this fuel tank connection hose has a light blue layer in the cross-section. Only a fraction of these hoses come from the affected two batches.

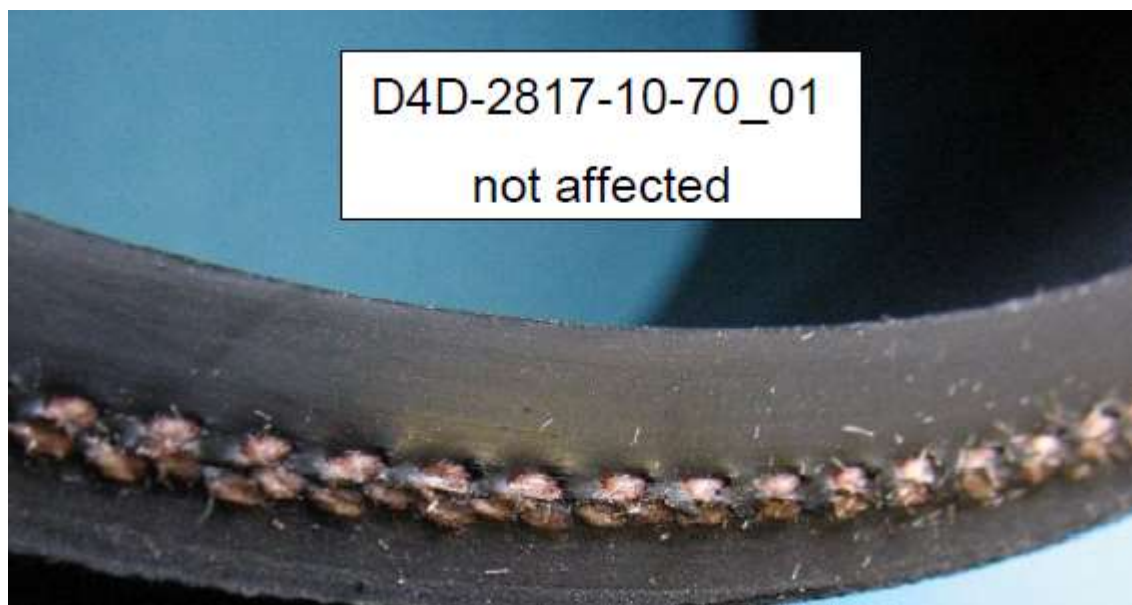
- D4D-2817-10-70\_01, this fuel tank connection hose has an all black cross section and is not affected.

5. Assemble the main fuel tank assembly with the new fuel tank connection hoses (P/N D4D-2817-10-70\_01) in accordance with AMM Chapter 28-10.
6. Install the main fuel tank assembly in to the aircraft in accordance with AMM Chapter 28-10.
