MANDATORY SERVICE BULLETIN NO. MSB 40NG-070 REV. 0

Type: DA 40 NG

Inspection of the safety ropes in the engine installation.

WORK INSTRUCTION WI-MSB 40NG-070 REV. 0

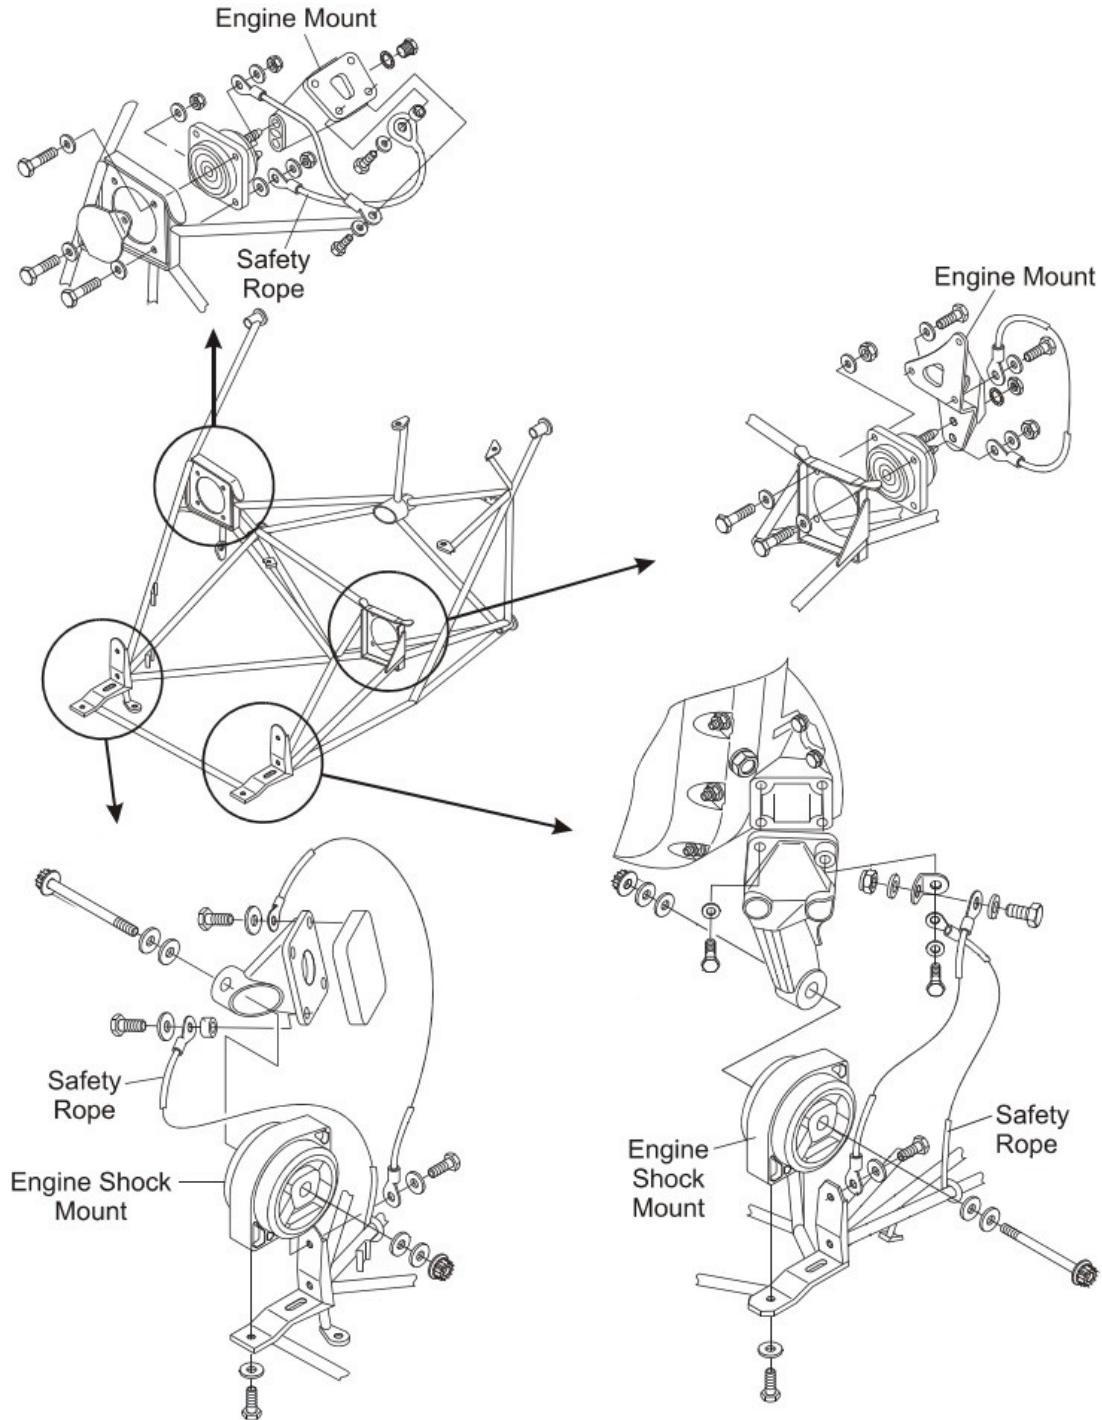
Figure 1. Locations of the safety ropes.

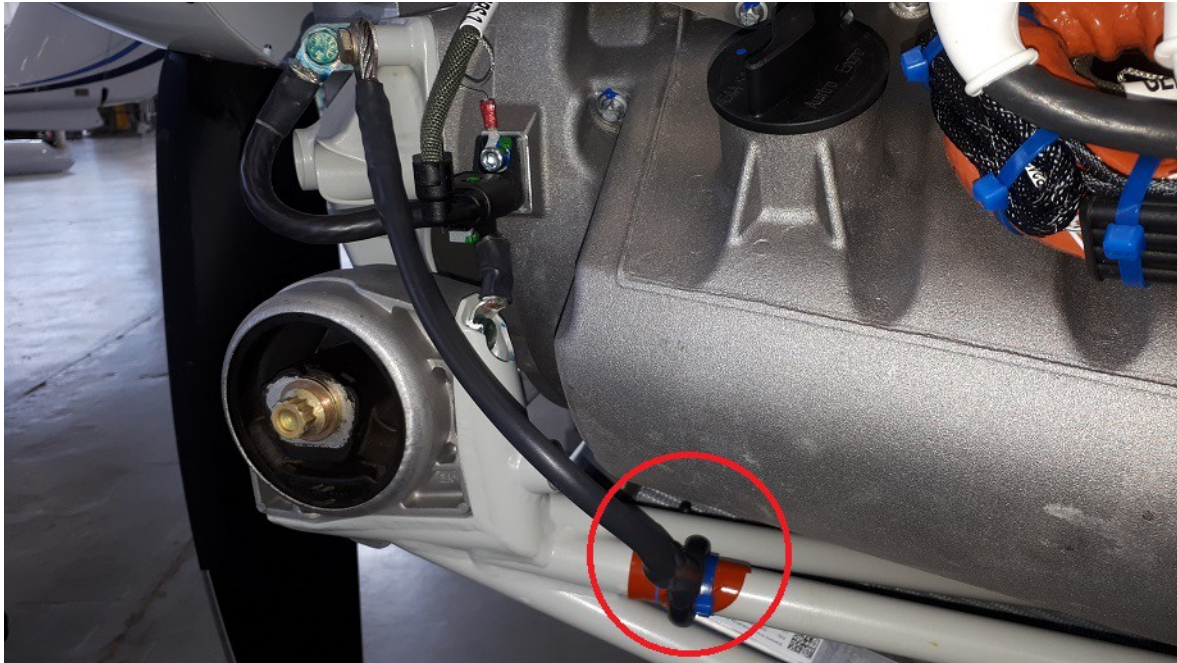
1. Ensure the engine is safe.
2. Remove the engine cowlings.
3. Inspect the safety rope and surrounding area at the front left of the engine (see Figure 2) for signs of chaffing. Pay special attention to the engine mount and the oil pan.

Figure 2. Safety rope at the front left of the engine. Note the silicone tape and zip tie used to secure the safety rope to the engine mount.

4. If the safety rope is not secured with silicone tape and a zip tie as shown in Figure 2, use silicone tape and a zip tie to secure the safety rope.
 - A. Ensure the safety rope is as far forward as possible, and does not interfere with other components in the engine installation or the cowling when installed.
 - B. Ensure the silicone tape completely wraps twice around the tube of the engine mount.

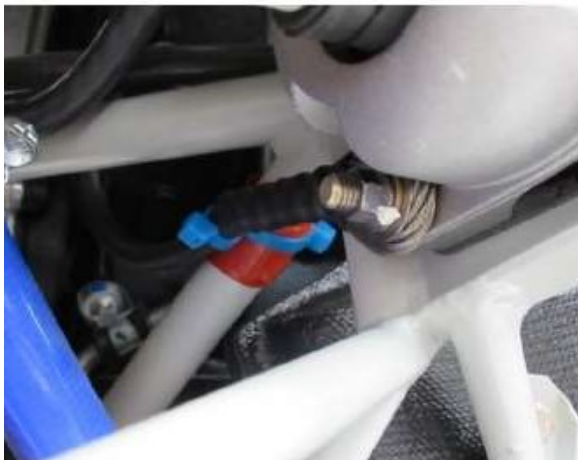
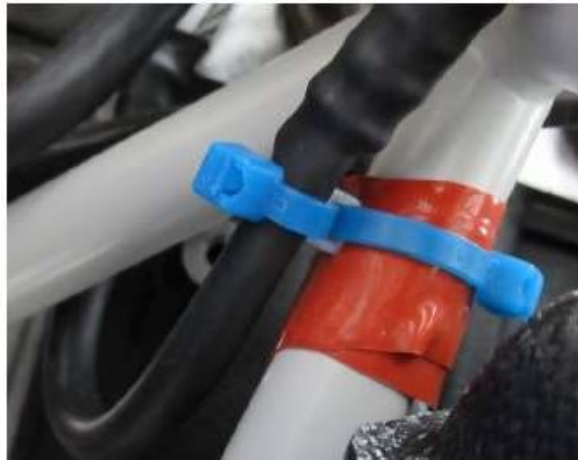
5. Inspect the safety rope and surrounding area at the aft right of the engine (see Figure 3) for signs of chaffing. Pay special attention to the engine mount.

Figure 3. Safety rope at aft right of the engine. Note the silicone tape, spacer, and two zip ties used to secure the safety rope.

6. If the safety rope is not secured with silicone tape and a zip ties as shown in Figure 3, use silicone tape, two zip ties, and a spacer to secure the safety rope.
 - A. Ensure the safety rope does not interfere with other components in the engine installation.
 - B. Ensure the silicone tape completely wraps twice around the tube of the engine mount.
7. Install the engine cowlings.
8. Report any signs of chaffing to Diamond Aircraft Industries.
9. Make a logbook entry indicating that this service bulletin has been performed.
10. Submit the execution report to Techpubs@diamondaircraft.com.
