OPTIONAL SERVICE BULLETIN NO. OSB F4-043 REV. 0

Type: DA 40 F

Vertical stabilizer rivet nuts replacement by anchor nuts.

WORK INSTRUCTION WI-OSB F4-043 REV. 0

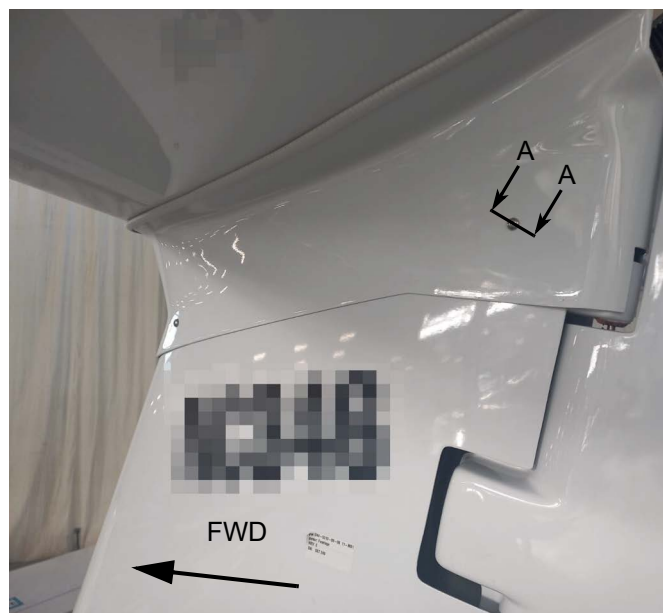
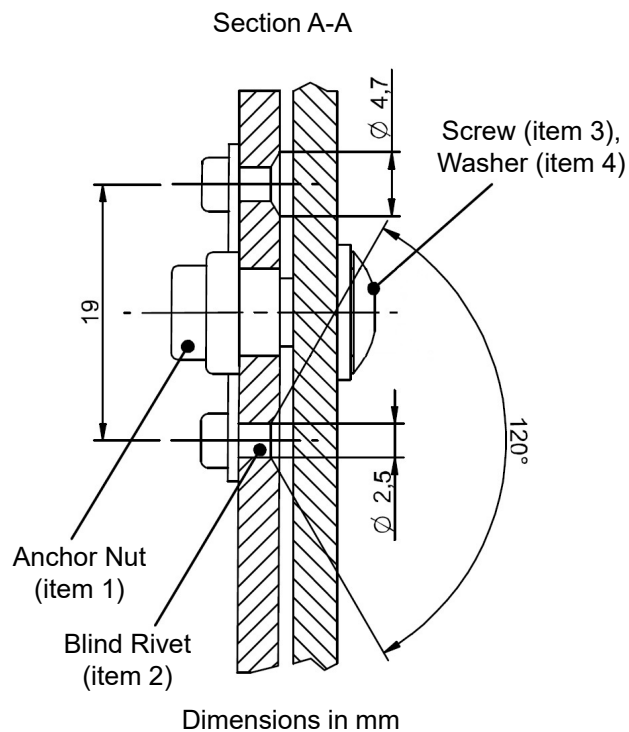
Figure 2. Anchor nut installation.

5. To install the 2 anchor nuts (item 1) at the same installation points of the rivet nuts, drill the vertical stabilizer to install the 4 blind rivets (item 2). Refer to Figure 2.

6. Install the 4 blind rivets (item 2) to attach the 2 anchor nuts (item 1) to the vertical stabilizer. Refer to Figures 2 and 3.

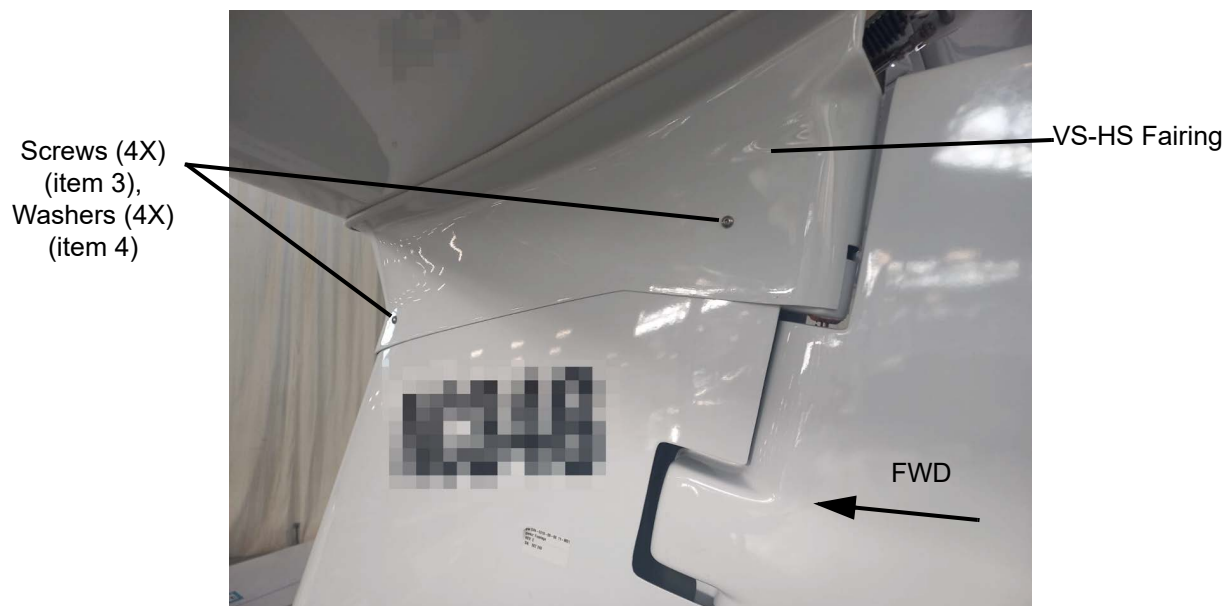
Figure 4. VS-HS fairing installation.

7. Put the VS-HS fairing in the installation position. Refer to Figure 4.
8. Install the 4 screws (item 3) and the 4 washers (item 4). Refer to Figure 4.
