SERVICE INFORMATION NO. SI 42NG-105/1

Austro Engine MSB-E4-030/3
ATA-Code: 72-50

MANDATORY SERVICE BULLETIN

Oil pump replacement

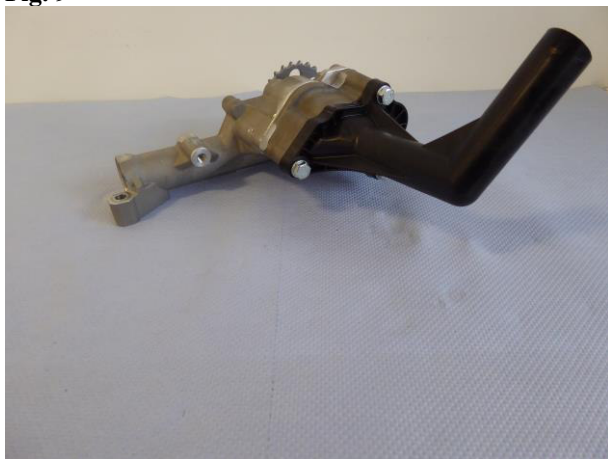
Fig. 10

Removed oil pump (E4A-50-000-BHY)

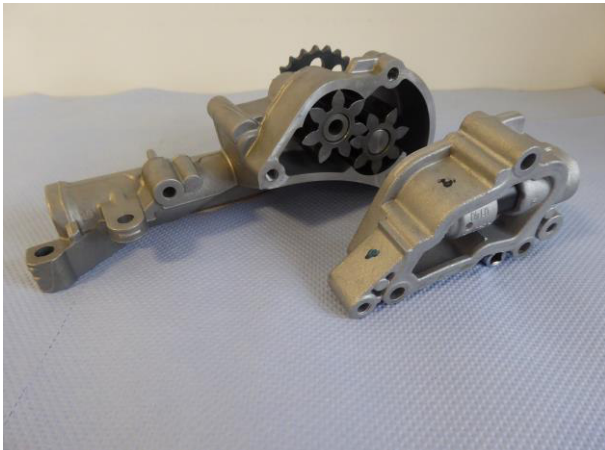
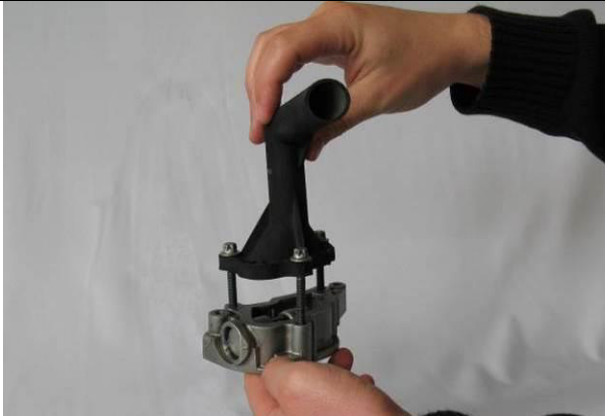
<p>New oil pump</p>

<p>Fig. 12</p>	<p>Fit the oil suction pipe [06] (E4A-50-100-BHY / re-used from the old oil pump) in place on the valve housing (E4A-50-520-000) and then insert the three hexagon screws [05] (ISO_4014-M6xM60-10.9 with washers ISO_7089-6 / alternative MBN 10 143-M6x63-10.9) through the holes.</p>
