SERVICE INFORMATION NO. SI 42NG-110

Austro Engine Mandatory Service Bulletin No. MSB-E4-031/0
ATA-Code: 72-50

MANDATORY SERVICE BULLETIN No. MSB-E4-031/0

Oil pump replacement

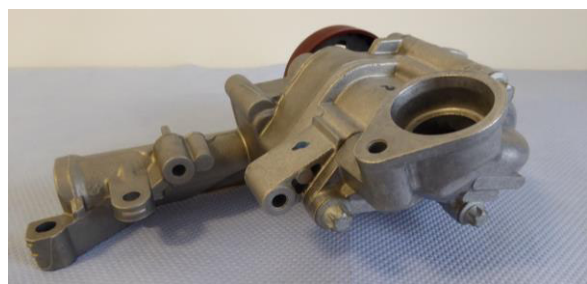
Fig. 0

Delivery of the new oil pump E4A-50-000-AHY

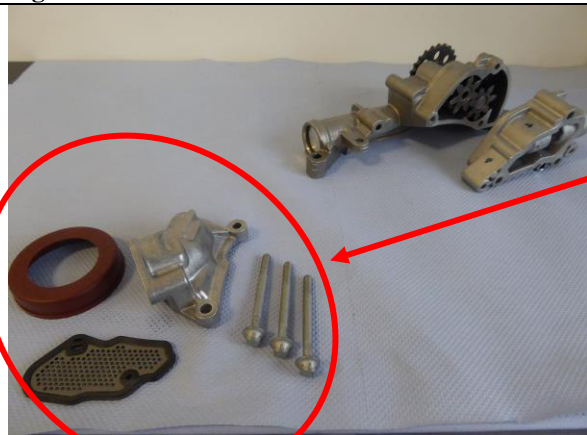
Fig. 1

Delivered oil pump

Remove the following parts of the new oil pump:

- Cover of the chain gear
- Original oil suction pipe (including screws and oil strainer)

Note: Discard the removed parts. The screws can be used as alternative (see step 4, figure 12).

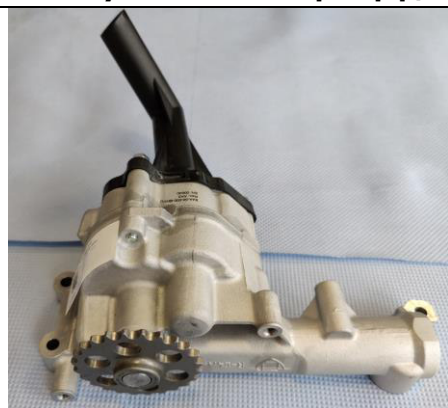
Fig. 2

Delivery of the new oil pump p/n E4A-50-000-BHY

Delivered oil pump

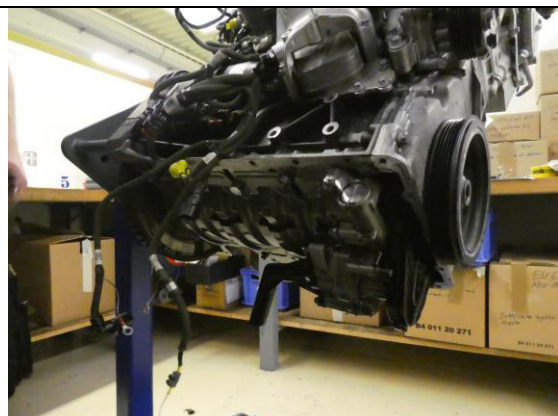
Fig. 3

After removal of the oil sump

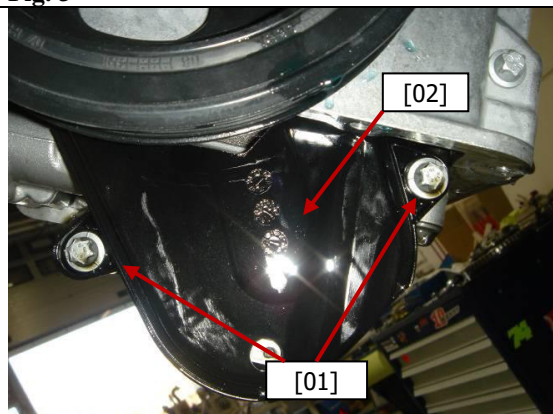
Fig. 4

Loosen two screws [01] that attach the chain cover [02] to the oil pump and remove the chain cover.

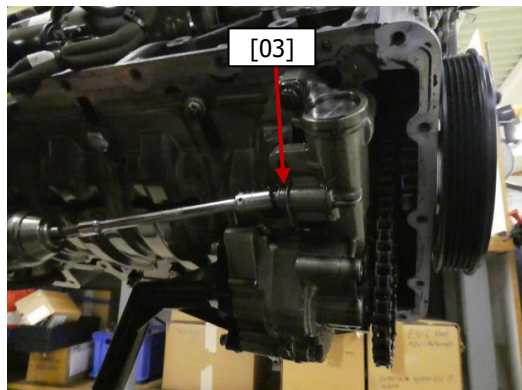
Fig. 5

Remove the screw [03] that attaches the oil pump to the oil repellent.

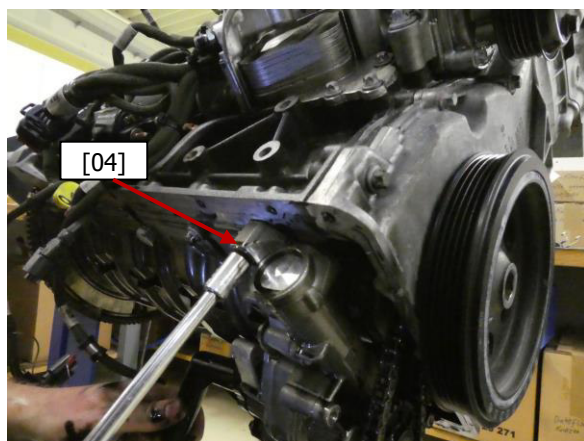
Fig. 6

Remove three screws [04] that attach the oil pump to the crankcase.

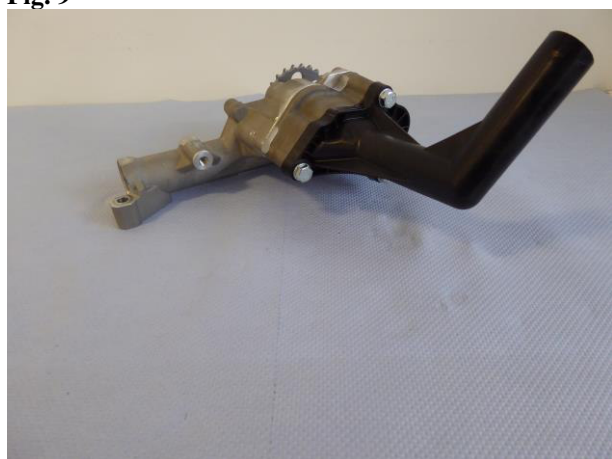
Fig. 10

Loosen the oil pump chain gear from the oil pump chain.

Remove the oil pump.

Examine the oil pump for blockage.
Make sure that the pump gears move freely when turned by hand.

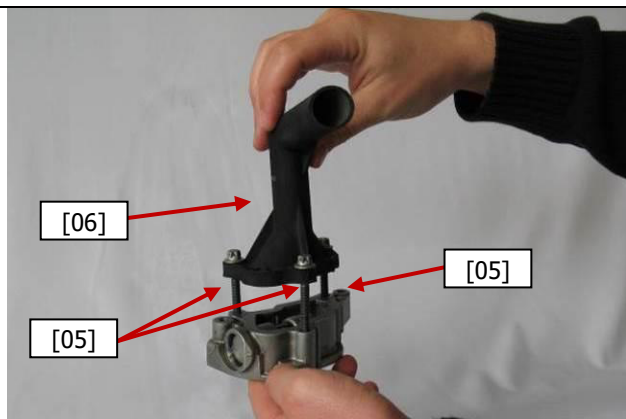
Fig. 11

Removed oil pump (E4A-50-000-BHY)

Loosen three screws [05] of the oil pump and remove the oil suction pipe with the integrated oil strainer [06] (E4A-50-100-BHY) from the old oil pump.

Note: The oil suction pipe with oil strainer and the screws [05] must be reused for the new oil pump installation.

After removal of the oil suction pipe, examine the oil pump gears for damage.

In case of a blocked, and/or partially blocked, and/or damaged oil pump, please contact Austro Engine for further instructions.

NOTE: Removed oil pump must be always returned to Austro Engine, including the engine flight hours recorded at the time of replacement.

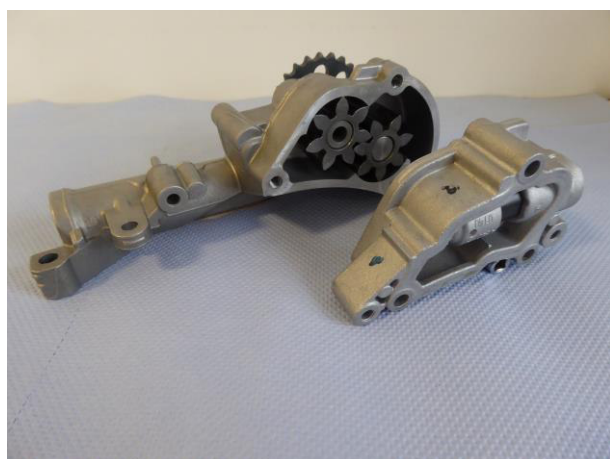
New oil pump

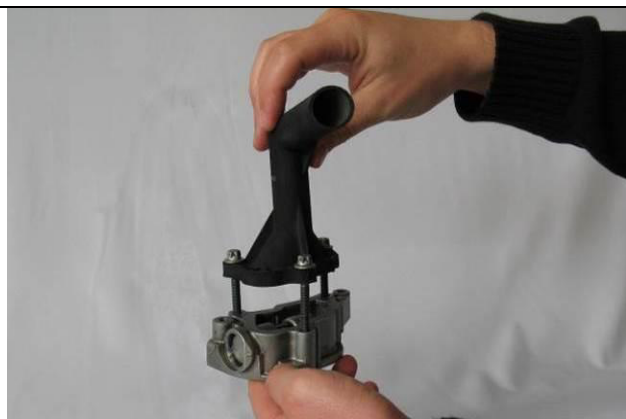
Fig. 12

Fit the oil suction pipe [06] (E4A-50-100-BHY / re-used from the old oil pump) in place on the valve housing (E4A-50-520-000) and then insert the three hexagon screws [05] (ISO_4014-M6xM60-10.9 with washers ISO_7089-6 / alternative MBN 10 143-M6x63-10.9) through the holes.

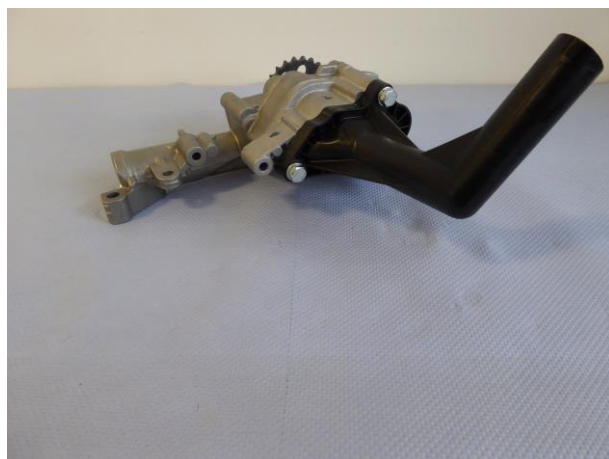
Apply Loctite 278 or Loctite 2701.
Tighten the oil pump housing with 12 Nm.

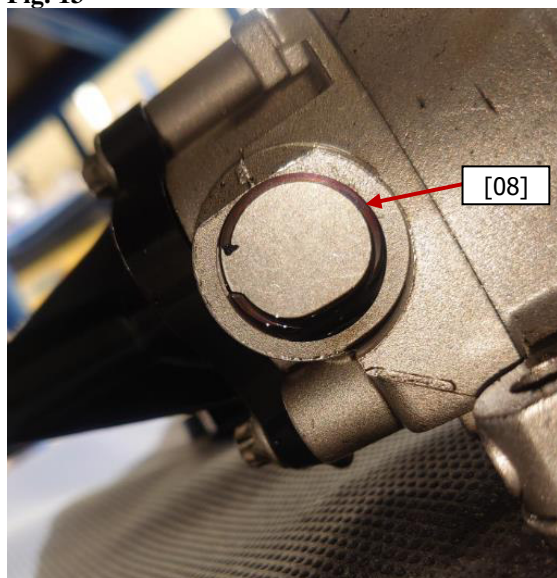
Fig. 14

Make sure that the circlips [07] (E4A-50-300-801) [08] (E4A-50-400-801) used to secure both plugs on the oil pump is in the correct position.

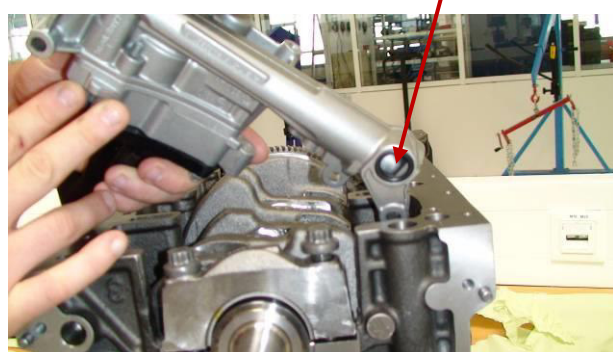
Fig. 16

Discard the O-Ring (OR_16x3-ACM 70) between the oil pump and the crankshaft housing.

Install a new O-Ring.
 Make sure it is correctly fitted.

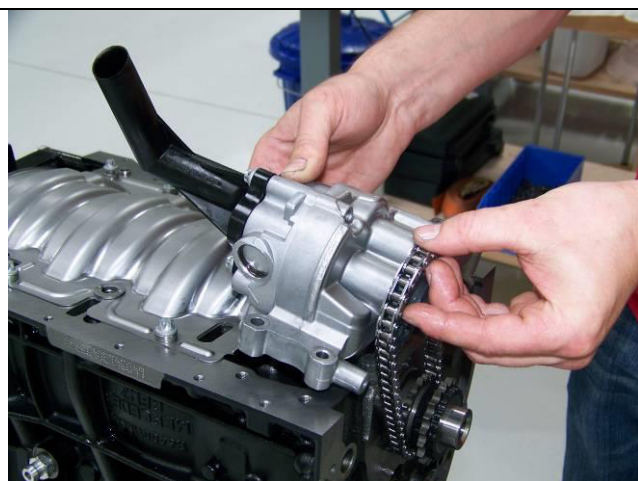
Fig. 17

Install the oil pump chain.
 Apply some approved engine oil (refer to the MM) on the chain before installation.

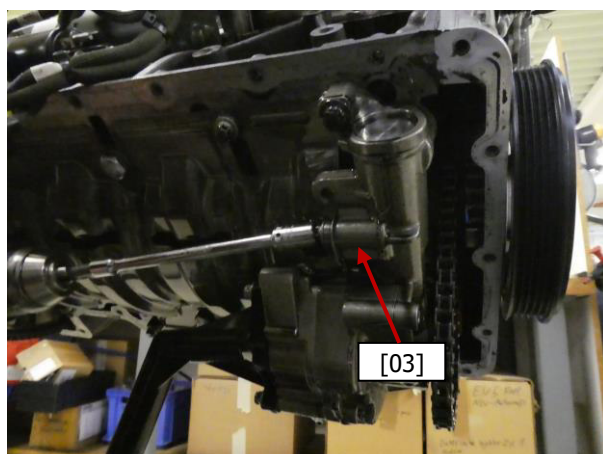
Fig. 20

Install the oil pump with O-Ring and three screws [04] (M7x27 – 8.8 – DBL 9400.40) on the crankcase.

Apply Loctite 2701 or 278 on the thread and tighten with a torque of 14 Nm.

Install the screw [03] that attaches the oil pump to the oil repellent. Apply with Loctite 243 and torque it with 12 Nm.

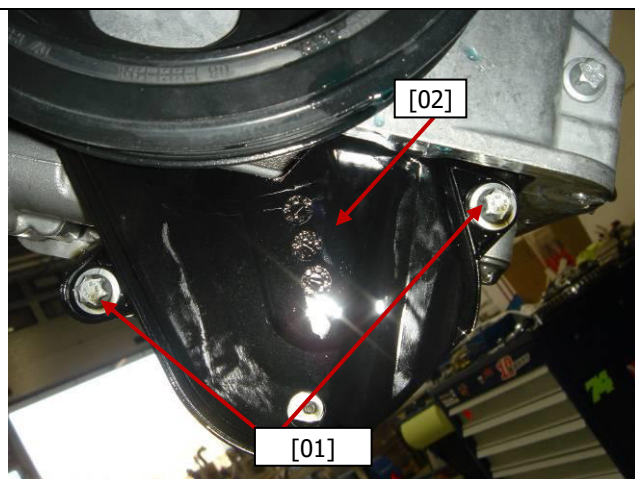
Fig. 21

Install the oil pump chain cover

Put the chain cover [02] in place on the oil pump and tighten the screws [01] (ISO8102-M6x20-10.9) (x2) with 12 Nm.

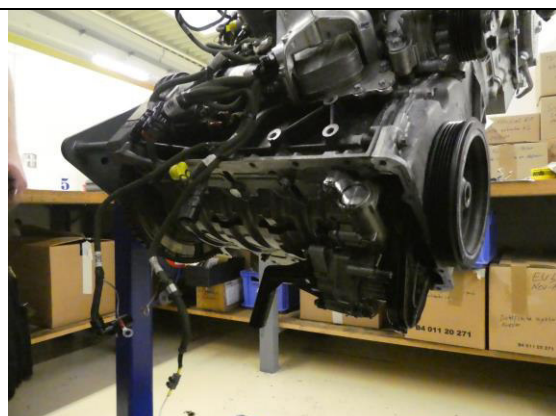
Fig. 3B

After removal of the oil sump

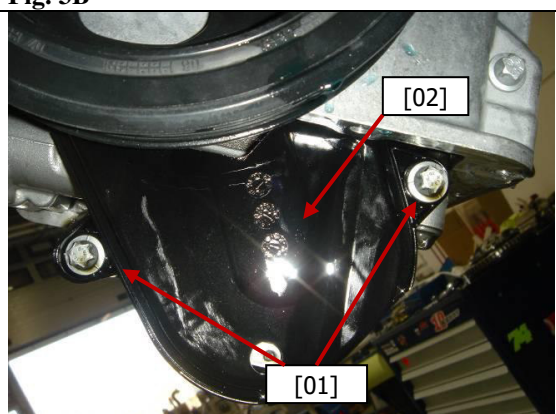
Fig. 4B

Loosen two screws [01] that attach the chain cover [02] to the oil pump and remove the chain cover.

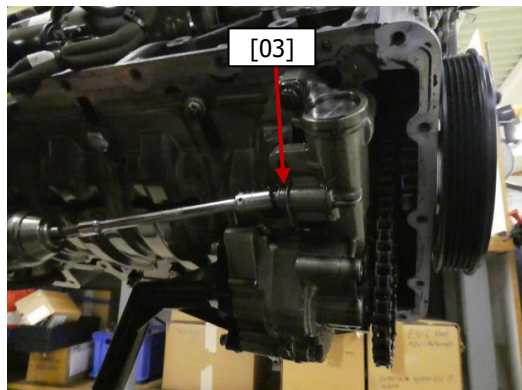
Fig. 5B

Remove the screw [03] that attaches the oil pump to the oil repellent.

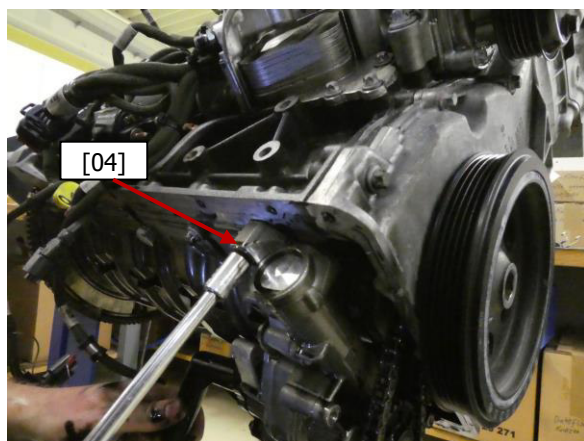
Fig. 6B

Remove three screws [04] that attach the oil pump to the crankcase.

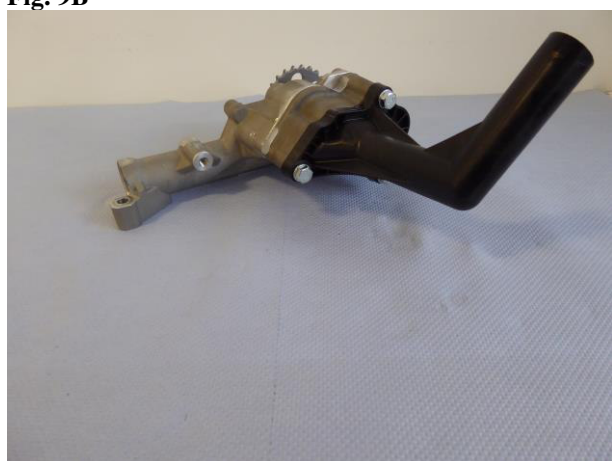
Fig. 10B

Loosen the oil pump chain gear from the oil pump chain.
Remove the oil pump.

Examine the oil pump for blockage.
Make sure that the pump gears move freely when turned by hand.

In case of a blocked, and/or partially blocked, and/or damaged oil pump, please contact Austro Engine for further instructions.

NOTE: Removed oil pump must be always returned to Austro Engine, including the engine flight hours recorded at the time of replacement.

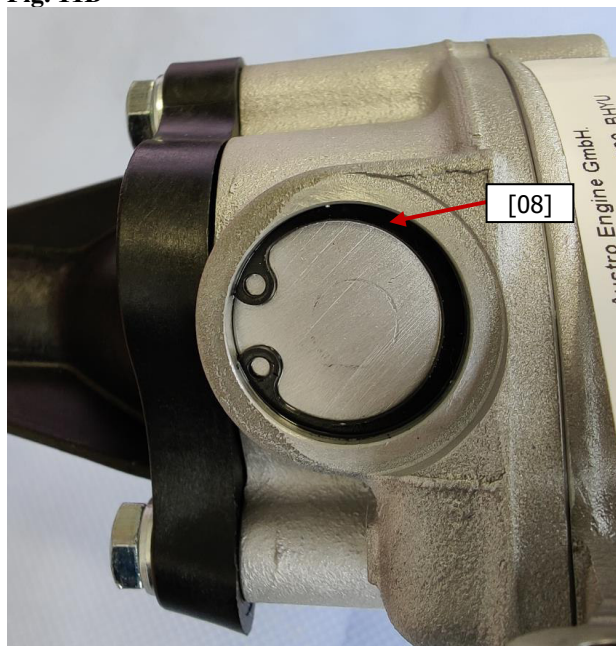
Fig. 12B

Make sure that the circlips [07] (E4A-50-300-801) [08] (E4A-50-400-801) used to secure both plugs on the oil pump is in the correct position.

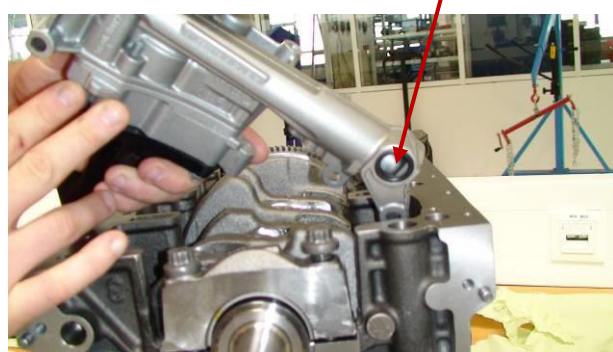
Fig. 14B

Discard the O-Ring (OR_16x3-ACM 70) between the oil pump and the crankshaft housing.

Install a new O-Ring.
Make sure it is correctly fitted.

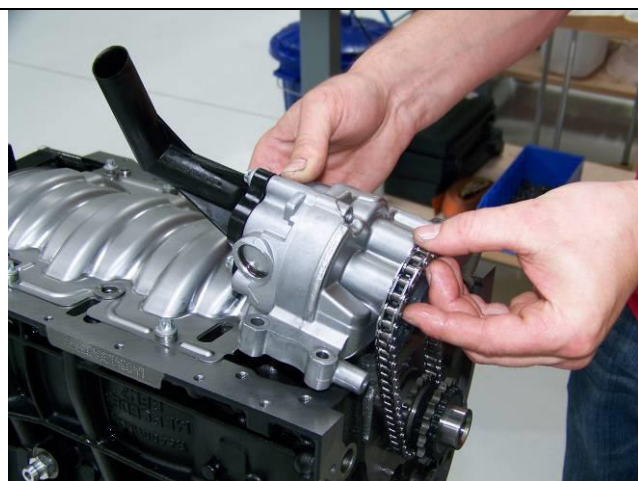
Fig. 15B

Install the oil pump chain.
Apply some approved engine oil (refer to the MM) on the chain before installation.

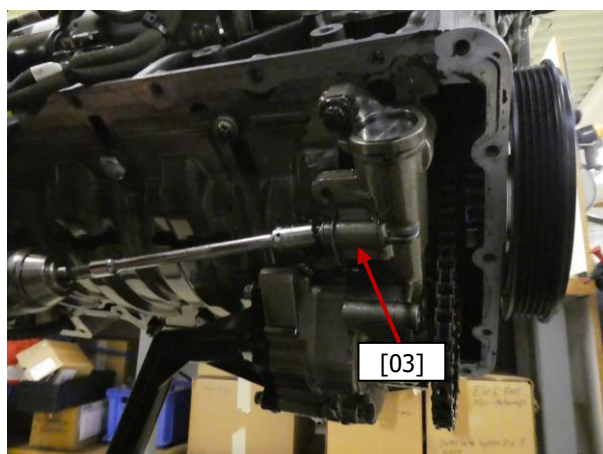
Fig. 18B

Install the oil pump with O-Ring and three screws [04] (M7x27 – 8.8 – DBL 9400.40) on the crankcase.

Apply Loctite 2701 or 278 on the thread and tighten with a torque of 14 Nm.

Install the screw [03] that attaches the oil pump to the oil repellent. Apply with Loctite 243 and torque it with 12 Nm.

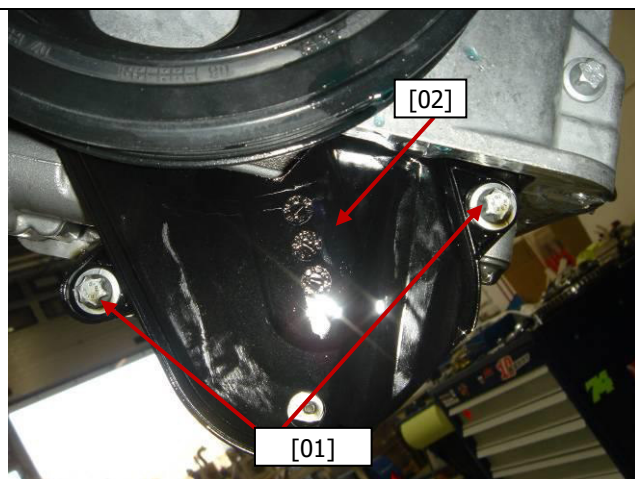
Fig. 19B

Install the oil pump chain cover

Put the chain cover [02] in place on the oil pump and tighten the screws [01] (ISO8102-M6x20-10.9) (x2) with 12 Nm.
