MANDATORY SERVICE BULLETIN

MSB 42-136/1

MSB 42NG-078

Inspection of NLG actuator attachment lever.

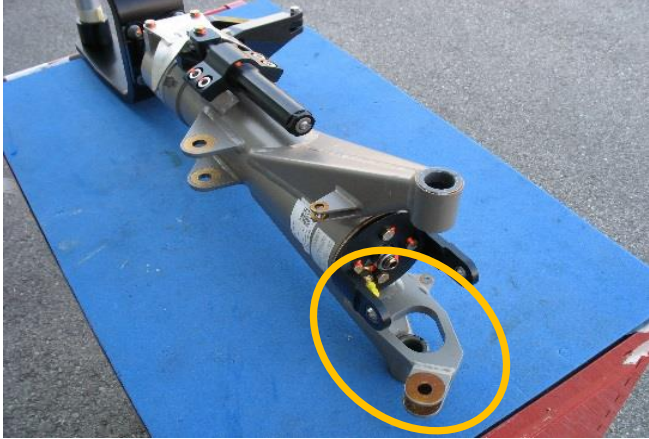
<p>Note: For better illustration, the examination process of the NLG actuator attachment lever is shown on a NLG leg that was removed from the airplane. It is not necessary to remove the NLG leg from the aircraft for examination of the NLG actuator attachment lever.</p>
<p>1</p>	<p>Clean the NLG actuator attachment lever.</p>

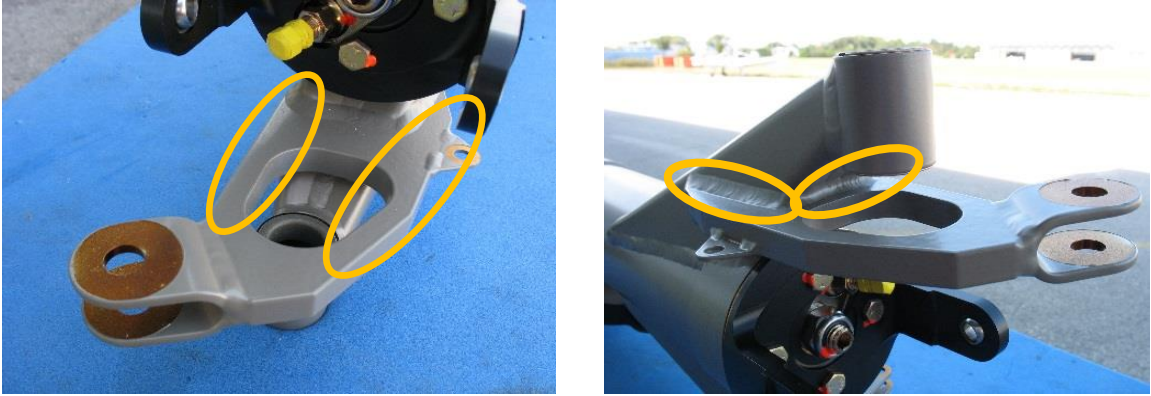
<p>2</p>	<p>Examine the NLG leg actuator attachment lever for cracks and damage in the area as indicated in the pictures.</p>

<p>3</p>	<p>If cracks or damage are found, replace NLG leg with a new part in accordance with AMM, section 32-20.</p>
<p>4</p>	<p>Clean working areas, check for foreign objects.</p>
<p>5</p>	<p>Check all altered, replaced, repaired parts for proper function.</p>
<p>6</p>	<p>Test all systems in working area for function.</p>
<p>7</p>	<p>Make all necessary entries in the airplane logs.</p>
