MANDATORY SERVICE BULLETIN

MSB 42-138

MSB 42NG-080

Replacement of Fuel Tank Connection Hoses.

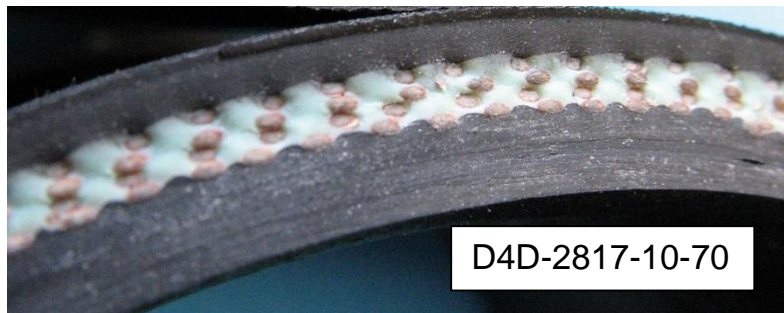
- D4D-2817-10-70
 This fuel tank connection hose has a light blue layer in the cross-section.
 Only a fraction of these hoses come from the affected two batches.

Note: The following pictures show the difference between the two types of fuel tank connection hoses in field.

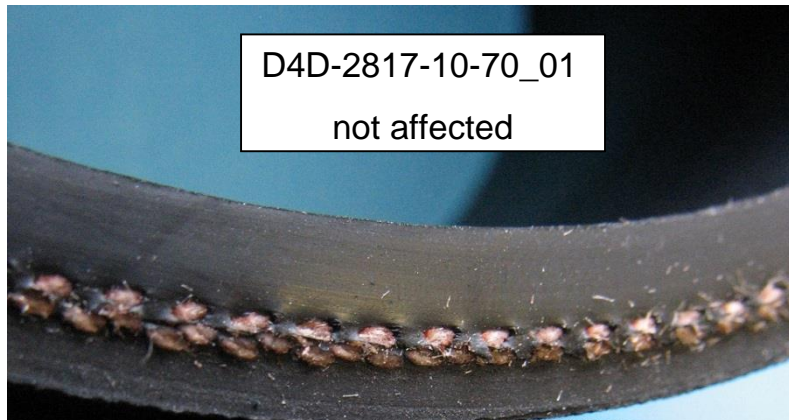
- D4D-2817-10-70_01
 This fuel tank connection hose has an all black cross section and is not affected.
