SERVICE INFORMATION NO. SI 42-147 SI 42NG-018

All DA 42, DA 42 M, DA 42 NG and DA 42 M-NG airplanes

Removal and installation of passenger seat

ATA-Code: 25-20

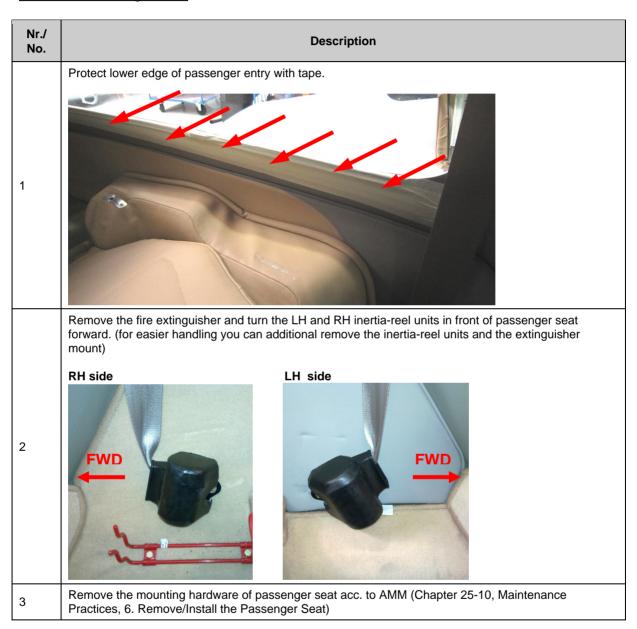
Removal of Passenger Seat:

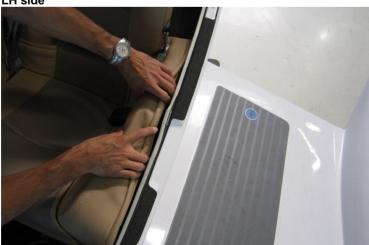
5 WHILE lifting LH side of passenger seat over lower edge of passenger entry.

If LH side of passenger seat is completely lifted over lower edge of passenger entry, move passenger seat out through passenger entry. (two people are recommended for this work)
