SERVICE INFORMATION LETTER NO. SI62-010/3

All DA 62 aircraft

Air Intake System Hose
ATA-Code: 71-60

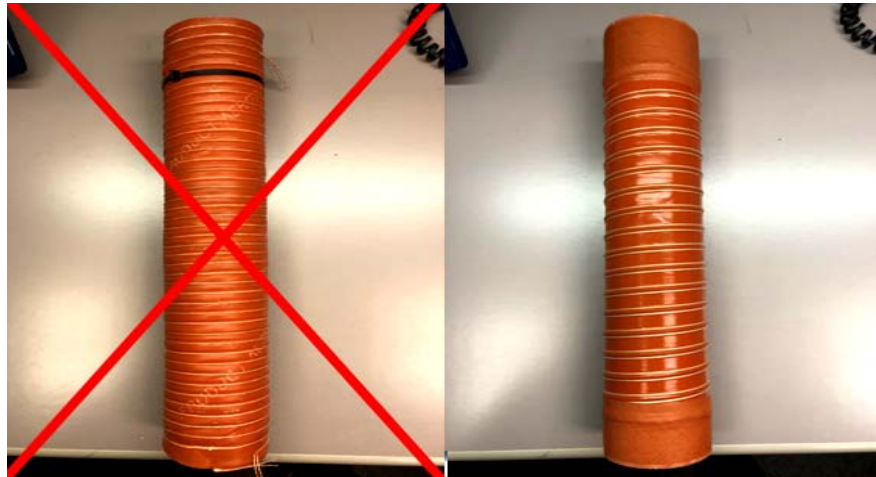
Figure 1: Left - SCEET Hose, Right - Current DAI Part

- 1.4.1 As shown in Figure 1 below, the SCEET hose can be identified by the “Aeroduct Product” stamping (or other reference), single string reinforcement and non-reinforced ends. The DAI part can be identified by the double stitching and in later serial number, the reinforced ends.

- 1.4.3 Upon inspection, if you cannot positively identify the hose as a correct DAI part, remove and discard the hose.
- 1.4.4 Install the DAI hose (P/N DS-HA2-75-0380-30-45) and ensure proper fitting of the hose. For the hose clamp installation, refer to the DA 62 AMM Chapter 20-70-00.

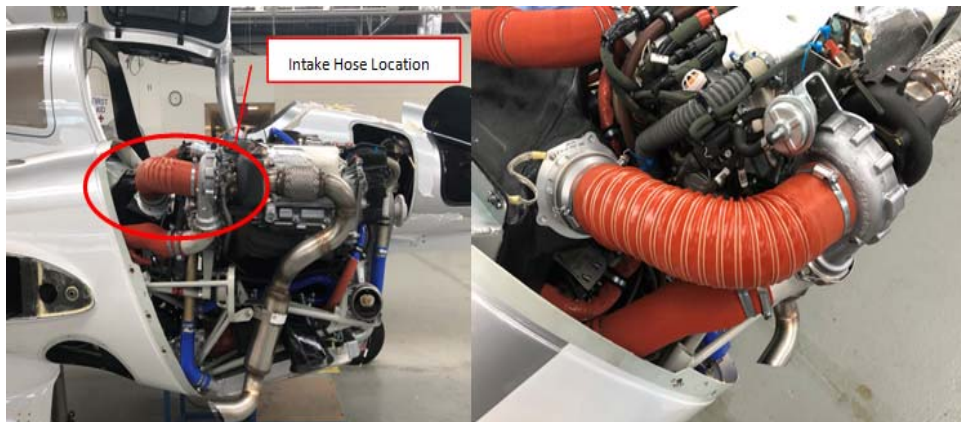
Figure 2: Intake Hose Location in DA 62 Aircraft

- 1.4.2 Customers are advised to confirm the correct part is installed on their DA 62 aircraft. The hose is installed in the air intake system between the alternate air valve and the turbocharger. Location of the hose is shown in Figure 2 below.
