## SERVICE INFORMATION NO. SI 20-081

Rotax Service Bulletin No. SB-912-071 Replacement of oil filter

# Replacement of oil filter for ROTAX® Engine Type 912 i, 912 and 914 (Series)

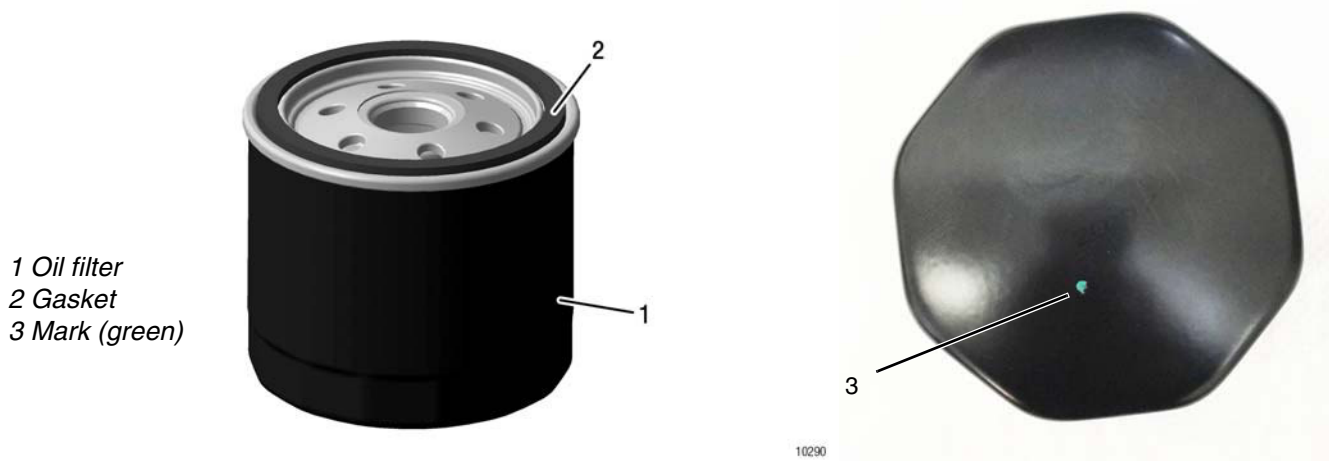
Fig. 1  
Oil filter

The above engines have been fitted by the manufacturer with an oil filter part no. 825016 with a production date code 10/17 up to 38/17 and have no green mark see Fig. 1).

All engines are affected, which have been equipped with an oil filter part no. 825016 (with a production date code from 10/17 up to 38/17) during engine repair, maintenance or general overhaul as of June 8<sup>th</sup>, 2017 to October 31<sup>st</sup>, 2017 and have no green mark. see Fig. 1).

Step	Procedure
1	Check the engine logbook and maintenance documentation or shipping documents to see if this Service Bulletin has already been accomplished.
2	<p>Check whether the affected oil filter shows a green mark on the crown of oil filter (as illustrated in Fig. 1) (same area as production date code).</p> <ul style="list-style-type: none"> <li>- green mark is present: this oil filter is OK as it has already been tested by the supplier and can be used even though the production date code is from 10/17 to 38/17. No further actions are required.</li> <li>- green mark NOT present: this oil filter is NOT OK, please follow the instructions in section 3.2).</li> </ul> <p>NOTE: If production date code is not easy to read, use a proper means of light (e.g. flashlight directed at a proper angle onto the oil filter crown etc.) for better visibility of the coding imprint.</p>

See Fig. 1.

Step	Procedure
1	Remove the affected oil filter according to the Maintenance Manual Line.
2	Install the new oil filter according to the Maintenance Manual Line.

See [Fig. 1](#).

Step	Procedure
1	Quarantine and/or remove affected filters from your inventory. Mark as unserviceable and return F.O.B. to your ROTAX® Authorized Distributor or their independent Service Centers.
