TECHNISCHE INFORMATION NR. SI 36-110

Alle HK 36 R, TS, TC, TTS, TTC, TTC-ECO Flugzeuge

Rotax Service Bulletin Nr. SB-912-071 und SB-914-053

Replacement of oil filter for ROTAX® Engine Type 912 i, 912 and 914 (Series)

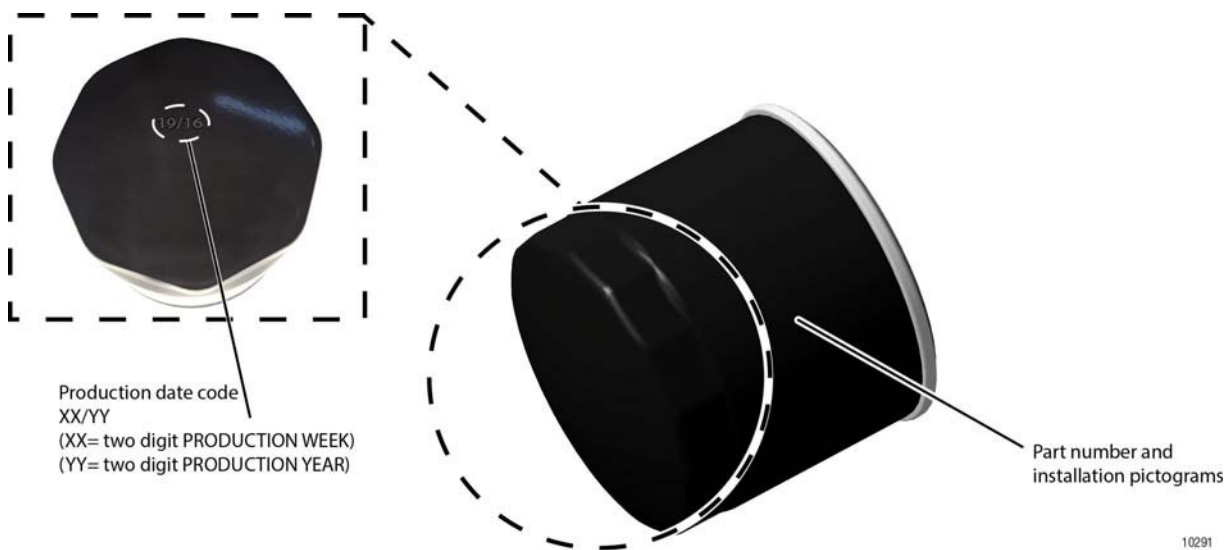
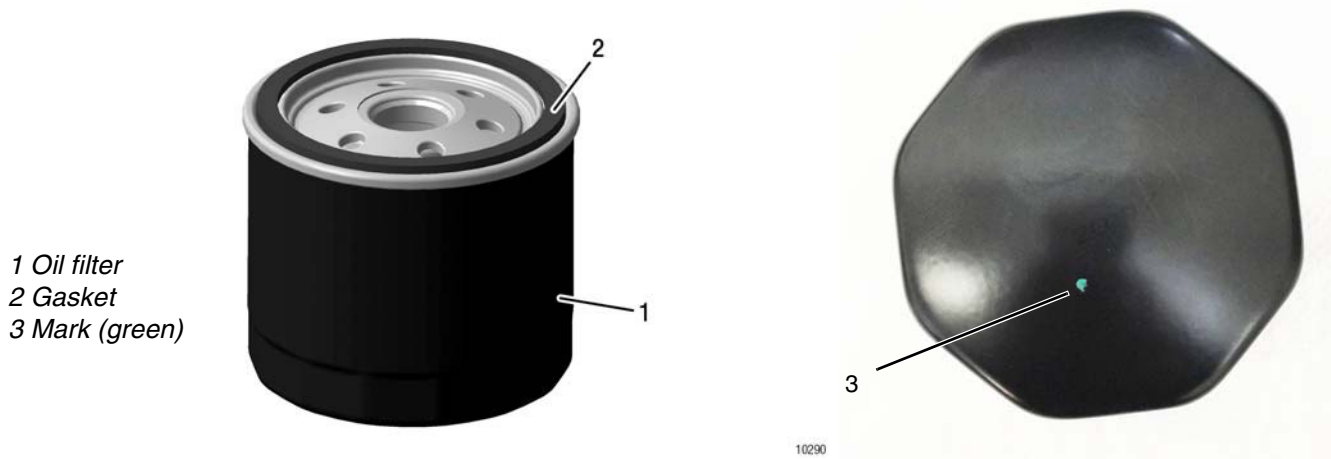
Fig. 1
Oil filter

The above engines have been fitted by the manufacturer with an oil filter part no. 825016 with a production date code 10/17 up to 38/17 and have no green mark see Fig. 1).

All engines are affected, which have been equipped with an oil filter part no. 825016 (with a production date code from 10/17 up to 38/17) during engine repair, maintenance or general overhaul as of June 8th, 2017 to October 31st, 2017 and have no green mark. see Fig. 1).

Step	Procedure
1	Check the engine logbook and maintenance documentation or shipping documents to see if this Service Bulletin has already been accomplished.
2	<p>Check whether the affected oil filter shows a green mark on the crown of oil filter (as illustrated in Fig. 1) (same area as production date code).</p> <ul style="list-style-type: none"> - green mark is present: this oil filter is OK as it has already been tested by the supplier and can be used even though the production date code is from 10/17 to 38/17. No further actions are required. - green mark NOT present: this oil filter is NOT OK, please follow the instructions in section 3.2). <p>NOTE: If production date code is not easy to read, use a proper means of light (e.g. flashlight directed at a proper angle onto the oil filter crown etc.) for better visibility of the coding imprint.</p>

See Fig. 1.

Step	Procedure
1	Remove the affected oil filter according to the Maintenance Manual Line.
2	Install the new oil filter according to the Maintenance Manual Line.

See [Fig. 1](#).
