OPTIONAL SERVICE BULLETIN NO. DA20-27-09 REV. 0

All DA 20-A1 aircraft.

Installation of the Diamond Aircraft flap control module unit and microswitch tray.

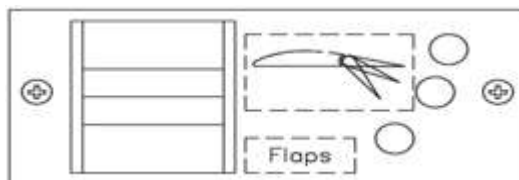
1. Pull the battery circuit breaker located on the right side of the instrument panel.
2. Disconnect the aircraft battery as per AMM Chapter 24-31-00.
3. Remove the instrument panel cover as per AMM Chapter 25-10-00.
4. Remove the flap controller from the instrument panel.

5. Plug the flap controller connector on the instrument panel harness into the Diamond Aircraft flap controller (P/N 22-2753-20-00SB); install into the same location as the previous controller using the supplied hardware.
6. Remove existing flap actuator as per DA201-A1 AMM Chapter 27-50-00.
7. Install the new flap actuator into the aircraft as per DA201-A1 AMM Chapter 27-50-00. Use the new (supplied) hardware (MS21044N4 nut, AN3-4A bolt, NAS1149F0363P washer).
8. If your DA 20-A1 aircraft has a single 6 pin connector (J2750-04) configuration, connected directly to the flaps position switch assembly, reference Figures 1.1, 1.2, and 1.3 for electrical wiring.

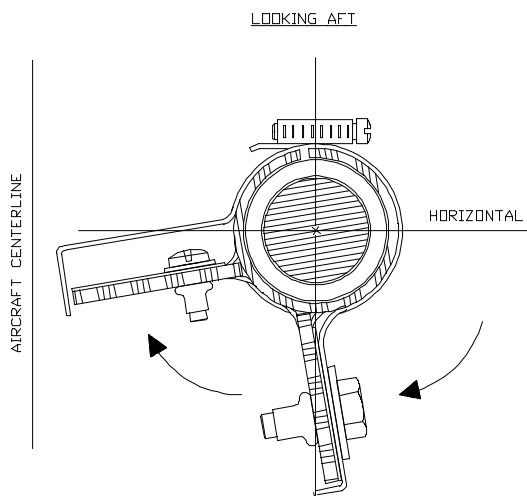
20. Confirm on the aircraft's ammeter that the load drops when the flap actuator comes to rest after each cycle of the flap positions. If the load remains high, check the following:
 - A. If in the landing position, adjust the LDFG limit microswitch.
 - B. If in the cruise position, adjust the microswitch tray. This may also require adjustment of the other switches after.
21. Install the flap actuator shield (P/N 22-2750-06-02) using the supplied hardware (AN3-4A bolt, and NAS1149F0363P washer). Install and secure hardware with Loctite 222.
22. Loosen hose clamps and rotate the microswitch tray until the short side of the cam can only be engaged by the plate with three microswitches. Tighten clamp.

23. Clean working area and inspect for foreign objects.
24. Make a logbook entry that this service bulletin has been incorporated.
