## MANDATORY SERVICE BULLETIN NO.

### MSB 40-103 / MSB F4-042 / MSB D4-114 / MSB 40NG-084

Actions to prevent Passenger Door Separation: Installation of Placards, AFM Procedure update and Inspection/Data Gathering.

Diamond Aircraft Industries have received reports of passenger door separating from aircraft during flight. In some cases, operators forgot to latch the passenger door before flight and that there have been attempts to latch the door during flight, which led to separation of the passenger door.

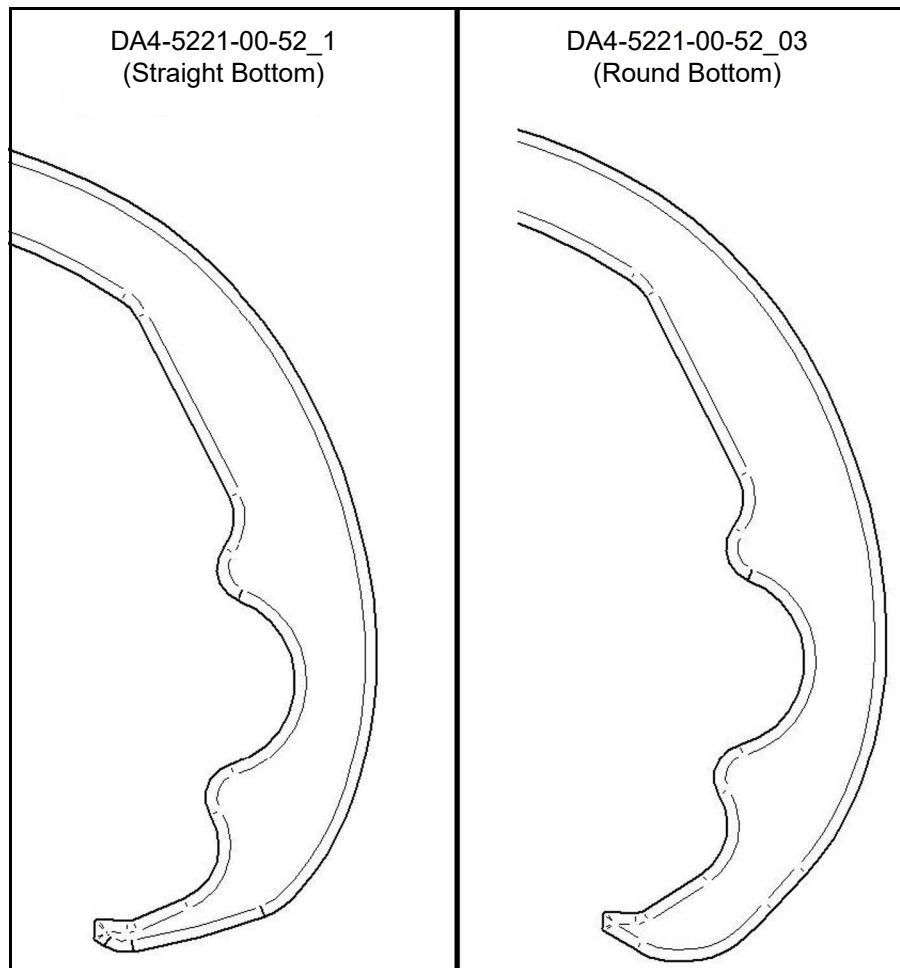
3. Examine the carbon hinges of the passenger door. Refer to AMM Section 52-10.
  - Take notes and correct any findings after this WI is completed.
  - In case of doubt, contact Diamond Aircraft Industries Inc.
  - Record any finding in the execution report in Appendix A.
4. Identify the version of the safety hook (straight bottom or round bottom). Refer to Figure 1. Record the version on the execution report in Appendix A.

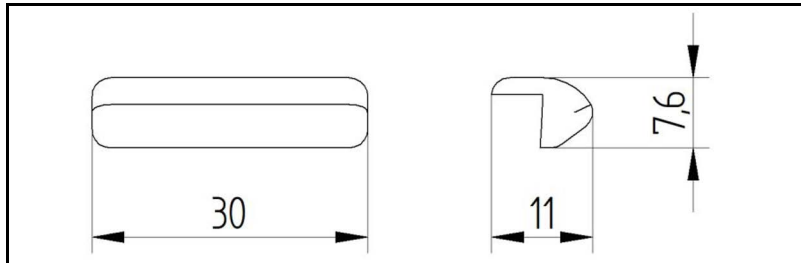
Small (DA4-5200-00-69)

7. Identify the version of the retaining block:  
 Record the version in the execution report.

8. If retaining block DA4-5200-00-69 is installed (refer to step 7):
  - a) Replace the retaining block according to MSB40-070 / MSBD4-079 / MSBF4-024.
  - b) Record the replacement of the retaining block on the execution report in Appendix A.
9. Examine the retaining block for signs of wear, corrosion and poor condition.
  - There must be no corrosion on the retaining block.
  - Wear at the inner sides of the retaining block must be less than 0.5 mm per side.
  - The engaging surface of the retaining block and the edge of the engaging surface that is facing the retaining block must not have any steps and ridges.
  - Scratches or uniform wear of surface protection are acceptable.

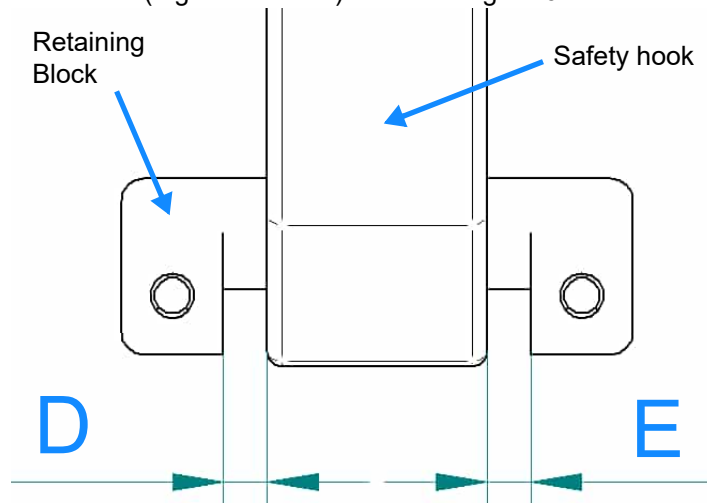
- Dimensions D and E (e.g. with a ruler). Refer to Figure 6.

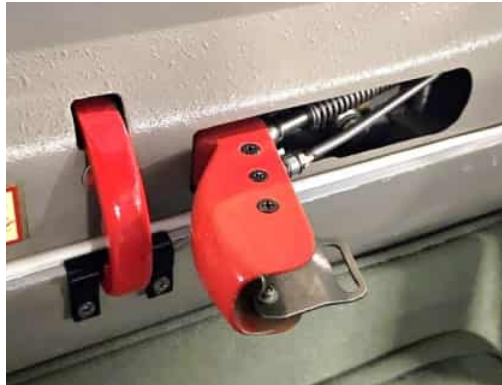
Figure 8. Old door latching mechanism

14. Data collection: Identify the version of the passenger door latching mechanism. Refer to Figures 8 and 9.

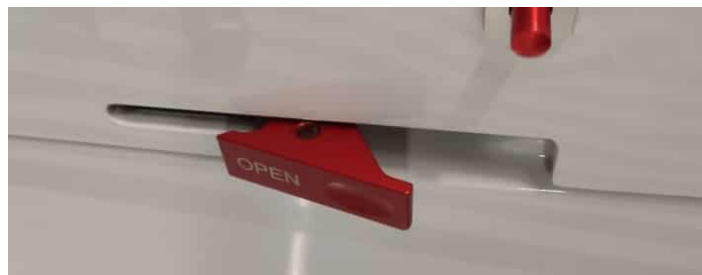
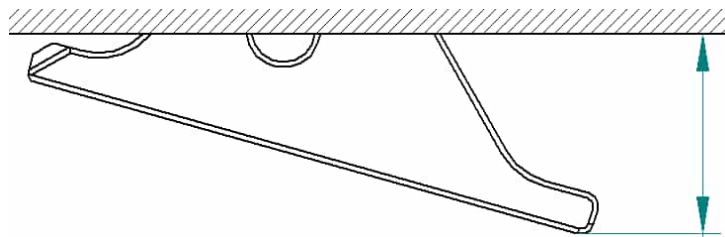
16. Data collection: If MÄM 40-139 is installed (refer to step 14):
- Identify when the gas spring of the passenger door latching mechanism was last replaced/ installed.
  - Record the date of the last replacement on the execution report in Appendix A.
17. If MÄM 40-139 is installed (refer to step 14), examine the condition of the gas spring of the latching mechanism:
- Open the passenger door.
  - Move the door handle to unlatched position.
  - Slowly move the passenger door handle to latched position and measure the distance where the passenger door handle snaps into latched position by itself (measured at the outermost point of the lever, refer to sketch below).

- If the distance is less than 20 mm, take note to replace the compression gas spring after the WI is completed. Refer to AMM Section 52-10.
  - If the distance is less than 20 mm after replacement of the gas spring, the cause is high friction in the latching system.
  - Examine the latching bolts according to step 21.
  - If the reason for high friction in the latching system cannot be found, take note to replace the latching system after the WI is completed. Refer to AMM Section 52-10.
- Record the measured distance and any replacements on the execution report in Appendix A.

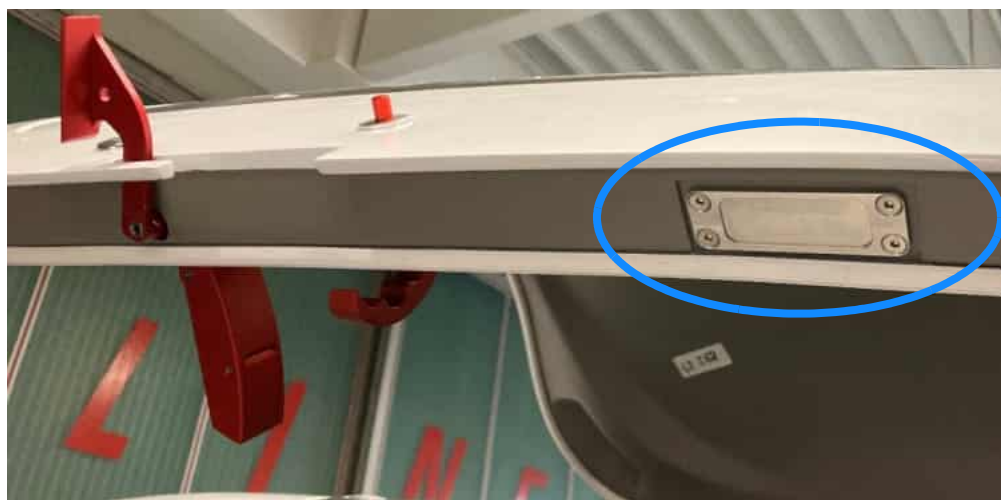
Figure 17. Metal plate

NOTE: Aid for identification: There is a metal plate bolted to the lower surface of the passenger door if MÄM 40-619 is installed. Refer to Figure 17.
