# MANDATORY SERVICE BULLETIN

Model DA 40 / DA 40 F / DA 40 D / DA 40 NG

## **MANDATORY SERVICE BULLETIN NO.** **MSB 40-103 / MSB F4-042 / MSB D4-114 / MSB 40NG-084** **REV. 1**

Actions to prevent Passenger Door Separation: Installation of Placards, AFM Procedure update and Inspection/Data Gathering.

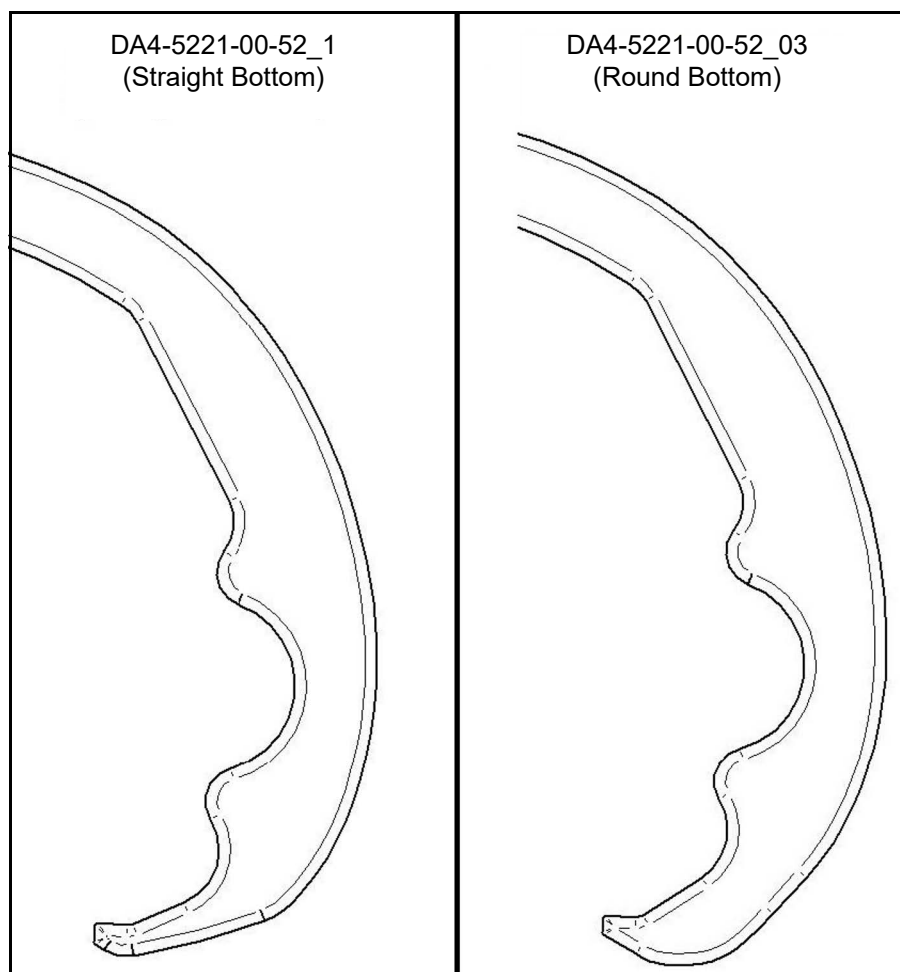
3. Examine the carbon hinges of the passenger door. Refer to AMM Section 52-10.
  - Take notes and correct any findings after this WI is completed.
  - In case of doubt, contact Diamond Aircraft Industries Inc.
  - Record any finding in the execution report in Appendix A.
4. Identify the version of the safety hook (straight bottom or round bottom). Refer to Figure 1.  
Record the version on the execution report in Appendix A.

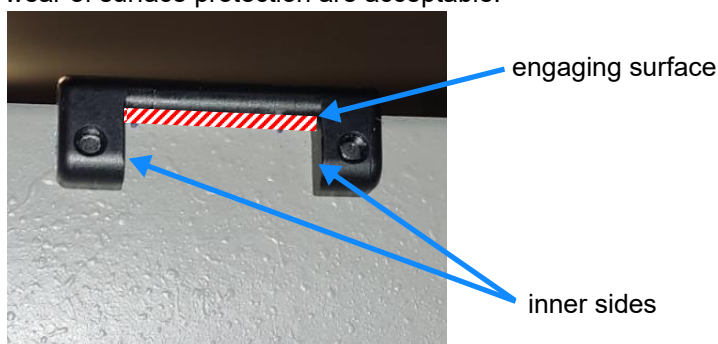
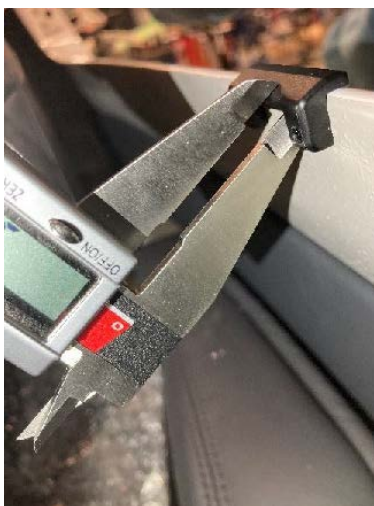
- The thickness of the retaining block measured perpendicular to the upper surface must be greater than:
  - 4 mm for retaining block DA4-5200-00-69\_02 (extended with undercut) or
  - 6 mm for all other retaining blocks. Refer to step 7 for retaining block versions.

- The width of the retaining block must be greater than 10 mm. Refer to Figure 3.
- The variation in thickness of the measured along the width of the retaining block must be less than 0.2 mm.

If the retaining block does not meet one or more of the acceptable conditions mentioned in step 9, take notes and replace the retaining block after the WI is completed. Refer to section IV for removal/installation of the retaining block.

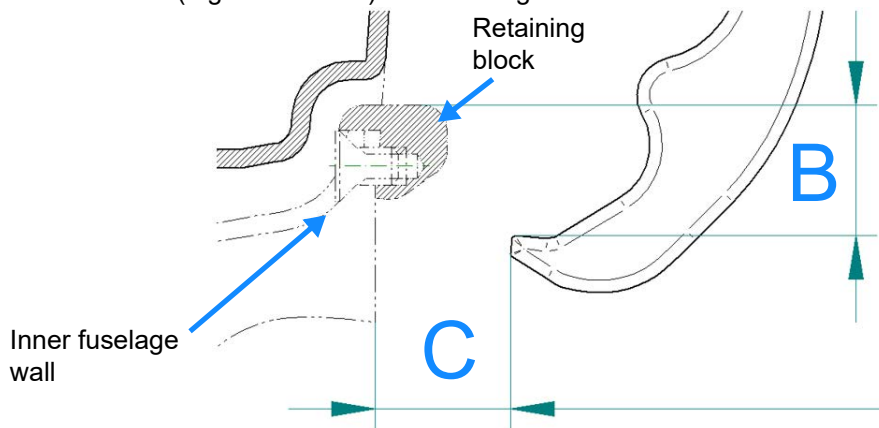
- Dimension B: distance between the top surface of the retaining block to the top surface of the engaging section of the safety hook in resting position (e.g. with a ruler). Refer to Figure 5.
- Dimension C: horizontal distance between the tip of the safety hook and the fuselage wall (e.g. with a ruler). Refer to Figure 9.

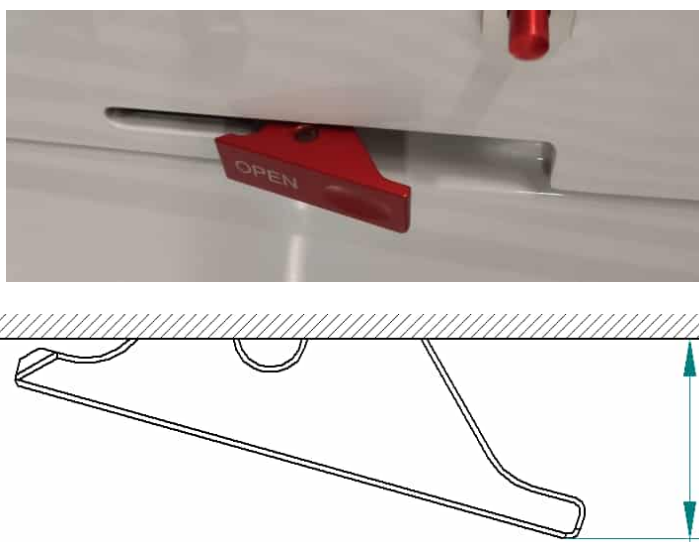
16. Data collection: If MÄM 40-139 is installed (refer to step 14):
- Identify when the gas spring of the passenger door latching mechanism was last replaced/installed.
  - Record the date of the last replacement on the execution report in Appendix A.
17. If MÄM 40-139 is installed (refer to step 14), examine the condition of the gas spring of the latching mechanism:
- Open the passenger door.
  - Move the door handle to unlatched position.
  - Slowly move the passenger door handle to latched position and measure the distance where the passenger door handle snaps into latched position by itself (measured at the outermost point of the lever, refer to sketch below).

- If the distance is less than 20 mm, take note to replace the compression gas spring after the WI is completed. Refer to AMM Section 52-10.
  - If the distance is less than 20 mm after replacement of the gas spring, the cause is high friction in the latching system.
  - Examine the latching bolts according to step 21.
  - If the reason for high friction in the latching system cannot be found, take note to replace the latching system after the WI is completed. Refer to AMM Section 52-10.
- Record the measured distance and any replacements on the execution report in Appendix A.

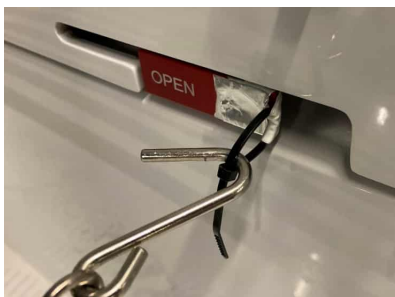
Figure 13. Force measurement example

- a) **Close** and latch the passenger door.
- b) Attach a spring scale with suitable measurement range to the external passenger door handle. Refer to Figure 13.
- c) Measure the force necessary to unlatch the passenger door.
  - The force must be **between** 2 kg (20 N) and 6 kg (60 N).
  - If the force is **greater** than 6 kg (60 N):
    - Identify the reason for exceeding the maximum force limit and rectify any findings.
  - If the force is **less** than 2 kg (20 N):
    - Replace the door sealant (partial) and repeat the test. Refer to section IV.
- d) **Open** the passenger door.
- e) Move the passenger door handle to the latched position.

- f) Measure the force necessary to move the passenger door handle to the unlatched position.
  - The force must be **greater** than 1.8 kg (18 N).
  - If the force is less than 1.8 kg (18 N) and step c) was passed:
    - Replace the gas spring within 12 months. Until then, repeat step c) every 100 hours to ensure force for the **closed** door remains between 2 kg (20 N) and 6 kg (60 N).
  - If the force is less than 1.8 kg (18 N) and step c) cannot be passed:
    - Replace gas spring immediately and repeat step c) and step f).
  - Record the measured forces and any findings on the execution report in Appendix A.
- g) If MÄM 40-139 is not installed (old latching mechanism, refer to step 14) and you fail the tests, replace the metallic spring (Refer to AMM Section 52-10) or replace the old door latch with the new door latch as per RSB 40-093 / RSB D4-105 / RSB 40NG-053.

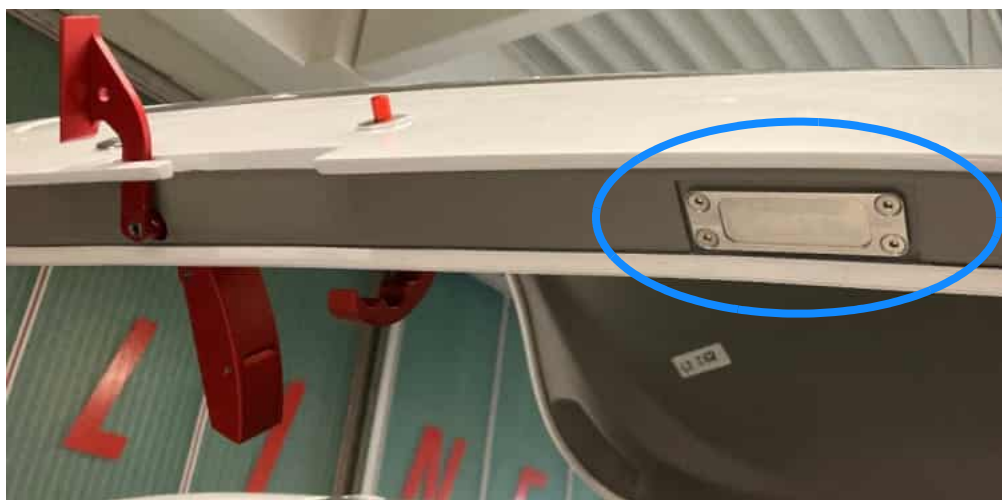
Figure 17. Metal plate

NOTE: Aid for identification: There is a metal plate bolted to the lower surface of the passenger door if MÄM 40-619 is installed. Refer to Figure 17.
