**MANDATORY SERVICE BULLETIN NO.**  
**MSB 40-103 / MSB F4-042 / MSB D4-114 / MSB 40NG-084**  
**REV. 2**

Type: DA 40 / DA 40 D / DA 40 F / DA 40 NG

Actions to prevent Passenger Door Separation: Installation of Placards, AFM Procedure update and Inspection/Data Gathering.

**WORK INSTRUCTION**  
**WI-MSB 40-103 / WI-MSB F4-042 / WI-MSB D4-114 / WI-MSB 40NG-084**  
**REV. 2**

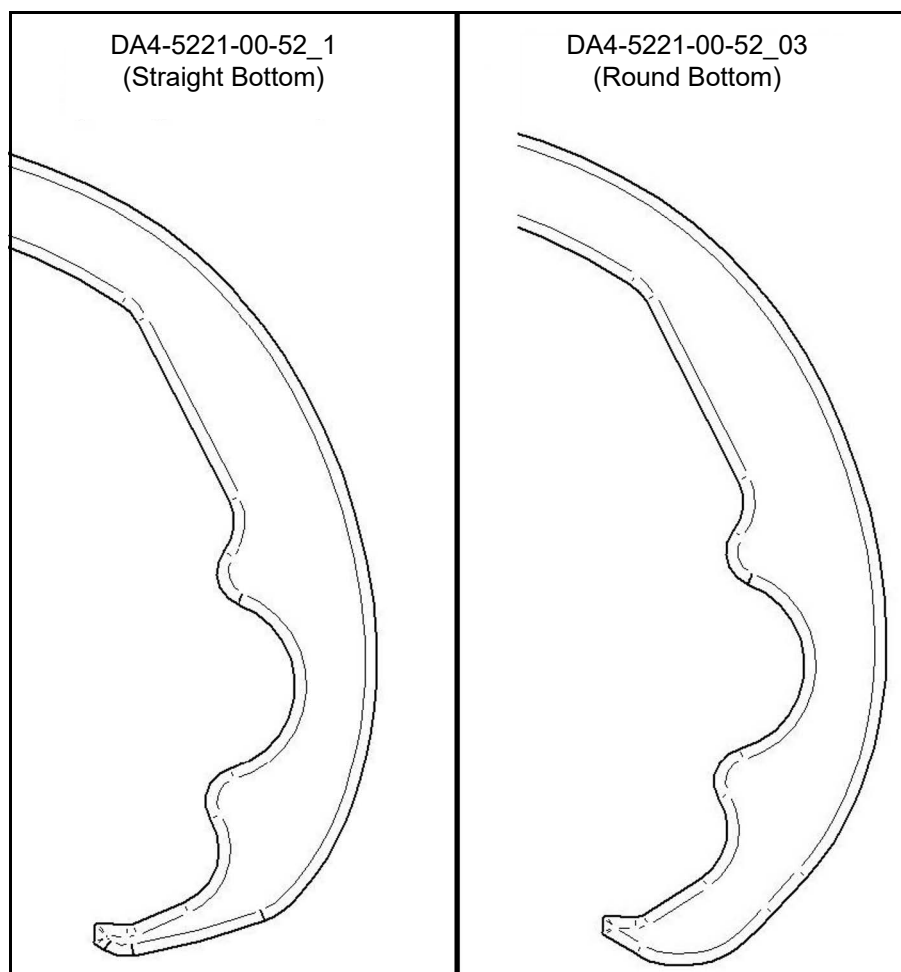
3. Examine the carbon hinges of the passenger door. Refer to AMM Section 52-10.
  - Take notes and correct any findings after this WI is completed.
  - In case of doubt, contact Diamond Aircraft Industries Inc.
  - Record any finding in the execution report in Appendix A.
4. Identify the version of the safety hook (straight bottom or round bottom). Refer to Figure 1.  
Record the version on the execution report in Appendix A.

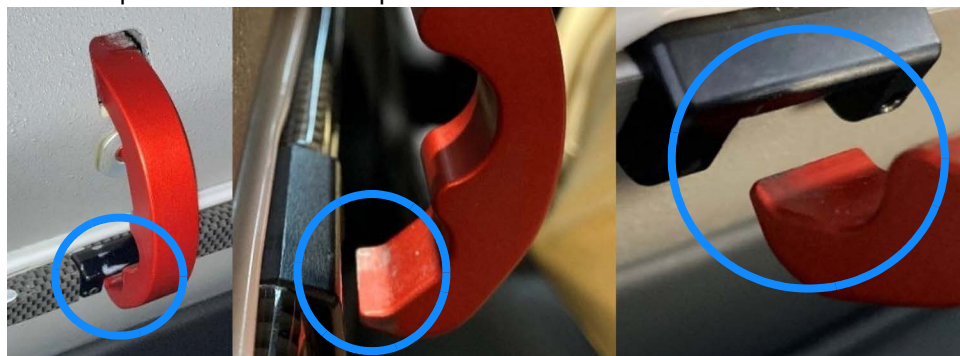
Acceptable condition examples:

c) Examine the tip of the safety hook for wear:

- Wear of edges of safety hook.
- The width of the tip of the safety hook must be greater than 10.5mm.

- h) If the safety hook does not meet one or more of the acceptable conditions listed above on sub-steps **a** through **g**, take note to replace the safety hook after this WI is completed. Refer to Section IV for replacement of the safety hook.

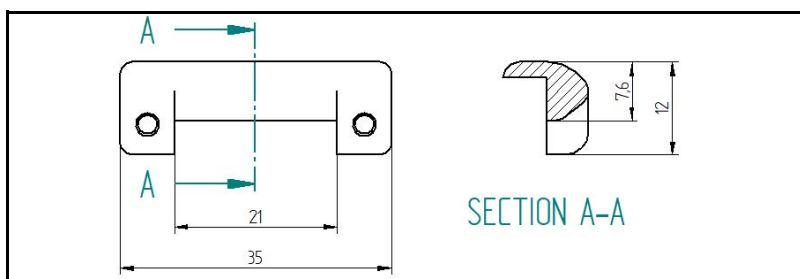
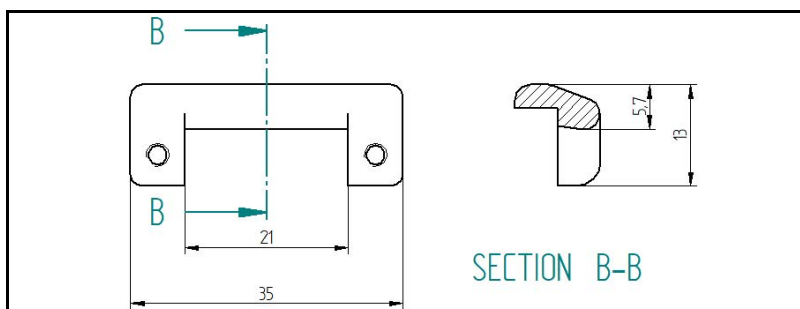
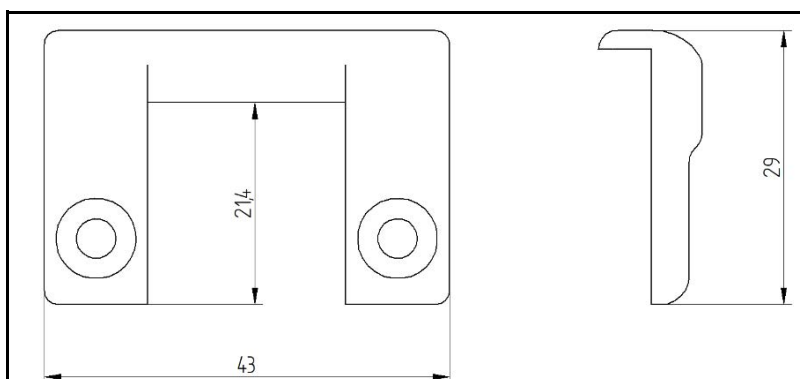
7. Identify the version of the retaining block:  
Record the version in the execution report.

Small (DA4-5200-00-69)

Extended without undercut (DA4-5200-00-69\_1)

Extended with undercut (DA4-5200-00-69\_02)

Long extended (DA4-5200-00-69-SB)

8. If retaining block DA4-5200-00-69 is installed (refer to step 7):
  - a) Replace the retaining block according to MSB40-070 / MSBD4-079 / MSBF4-024.
  - b) Record the replacement of the retaining block on the execution report in Appendix A.
9. Examine the retaining block for signs of wear, corrosion and poor condition.
  - There must be no corrosion on the retaining block.
  - Wear at the inner sides of the retaining block must be less than 0.5 mm per side.
  - The engaging surface of the retaining block and the edge of the engaging surface that is facing the retaining block must not have any steps and ridges.
  - Scratches or uniform wear of surface protection are acceptable.

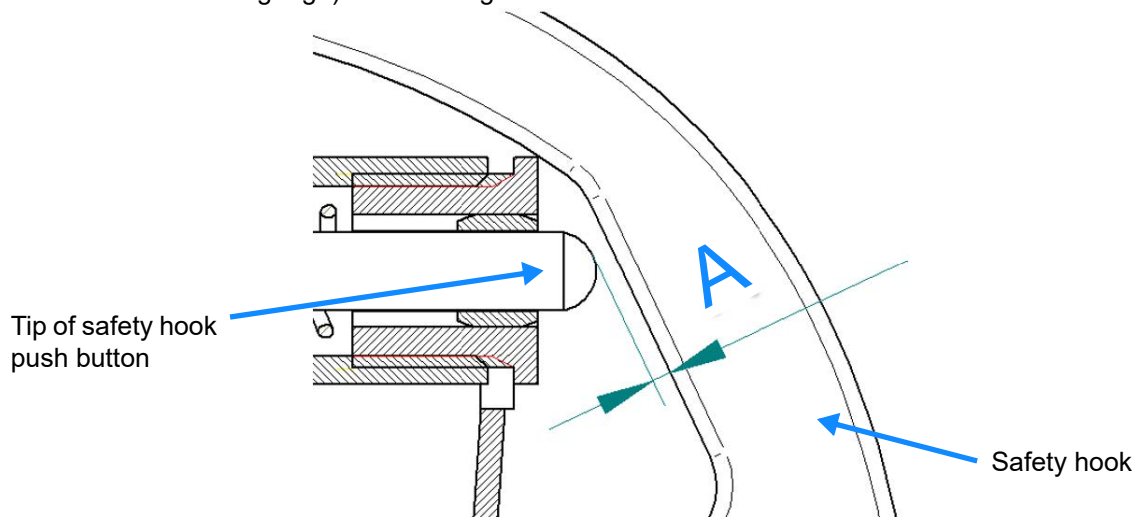
- Dimension A: distance of push button to the safety hook in resting position (e.g. with a feeler gauge). Refer to Figure 4.

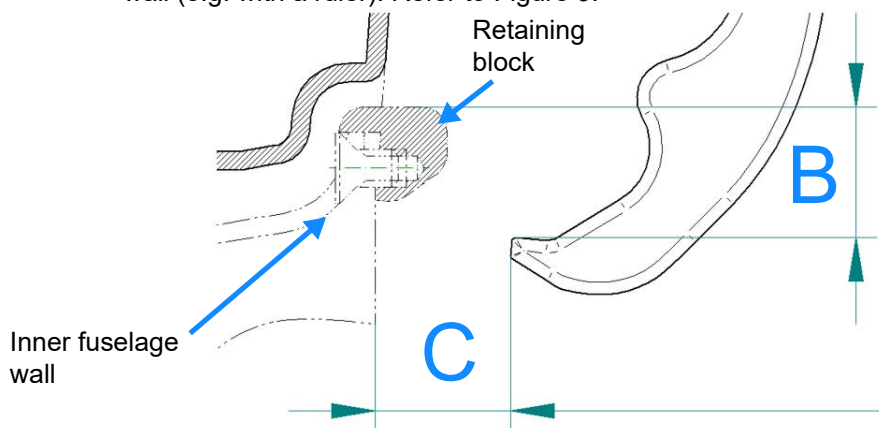
- Dimension B: distance between the top surface of the retaining block to the top surface of the engaging section of the safety hook in resting position (e.g. with a ruler). Refer to Figure 5.
- Dimension C: horizontal distance between the tip of the safety hook and the fuselage wall (e.g. with a ruler). Refer to Figure 9.

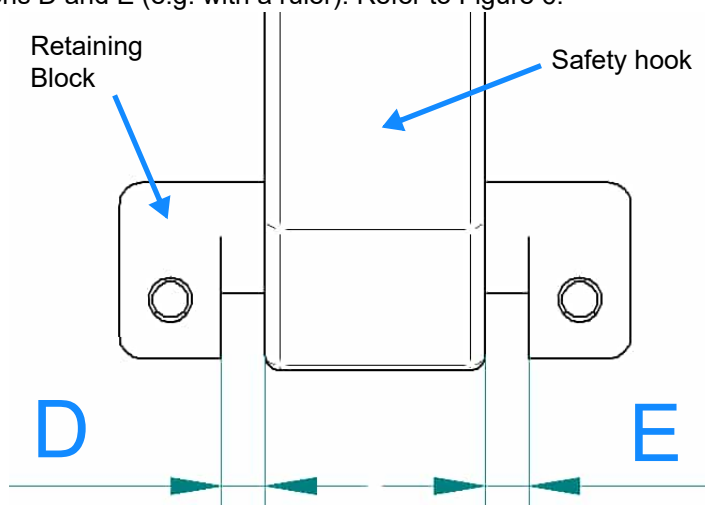
- Dimensions D and E (e.g. with a ruler). Refer to Figure 6.

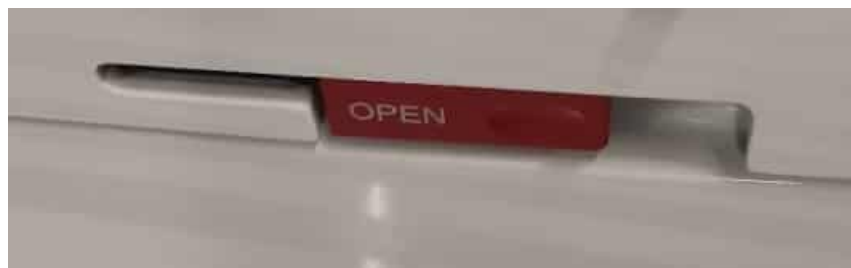
19. Data collection: Position of the external passenger door handle. Refer to Figures 11 and 12.

Figure 12. Recessed passenger door handle example

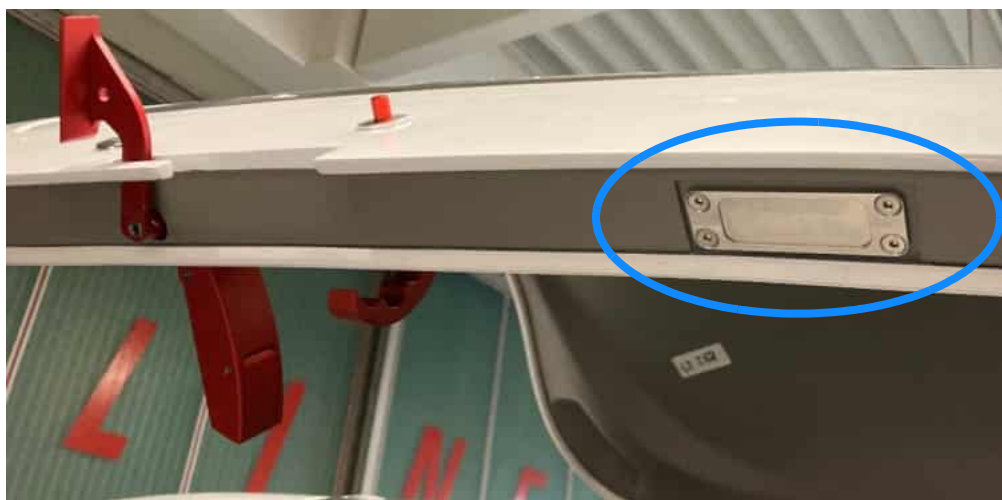
NOTE: Aid for identification: There is a metal plate bolted to the lower surface of the passenger door if MÄM 40-619 is installed. Refer to Figure 17.

Figure 17. Metal plate
