MANDATORY SERVICE BULLETIN NO.

MSB 40-103 / MSB F4-042 / MSB D4-114 / MSB 40NG-084

Actions to prevent Passenger Door Separation: Installation of Placards, AFM Procedure update and Inspection/Data Gathering.

ATA-Code: 52-20

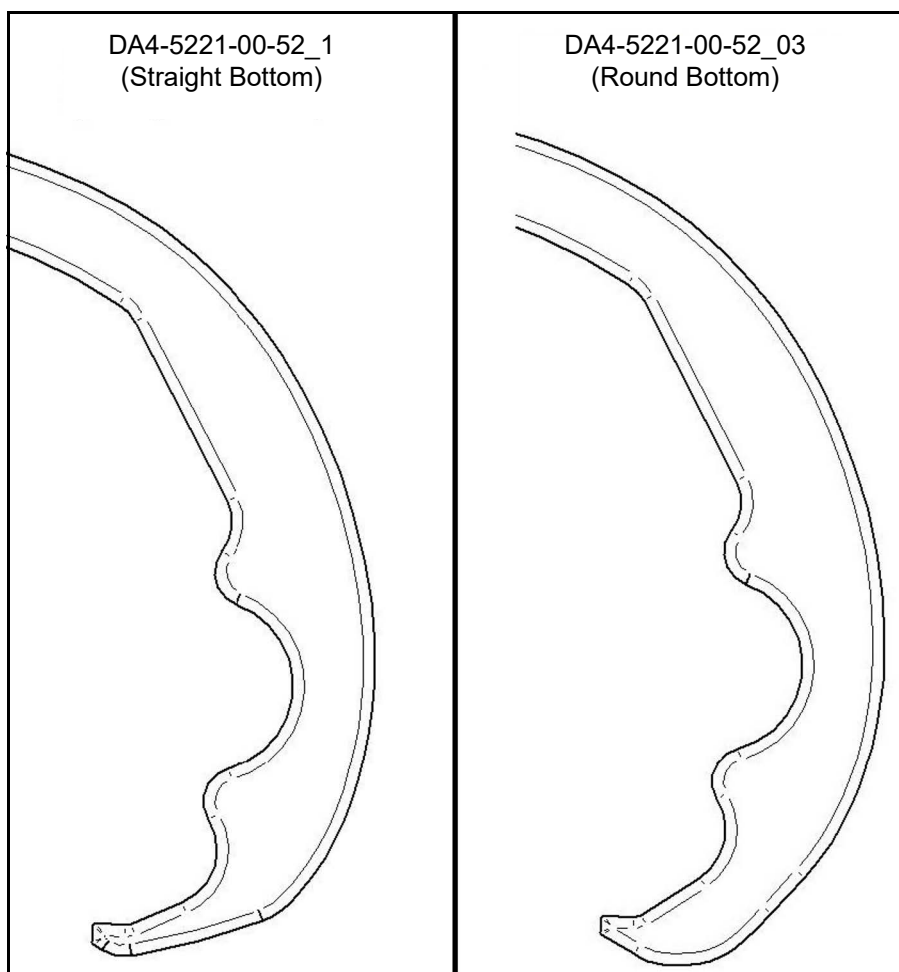
3. Examine the carbon hinges of the passenger door. Refer to AMM Section 52-10.
 - Take notes and correct any findings after this WI is completed.
 - In case of doubt, contact Diamond Aircraft Industries Inc.
 - Record any finding in the execution report in Appendix A.
4. Identify the version of the safety hook (straight bottom or round bottom). Refer to Figure 1. Record the version on the execution report in Appendix A.

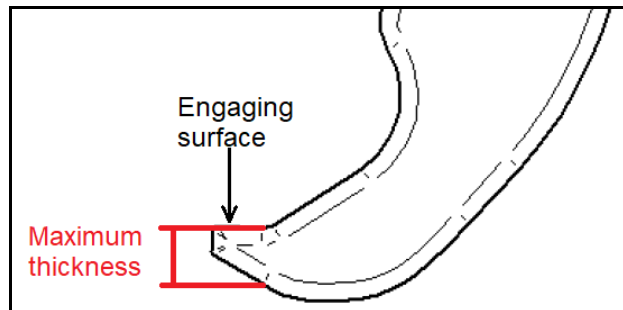
- f) Measure the maximum thickness of the safety hook at the location of the engaging surface, perpendicular to the engaging surface.
- The maximum thickness must be greater than 2.5 mm.
 - The the variation of thickness measured along the width of the safety hook must be less than 0.2 mm.

- h) If the safety hook does not meet one or more of the acceptable conditions listed above on sub-steps **a** through **g**, take note to replace the safety hook after this WI is completed. Refer to Section IV for replacement of the safety hook.

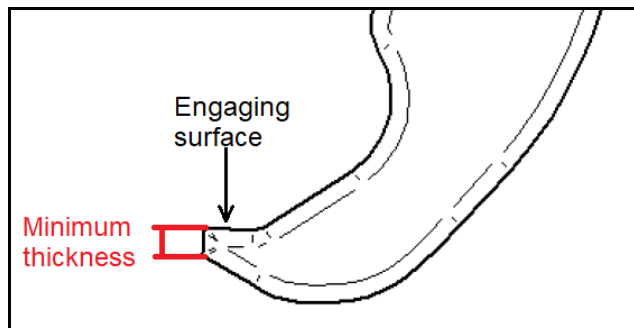
- g) Measure the minimum thickness of the safety hook at the location of the engaging surface, perpendicular to the engaging surface.
- The minimum thickness must be greater than 1.5 mm.
 - The variation of thickness measured along the width of the safety hook must be less than 0.2 mm.

- The edge of the engaging surface of the safety hook that is facing towards the retaining block must not have any ridges.

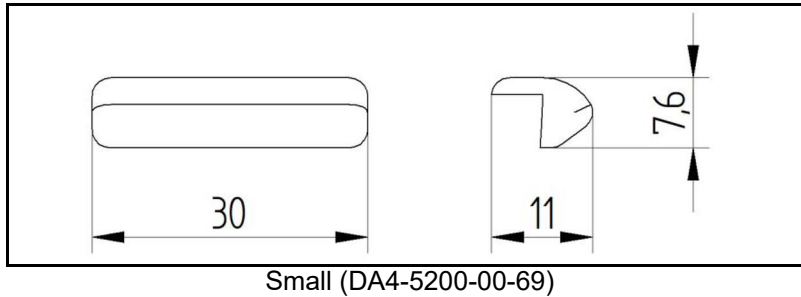
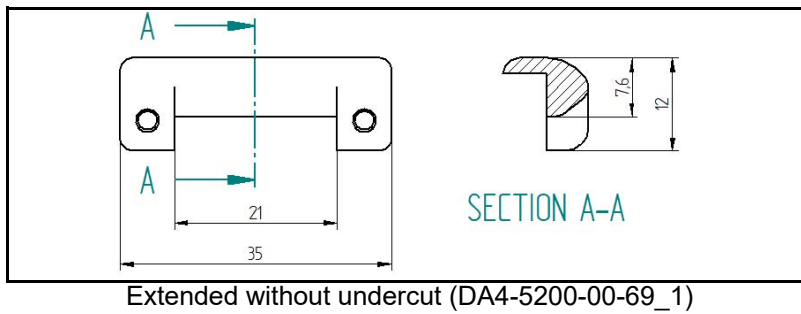
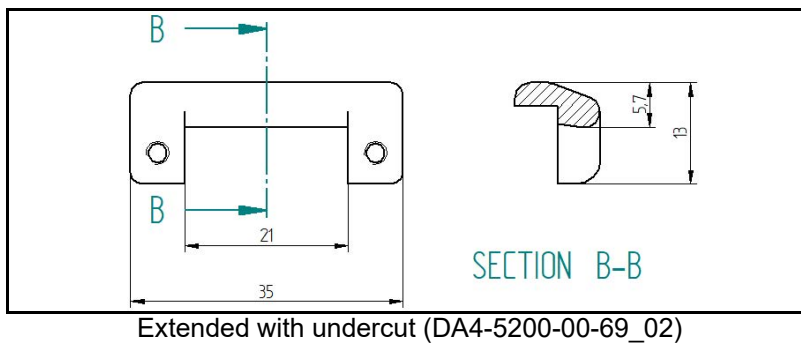
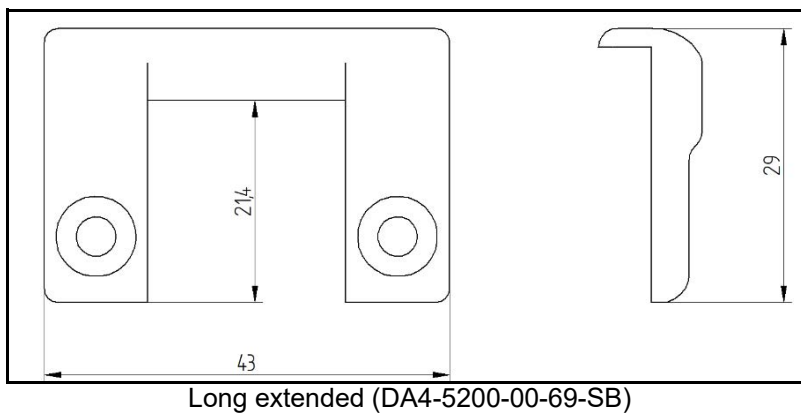
7. Identify the version of the retaining block:
 Record the version in the execution report.

8. If retaining block DA4-5200-00-69 is installed (refer to step 7):
 - a) Replace the retaining block according to MSB40-070 / MSBD4-079 / MSBF4-024.
 - b) Record the replacement of the retaining block on the execution report in Appendix A.
9. Examine the retaining block for signs of wear, corrosion and poor condition.
 - There must be no corrosion on the retaining block.
 - Wear at the inner sides of the retaining block must be less than 0.5 mm per side.
 - The engaging surface of the retaining block and the edge of the engaging surface that is facing the retaining block must not have any steps and ridges.
 - Scratches or uniform wear of surface protection are acceptable.

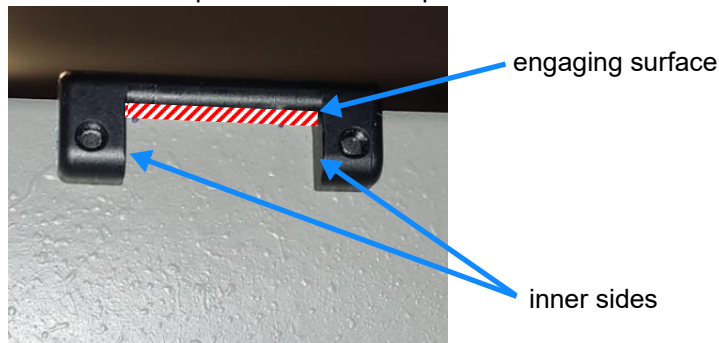
- The thickness of the retaining block measured perpendicular to the upper surface must be greater than:
 - 4 mm for retaining block DA4-5200-00-69_02 (extended with undercut) or
 - 6 mm for all other retaining blocks. Refer to step 7 for retaining block versions.

If the retaining block does not meet one or more of the acceptable conditions mentioned in step 9, take notes and replace the retaining block after the WI is completed. Refer to section IV for removal/installation of the retaining block.

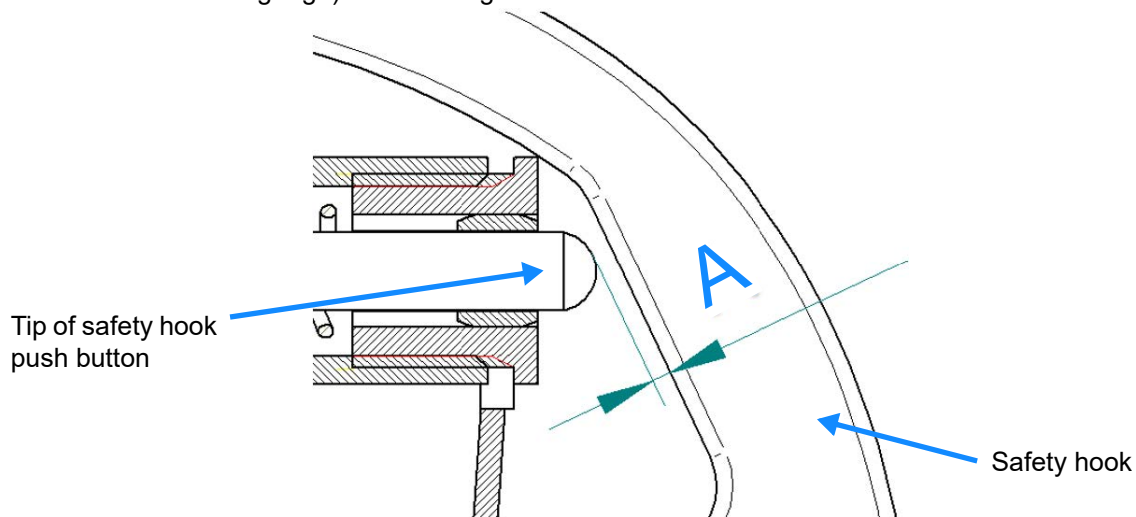
- b) Record the measurements on the execution report in Appendix A.
- Dimension A: distance of push button to the safety hook in resting position (e.g. with a feeler gauge). Refer to Figure 4.

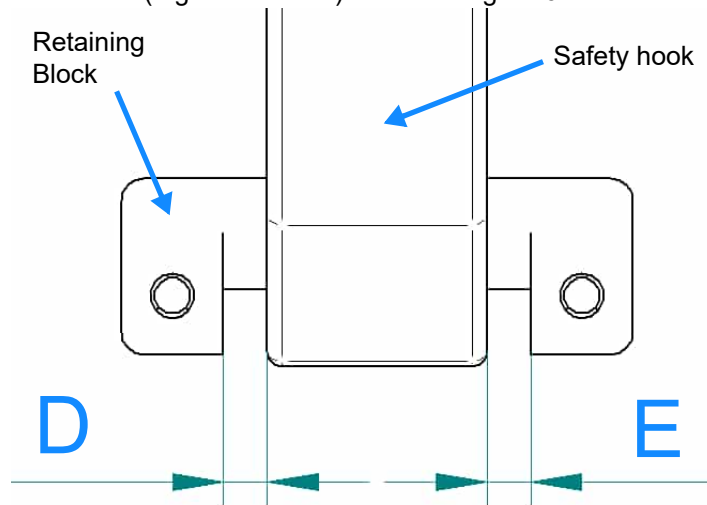
- Dimensions D and E (e.g. with a ruler). Refer to Figure 6.

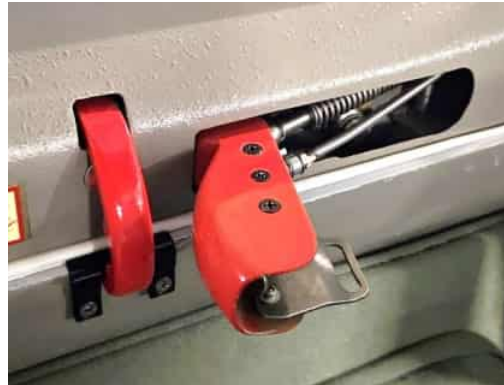
Figure 8. Old door latching mechanism

14. Data collection: Identify the version of the passenger door latching mechanism. Refer to Figures 8 and 9.

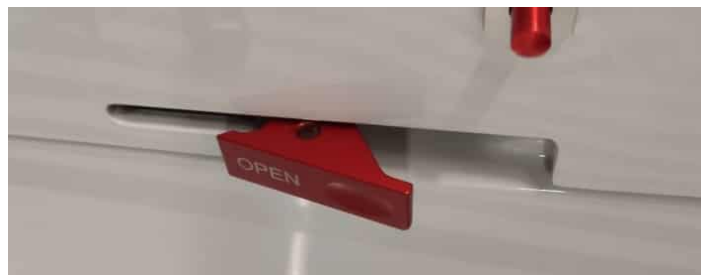
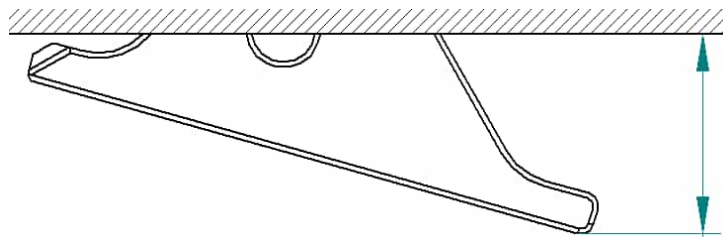
- If the distance is less than 20 mm, take note to replace the compression gas spring after the WI is completed. Refer to AMM Section 52-10.
 - If the distance is less than 20 mm after replacement of the gas spring, the cause is high friction in the latching system.
 - Examine the latching bolts according to step 21.
 - If the reason for high friction in the latching system cannot be found, take note to replace the latching system after the WI is completed. Refer to AMM Section 52-10.
- Record the measured distance and any replacements on the execution report in Appendix A.

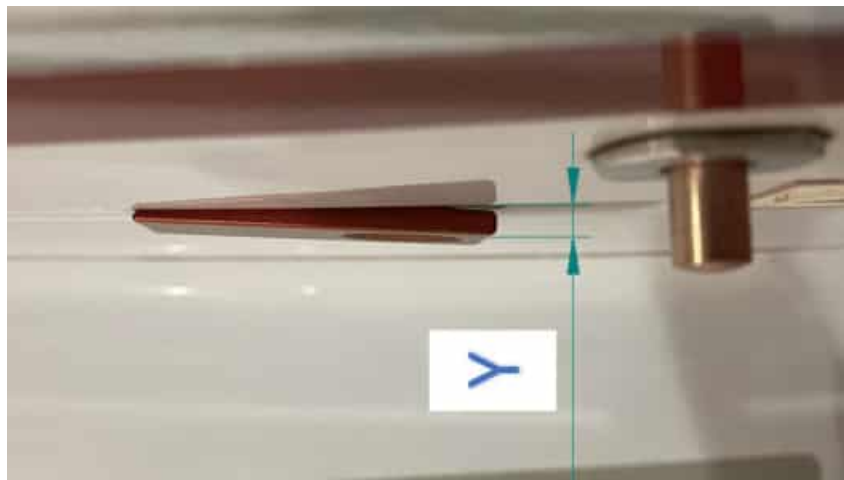
Figure 11. Protrusion measurement

19. Data collection: Position of the external passenger door handle. Refer to Figures 11 and 12.
- Close the passenger door.
 - Push the external passenger door handle into the latched position until it stops.
 - Examine if the passenger door handle is recessed, flush or protruding over the passenger door surface.
 - Record the condition of the passenger door handle on the execution report in Appendix A.
 - If the handle protrudes from the surface of the passenger door, measure the protrusion.
 - Record the measurement on the execution report in Appendix A.

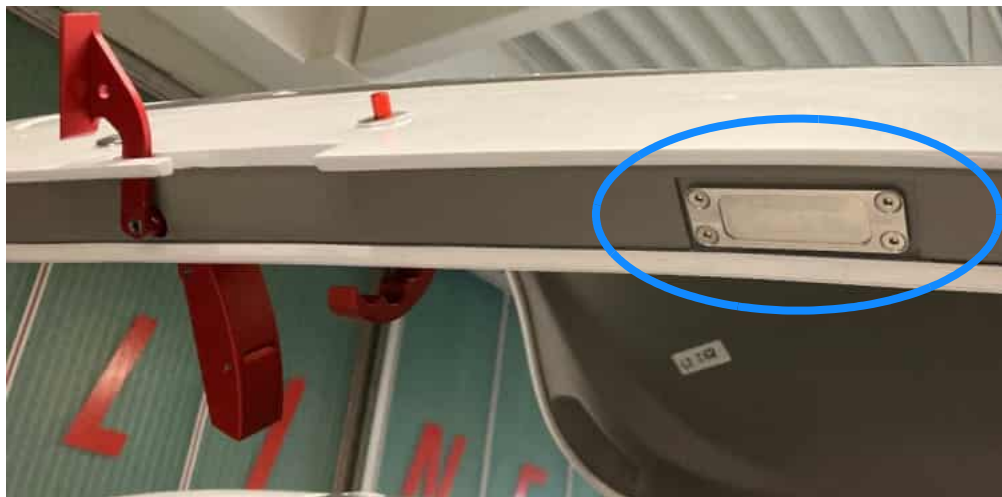
Figure 17. Metal plate

NOTE: Aid for identification: There is a metal plate bolted to the lower surface of the passenger door if MÄM 40-619 is installed. Refer to Figure 17.

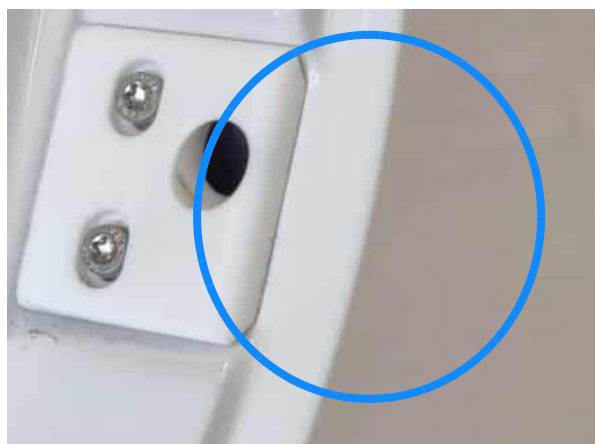
Figure 20. Rear

24. Data collection: Inspect the door frame in the area around the front and rear latching bolts for damage. Refer to Figures 19 and 20.

Record any damage on the execution report in Appendix A.
