# MANDATORY SERVICE BULLETIN

Model DA 40 / DA 40 F / DA 40 D / DA 40 NG

## **MANDATORY SERVICE BULLETIN NO.** **MSB 40-103 / MSB F4-042 / MSB D4-114 / MSB 40NG-084** **REV. 1**

Actions to prevent Passenger Door Separation: Installation of Placards, AFM Procedure update and Inspection/Data Gathering.

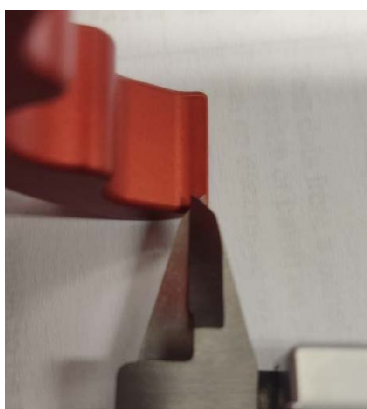
- e) Measure the width of the engaging surface.
- The width must be greater than 1.5 mm.

- f) Measure the maximum thickness of the safety hook at the location of the engaging surface, perpendicular to the engaging surface.
- The maximum thickness must be greater than 2.5 mm.
  - The variation of thickness measured along the width of the safety hook must be less than 0.2 mm.

- h) If the safety hook does not meet one or more of the acceptable conditions listed above on sub-steps **a** through **g**, take note to replace the safety hook after this WI is completed. Refer to Section IV for replacement of the safety hook.

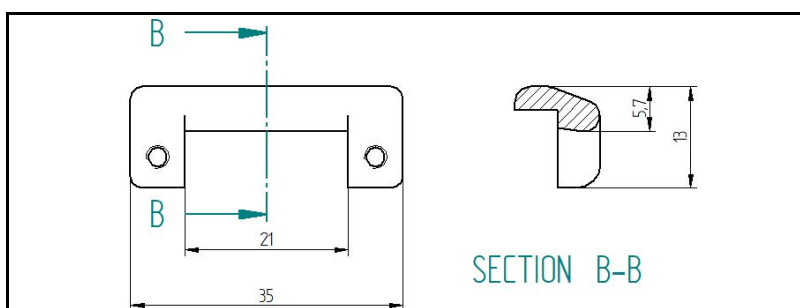
Extended with undercut (DA4-5200-00-69\_02)

7. Identify the version of the retaining block:  
 Record the version in the execution report.

- The thickness of the retaining block measured perpendicular to the upper surface must be greater than:
  - 4 mm for retaining block DA4-5200-00-69\_02 (extended with undercut) or
  - 6 mm for all other retaining blocks. Refer to step 7 for retaining block versions.

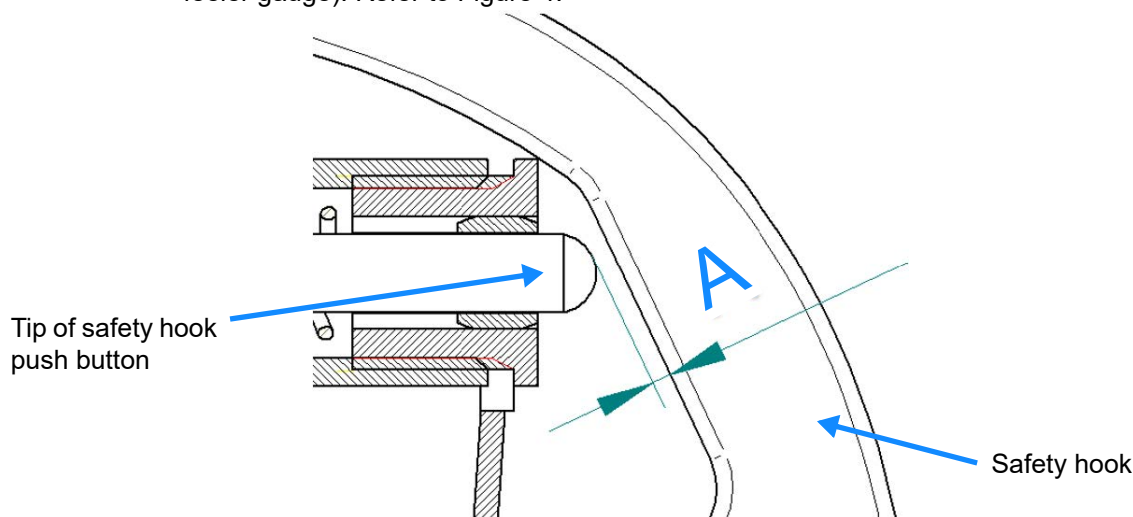
- Dimension A: distance of push button to the safety hook in resting position (e.g. with a feeler gauge). Refer to Figure 4.

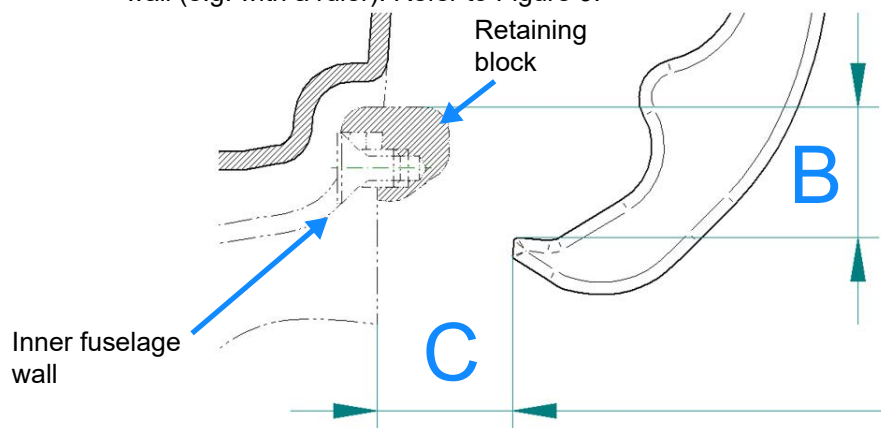
- Dimension B: distance between the top surface of the retaining block to the top surface of the engaging section of the safety hook in resting position (e.g. with a ruler). Refer to Figure 5.
- Dimension C: horizontal distance between the tip of the safety hook and the fuselage wall (e.g. with a ruler). Refer to Figure 9.

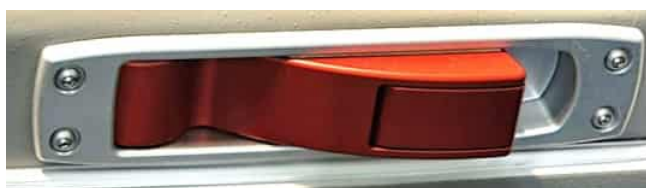
14. Data collection: Identify the version of the passenger door latching mechanism. Refer to Figures 8 and 9.

Figure 9. New door latching mechanism (MÄM 40-139 Installed)

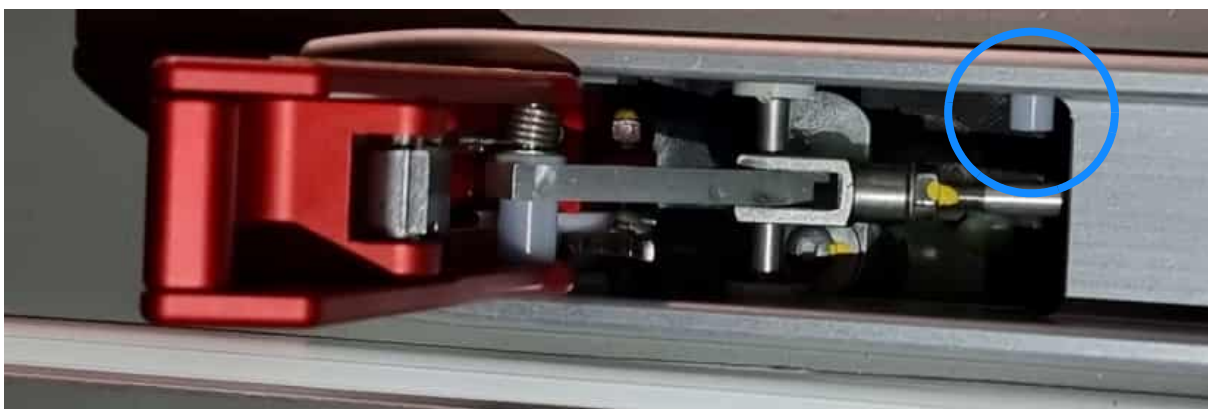
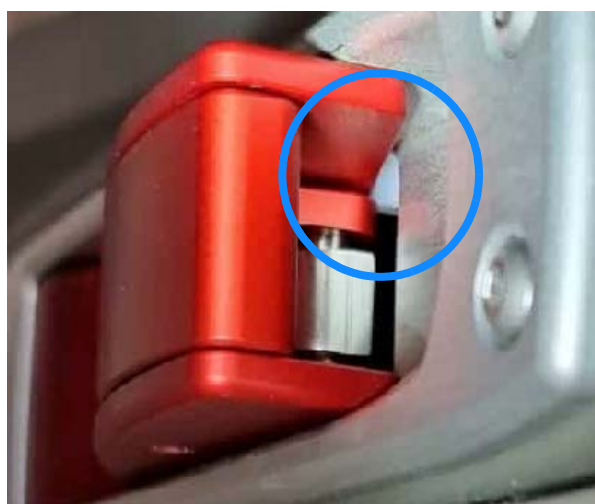
18. If MÄM 40-139 is installed (refer to step 14), examine the adjustment of the gas spring in the passenger door latching mechanism.

- The gas spring inside the door handle must push the door handle into the latched position firmly against the stop:
  - a) Open the passenger door.
  - b) Move the passenger door handle to the latched position.
  - c) Examine if the door handle is pushed into the mechanical stop inside the door handle mechanism (marked in the pictures below).
  - d) If the passenger door handle is not pushed against the mechanical stop by the gas spring, adjust the gas spring (refer to AMM section 52-10) and repeat this step.
  - e) Record if the gas spring was adjusted properly on the execution report in Appendix A.

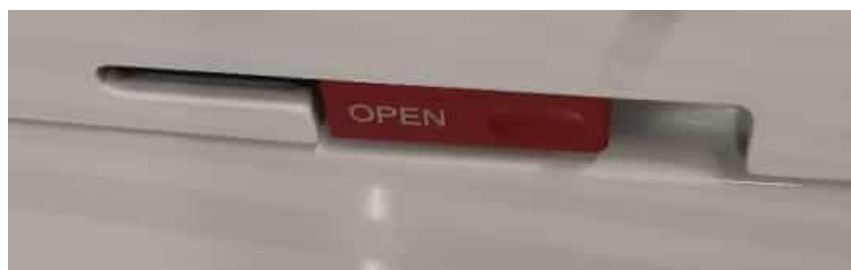
Figure 12. Recessed passenger door handle example
