MANDATORY SERVICE BULLETIN NO.
MSB 40-103 / MSB F4-042 / MSB D4-114 / MSB 40NG-084
REV. 2

Actions to prevent Passenger Door Separation: Installation of Placards, AFM Procedure update and Inspection/Data Gathering.

Diamond Aircraft Industries have received reports of passenger door separating from aircraft during flight. In some cases, operators forgot to latch the passenger door before flight and that there have been attempts to latch the door during flight, which led to separation of the passenger door.

WORK INSTRUCTION
WI-MSB 40-103 / WI-MSB F4-042 / WI-MSB D4-114 / WI-MSB 40NG-084
REV. 2

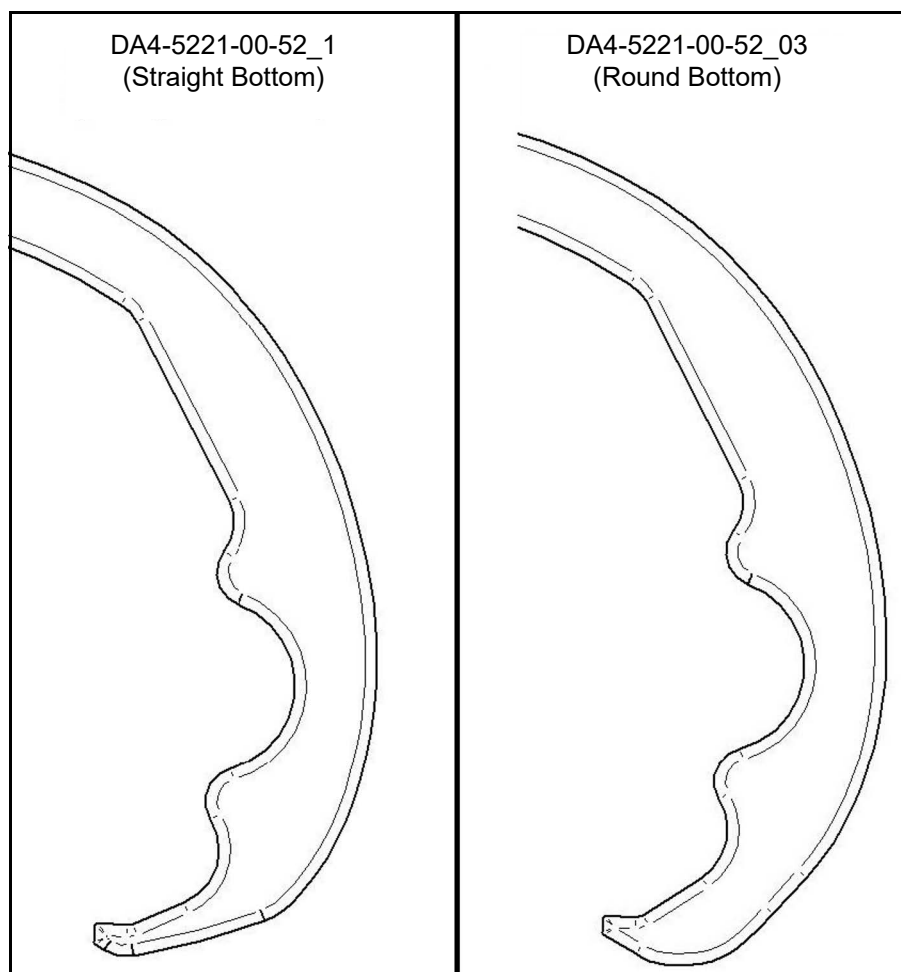
3. Examine the carbon hinges of the passenger door. Refer to AMM Section 52-10.
 - Take notes and correct any findings after this WI is completed.
 - In case of doubt, contact Diamond Aircraft Industries Inc.
 - Record any finding in the execution report in Appendix A.
4. Identify the version of the safety hook (straight bottom or round bottom). Refer to Figure 1.
Record the version on the execution report in Appendix A.

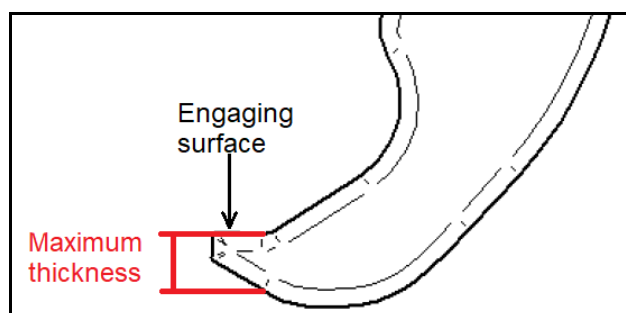
- f) Measure the maximum thickness of the safety hook at the location of the engaging surface, perpendicular to the engaging surface.
- The maximum thickness must be greater than 2.5 mm.
 - The variation of thickness measured along the width of the safety hook must be less than 0.2 mm.

- h) If the safety hook does not meet one or more of the acceptable conditions listed above on sub-steps **a** through **g**, take note to replace the safety hook after this WI is completed. Refer to Section IV for replacement of the safety hook.

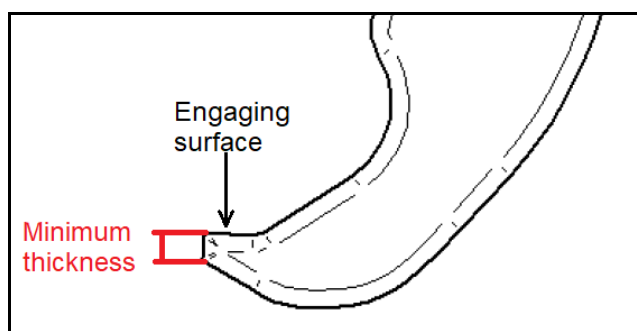
- g) Measure the minimum thickness of the safety hook at the location of the engaging surface, perpendicular to the engaging surface.
- The minimum thickness must be greater than 1.5 mm.
 - The variation of thickness measured along the width of the safety hook must be less than 0.2 mm.

- The edge of the engaging surface of the safety hook that is facing towards the retaining block must not have any ridges.

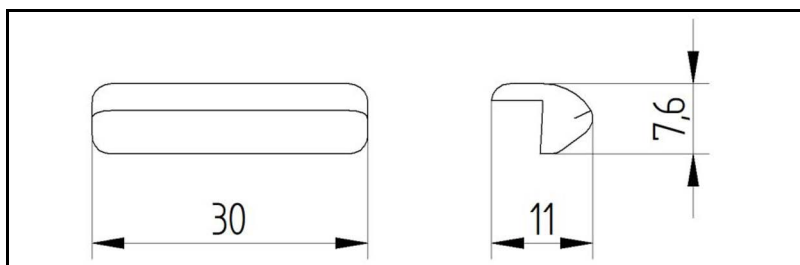
Small (DA4-5200-00-69)

7. Identify the version of the retaining block:
Record the version in the execution report.

8. If retaining block DA4-5200-00-69 is installed (refer to step 7):
 - a) Replace the retaining block according to MSB40-070 / MSBD4-079 / MSBF4-024.
 - b) Record the replacement of the retaining block on the execution report in Appendix A.
9. Examine the retaining block for signs of wear, corrosion and poor condition.
 - There must be no corrosion on the retaining block.
 - Wear at the inner sides of the retaining block must be less than 0.5 mm per side.
 - The engaging surface of the retaining block and the edge of the engaging surface that is facing the retaining block must not have any steps and ridges.
 - Scratches or uniform wear of surface protection are acceptable.

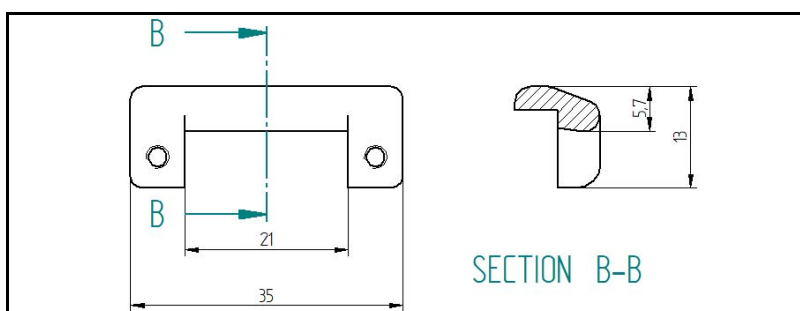
Extended with undercut (DA4-5200-00-69_02)

- The thickness of the retaining block measured perpendicular to the upper surface must be greater than:
 - 4 mm for retaining block DA4-5200-00-69_02 (extended with undercut) or
 - 6 mm for all other retaining blocks. Refer to step 7 for retaining block versions.

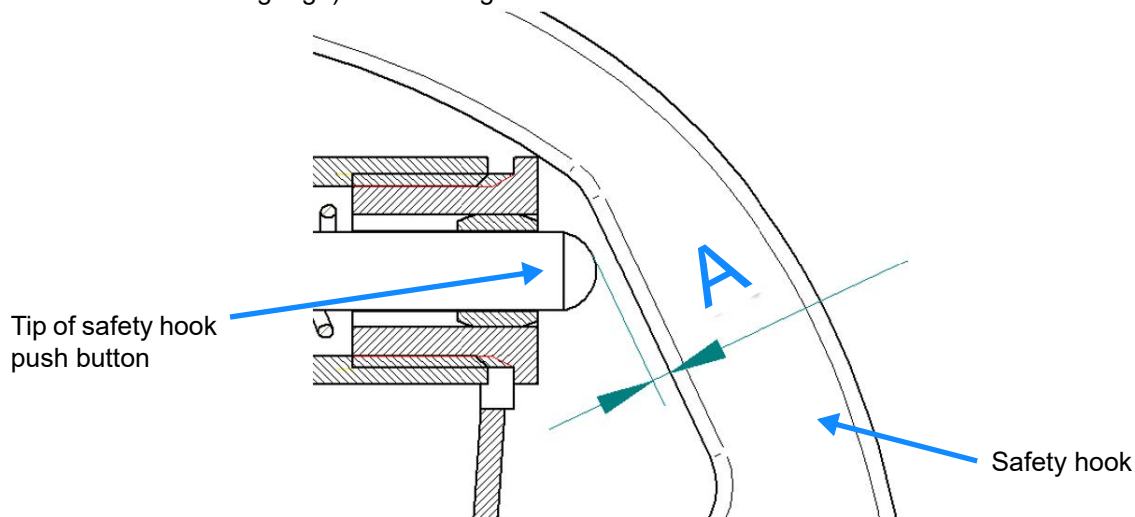
- Dimension A: distance of push button to the safety hook in resting position (e.g. with a feeler gauge). Refer to Figure 4.

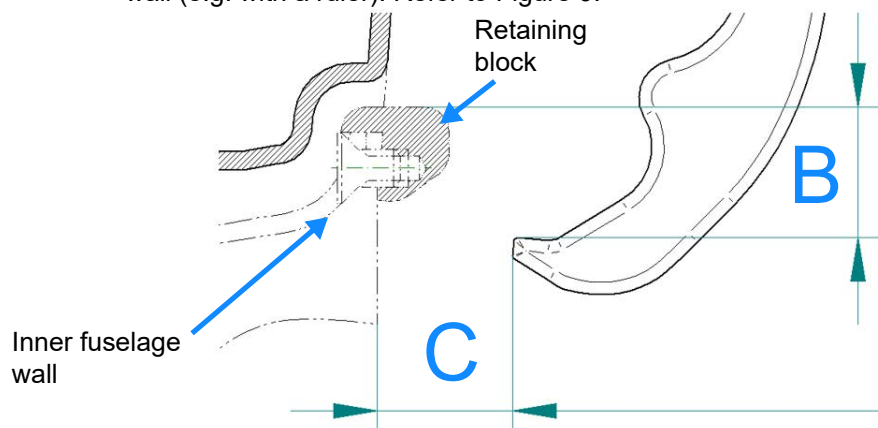
- Dimension B: distance between the top surface of the retaining block to the top surface of the engaging section of the safety hook in resting position (e.g. with a ruler). Refer to Figure 5.
- Dimension C: horizontal distance between the tip of the safety hook and the fuselage wall (e.g. with a ruler). Refer to Figure 9.

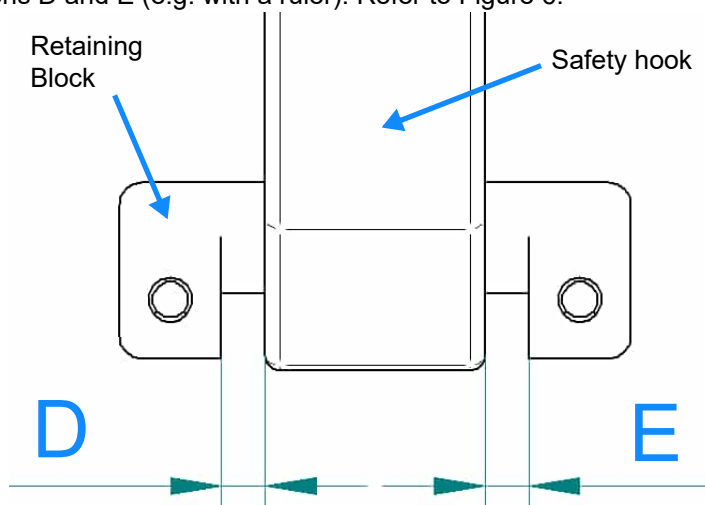
- Dimensions D and E (e.g. with a ruler). Refer to Figure 6.

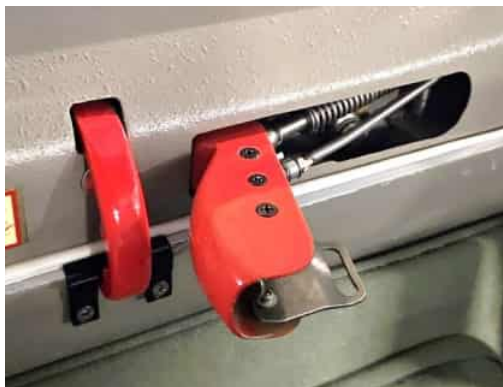
Figure 8. Old door latching mechanism

14. Data collection: Identify the version of the passenger door latching mechanism. Refer to Figures 8 and 9.

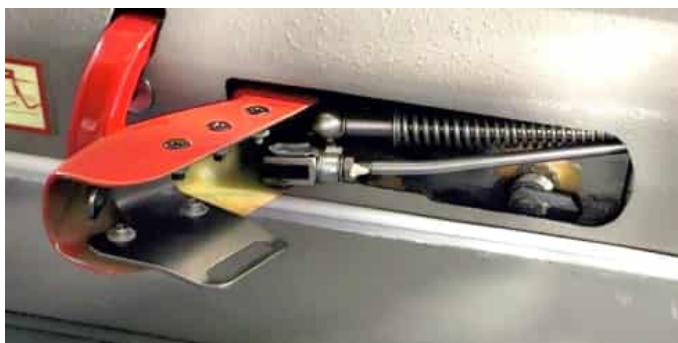
15. If the old passenger door latch is installed (refer to step 14), visually inspect the spring:
Refer to Figure 10.
- a) Move the passenger door handle to the unlatched position.
 - b) Visually inspect the spring.
 - Look specifically for a broken winding, replace the spring if found broken.
 - c) Record any findings on the execution report in Appendix A.

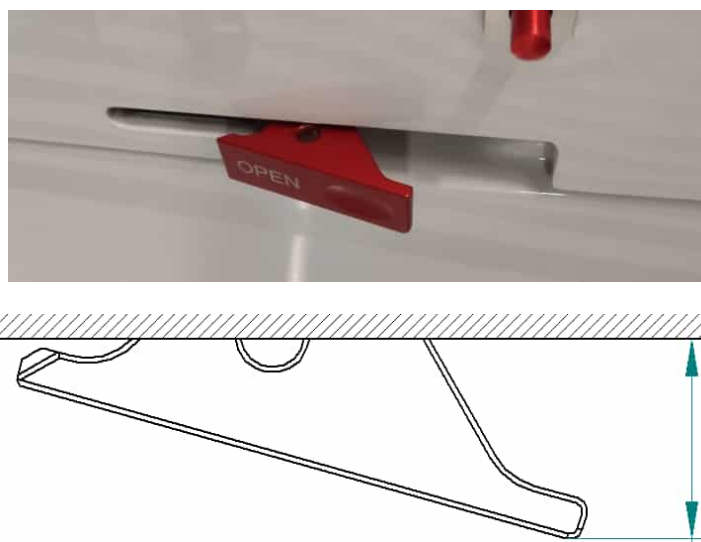
16. Data collection: If MÄM 40-139 is installed (refer to step 14):
- Identify when the gas spring of the passenger door latching mechanism was last replaced/installed.
 - Record the date of the last replacement on the execution report in Appendix A.
17. If MÄM 40-139 is installed (refer to step 14), examine the condition of the gas spring of the latching mechanism:
- Open the passenger door.
 - Move the door handle to unlatched position.
 - Slowly move the passenger door handle to latched position and measure the distance where the passenger door handle snaps into latched position by itself (measured at the outermost point of the lever, refer to sketch below).

- If the distance is less than 20 mm, take note to replace the compression gas spring after the WI is completed. Refer to AMM Section 52-10.
 - If the distance is less than 20 mm after replacement of the gas spring, the cause is high friction in the latching system.
 - Examine the latching bolts according to step 21.
 - If the reason for high friction in the latching system cannot be found, take note to replace the latching system after the WI is completed. Refer to AMM Section 52-10.
- Record the measured distance and any replacements on the execution report in Appendix A.

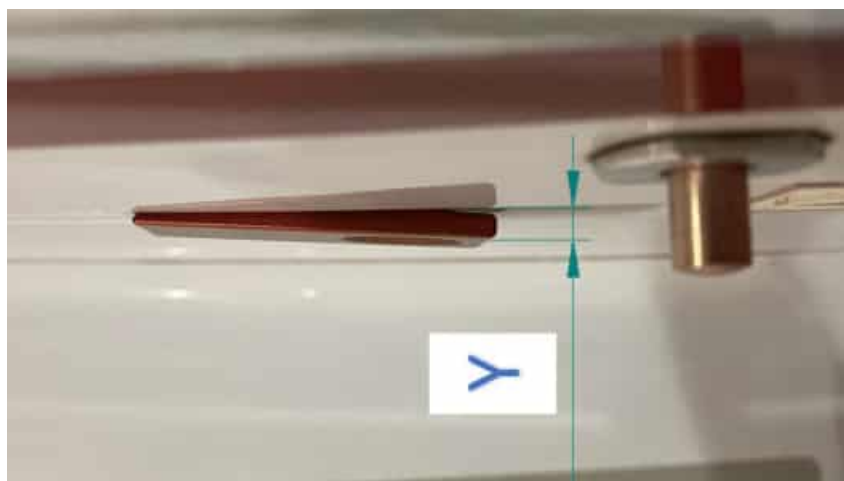
Figure 11. Protrusion measurement

19. Data collection: Position of the external passenger door handle. Refer to Figures 11 and 12.

- a) Close the passenger door.
- b) Push the external passenger door handle into the latched position until it stops.
- c) Examine if the passenger door handle is recessed, flush or protruding over the passenger door surface.
- d) Record the condition of the passenger door handle on the execution report in Appendix A.
- e) If the handle protrudes from the surface of the passenger door, measure the protrusion.
- f) Record the measurement on the execution report in Appendix A.

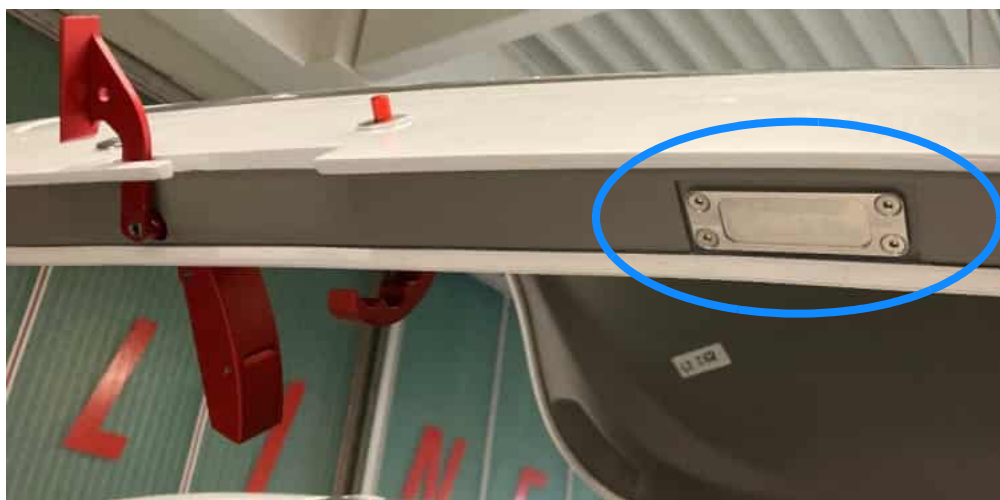
Figure 17. Metal plate

NOTE: Aid for identification: There is a metal plate bolted to the lower surface of the passenger door if MÄM 40-619 is installed. Refer to Figure 17.
