MANDATORY SERVICE BULLETIN

NO. MSB-D4-059/1

I.5 Subject

Replacement of aileron and flap bellcranks located in the wing, with bellcranks that allow for additional angular movement of the push rods, and replacement of bent rod ends.

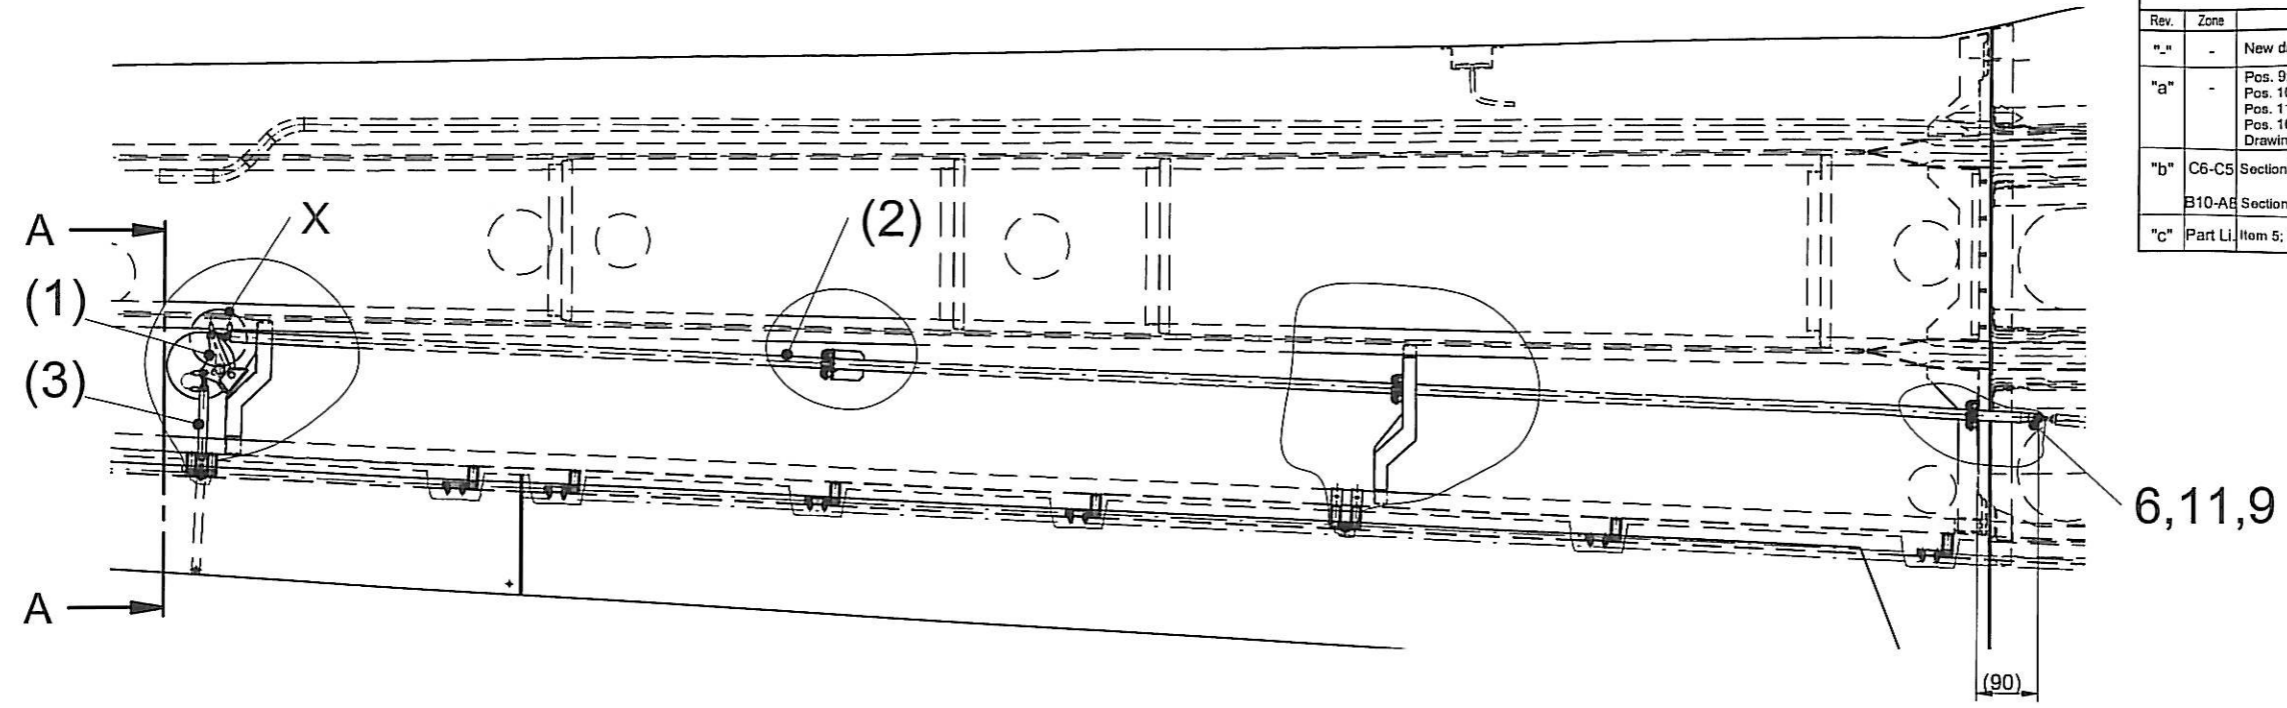
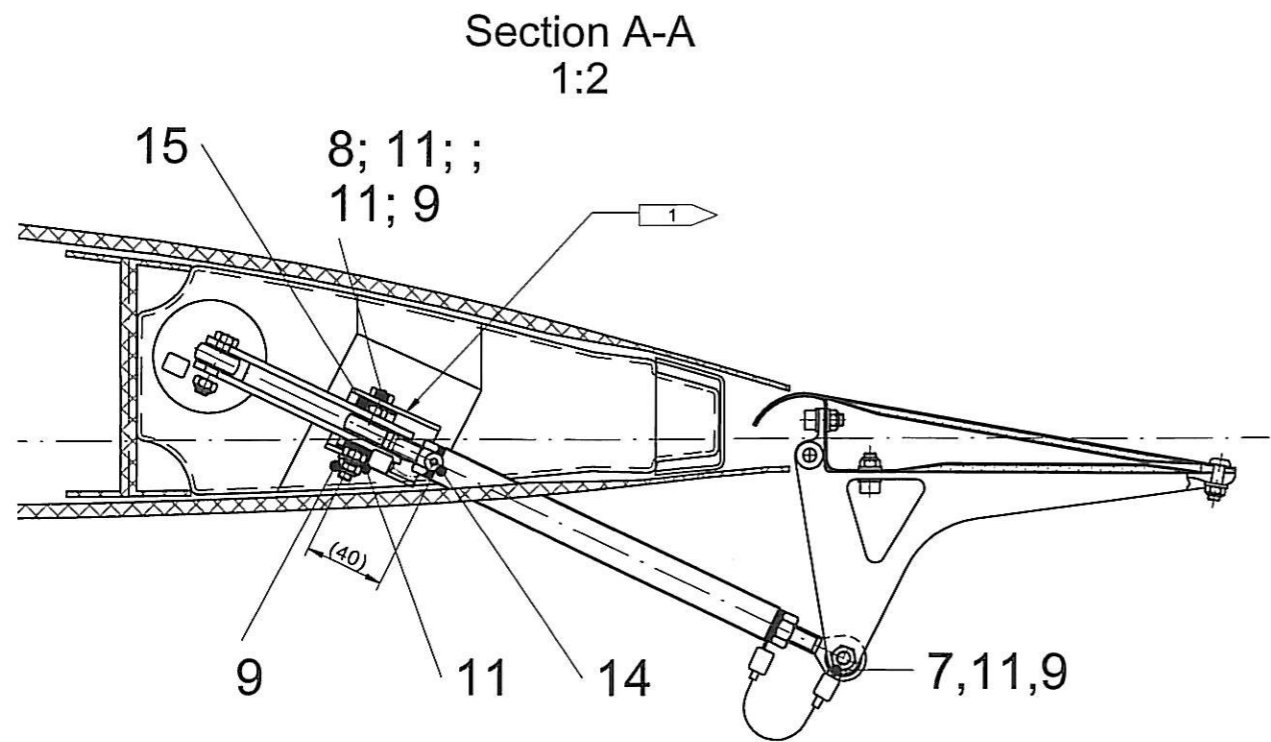
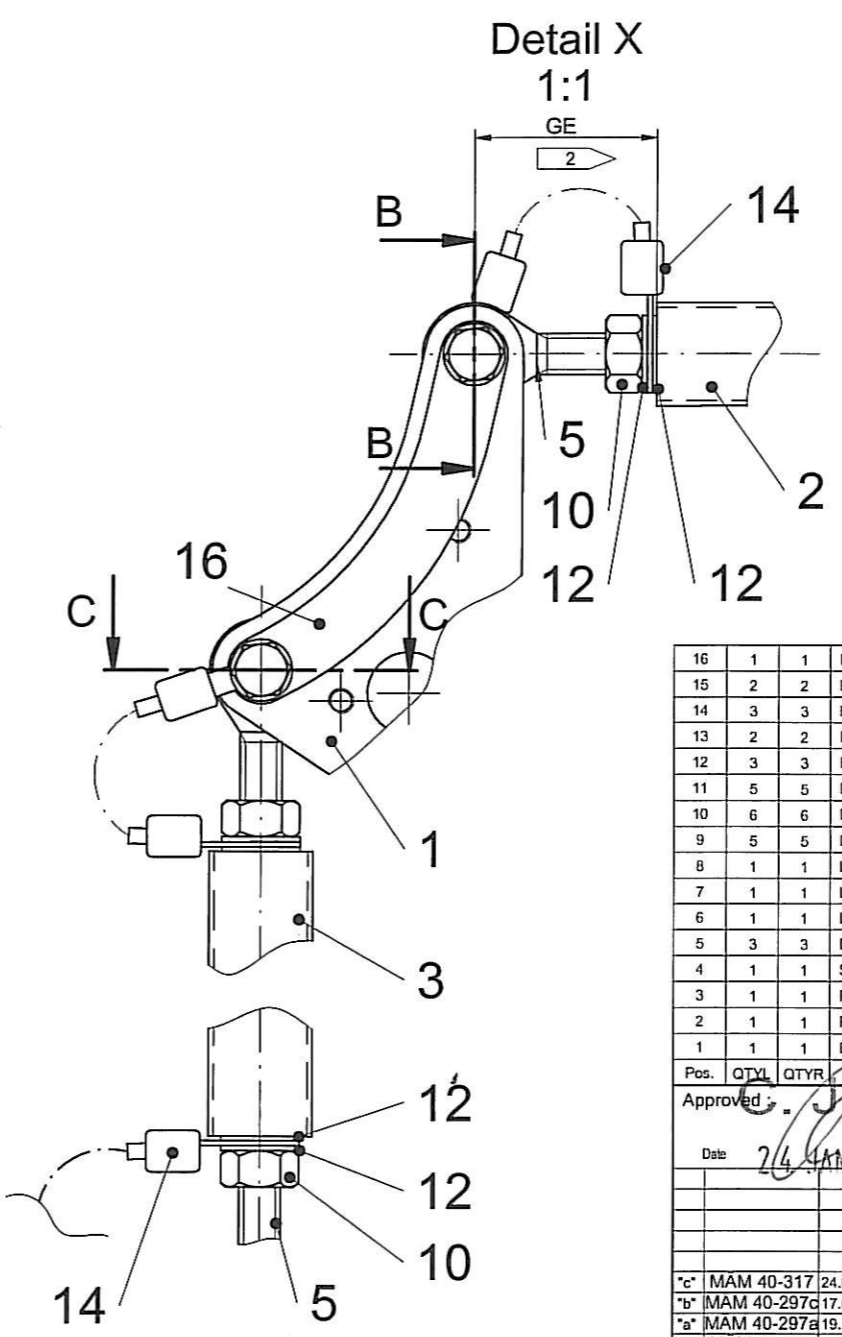
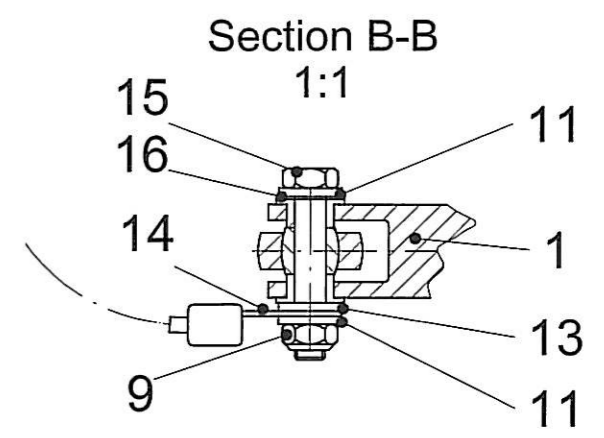
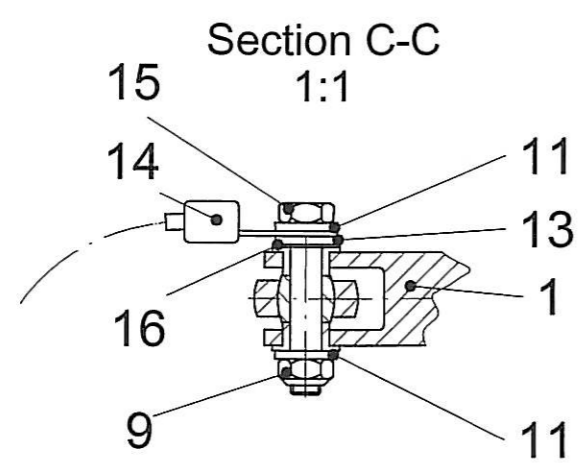
Figure 2: Flap Controls in the Wing (colored items are affected by this SB)

Rod ends in the aileron and flap control system were slightly bent to achieve clearance. This non-preferable practice became obsolete, since a new design of the bellcranks is available. This service bulletin calls for replacement of the bent rod ends and the installation of the new design bellcranks.

10.	Disconnect/Remove flap push rods from the bellcrank.
11.	Record adjusted length of the short pushrod (from the flap bellcrank to the flap horn).
12.	Replace flap bellcrank, refer to section AMM section 27-00-00. NOTE: Keep bolt and washers, replace self-locking nut. NOTE: In order to remove the bolt holding the bellcrank, it may be necessary to loosen or remove the bolts holding the pedestal to the rib. If so all loosened or removed bolts must be installed properly after installation of the new bellcrank!

13.	Replace bent rod end (eye-end fitting with spherical bearing) and adjust to correct length, refer to AMM section 27-00-00. CAUTION: The thread of the rod end must be in safety.
