**MANDATORY SERVICE BULLETIN NO.**

**MSB 40-103 / MSB F4-042 / MSB D4-114 / MSB 40NG-084**

Actions to prevent Passenger Door Separation: Installation of Placards, AFM Procedure update and Inspection/Data Gathering.

ATA-Code: 52-20

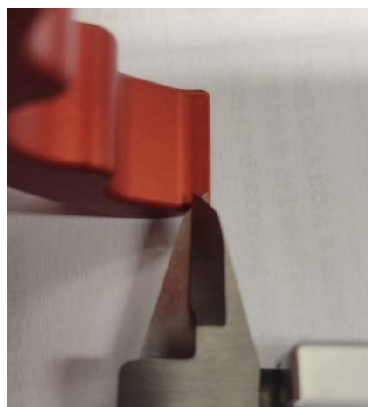
- e) Measure the width of the engaging surface.
- The width must be greater than 1.5 mm.

- h) If the safety hook does not meet one or more of the acceptable conditions listed above on sub-steps **a** through **g**, take note to replace the safety hook after this WI is completed. Refer to Section IV for replacement of the safety hook.

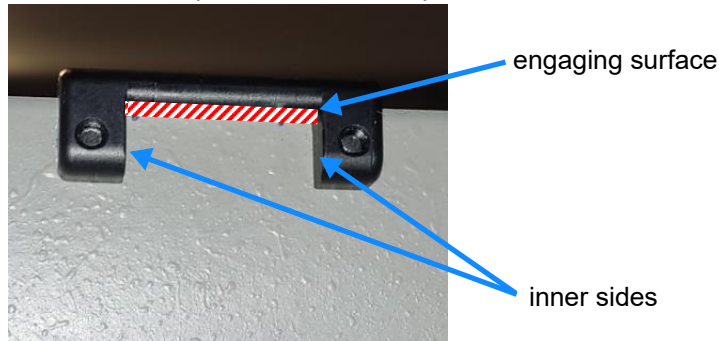
- The thickness of the retaining block measured perpendicular to the upper surface must be greater than:
  - 4 mm for retaining block DA4-5200-00-69\_02 (extended with undercut) or
  - 6 mm for all other retaining blocks. Refer to step 7 for retaining block versions.

If the retaining block does not meet one or more of the acceptable conditions mentioned in step 9, take notes and replace the retaining block after the WI is completed. Refer to section IV for removal/installation of the retaining block.

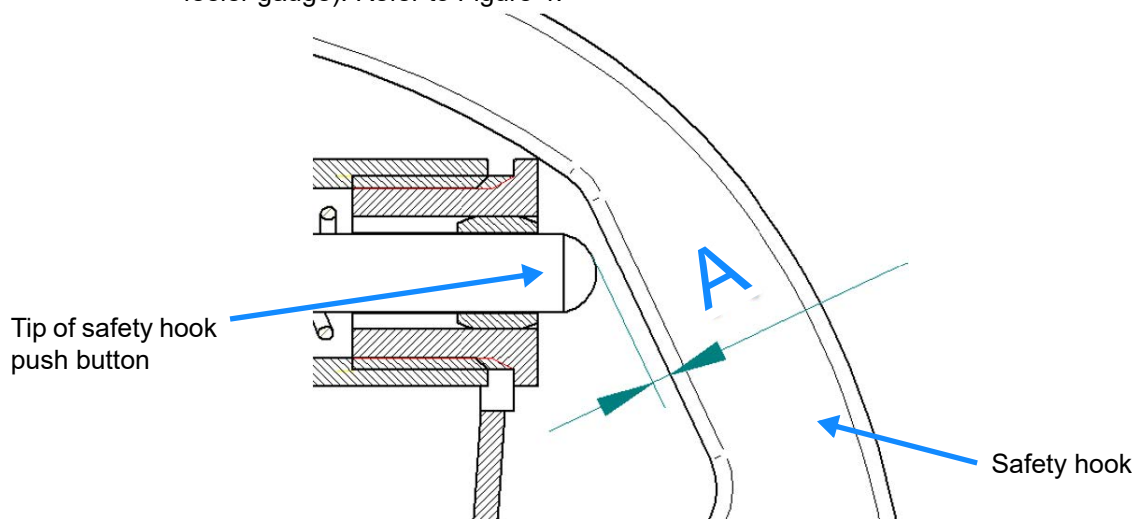
- b) Record the measurements on the execution report in Appendix A.
- Dimension A: distance of push button to the safety hook in resting position (e.g. with a feeler gauge). Refer to Figure 4.
