<u>MANDATORY SERVICE BULLETIN NO.</u> MSB 40-103 / MSB F4-042 / MSB D4-114 / MSB 40NG-084 <u>REV. 2</u>

Type: DA 40 / DA 40 D / DA 40 F / DA 40 NG

I.5 Subject

Actions to prevent Passenger Door Separation: Installation of Placards, AFM Procedure update and Inspection/Data Gathering.

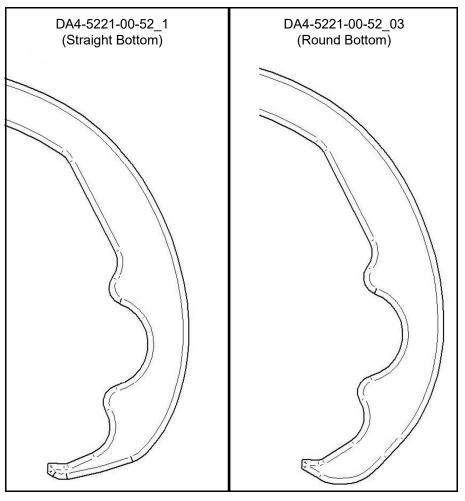
- 3. Examine the carbon hinges of the passenger door. Refer to AMM Section 52-10.
 - Take notes and correct any findings after this WI is completed.
 - In case of doubt, contact Diamond Aircraft Industries Inc.
 - Record any finding in the execution report in Appendix A.
- 4. Identify the version of the safety hook (straight bottom or round bottom). Refer to Figure 1. Record the version on the execution report in Appendix A.

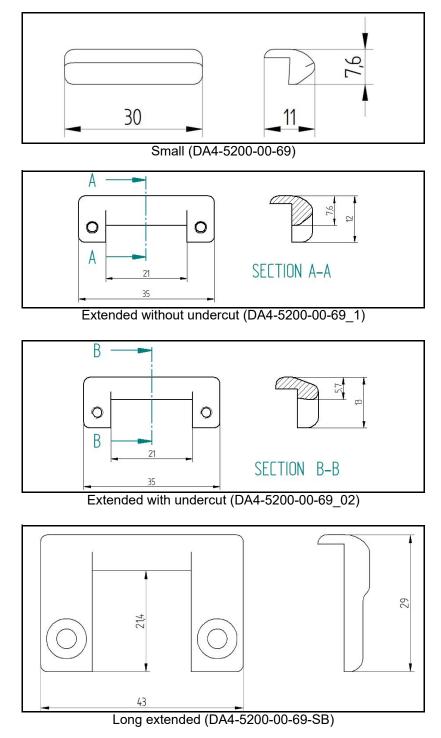
Identify the version of the retaining block: Record the version in the execution report.

- 8. If retaining block DA4-5200-00-69 is installed (refer to step 7):
 - a) Replace the retaining block according to MSB40-070 / MSBD4-079 / MSBF4-024.
 - b) Record the replacement of the retaining block on the execution report in Appendix A.
- 9. Examine the retaining block for signs of wear, corrosion and poor condition.
 - There must be no corrosion on the retaining block.
 - Wear at the inner sides of the retaining block must be less than 0.5 mm per side.
 - The engaging surface of the retaining block and the edge of the engaging surface that is facing the retaining block must not have any steps and ridges.
 - Scratches or uniform wear of surface protection are acceptable.

If the retaining block does not meet one or more of the acceptable conditions mentioned in step 9, take notes and replace the retaining block after the WI is completed. Refer to section IV for removal/installation of the retaining block.

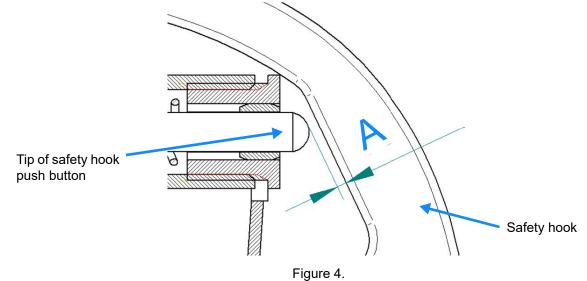
- b) Record the measurements on the execution report in Appendix A.
 - Dimension A: distance of push button to the safety hook in resting position (e.g. with a feeler gauge). Refer to Figure 4.

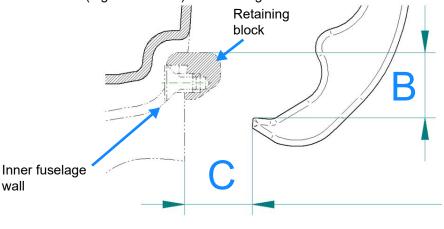
- Dimension B: distance between the top surface of the retaining block to the top surface of the engaging section of the safety hook in resting position (e.g. with a ruler). Refer to Figure 5.
- Dimension C: horizontal distance between the tip of the safety hook and the fuselage wall (e.g. with a ruler). Refer to Figure 9.

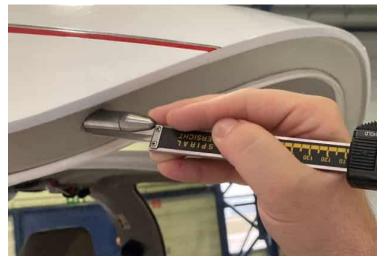
Figure 16. Rear latching bolt

- 21. Examine the latching bolts of the passenger door for looseness, excessive play, wear, corrosion and poor condition. Refer to Figure 14.
 - It must not be possible to rotate the latching bolts by hand force.

- If the radial play is greater than 0.8 mm, contact Diamond Aircraft Industries Inc.
 - No signs of corrosion is allowed.
 - If you find signs of corrosion on the latching bolts, take note and replace the latching bolts after the WI is completed. Refer to AMM 52-10 for replacement.

- No deformation (dents, bends, cracks) on the latching bolts is allowed.
 - If deformations of the latching bolts are found, take note and replace the latching bolts after the WI is completed. Refer to AMM 52-10 for replacement

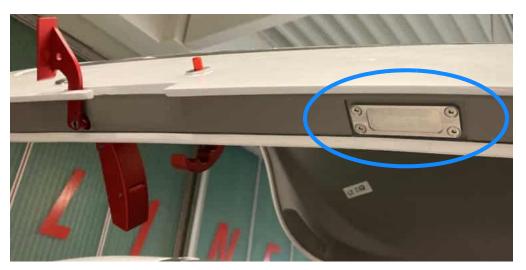
Figure 17. Metal plate

NOTE: Aid for identification: There is a metal plate bolted to the lower surface of the passenger door if MÄM 40-619 is installed. Refer to Figure 17.

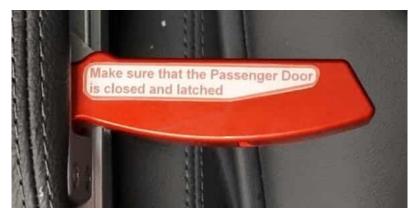
- 26. Insert AFM-TR-MÄM 40-1203, latest revision, into the AFM or use an AFM revision that has this temporary revision incorporated.
- 27. Insert AMM-TR-MÄM 40-1203, latest revision, into the AMM or use an AMM revision that has this temporary revision incorporated.
- 28. If MÄM 40-139 is installed (new door latching mechanism, refer to step 14), install placard (item 2) to the upper side of the inner canopy handle. Refer to Figure 21.
- NOTE: The placard can be self-fabricated in accordance with Appendix B.
 - a) Unlatch the canopy.

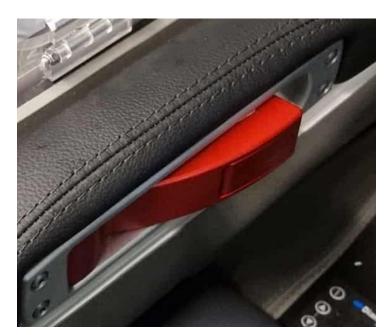
- b) Clean the canopy handle from dirt and grease.
- c) Align the placard with the straight edge and position it in spanwise direction so that it is completely visible from the pilot's perspective if the canopy handle is in the unlatched position.
- d) The placard must disappear when the canopy handle is in the latched position. Refer to Figure 22.

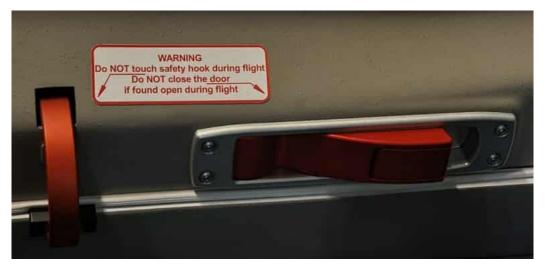
Figure 25. New latching mechanism (MÄM 40-139 installed)

30. Install placard (item 1) to the passenger door. Refer to Figures 25 and 26.

- a) Clean the area where the placard will be attached from dirt and grease.
- b) Position the placard approximately 10 mm forward of the safety hook cut-out in the passenger door and approximately 10 mm above the passenger door handle.

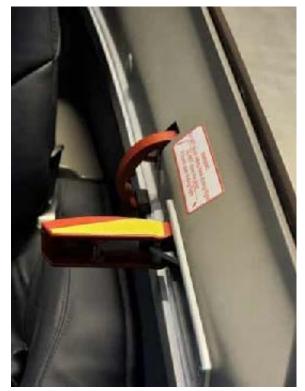
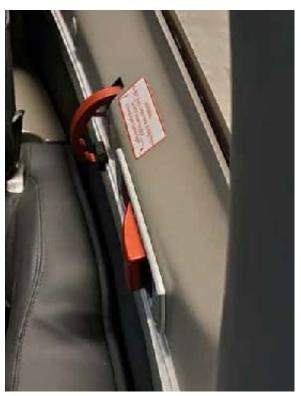
- 31. If MÄM 40-139 is installed (new latching mechanism, refer to step 14), install placard (item 4) on the top surface of the inner passenger door handle. Refer to Figure 27.
- NOTE: The placard can be self-fabricated in accordance with Appendix B.
 - a) Clean the inner passenger door handle from dirt and grease.
 - b) Close and latch the passenger door.
 - c) Mark the line on the passenger door handle where it is visible when observed from the pilot's perspective over the LH shoulder.
 - d) Unlatch the passenger door.
 - e) Align the placard with the marked line.
 - f) Trim the placard on the edges of the passenger door handle, if necessary.
 - The placard must completely disappear with the passenger door latched when observed from the pilot's perspective over the LH shoulder. Refer to Figure 27, latch closed.

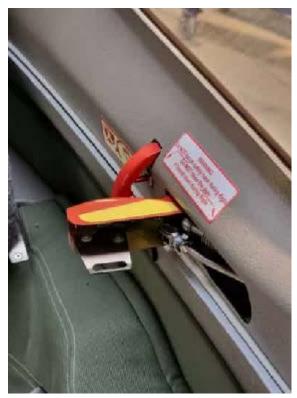
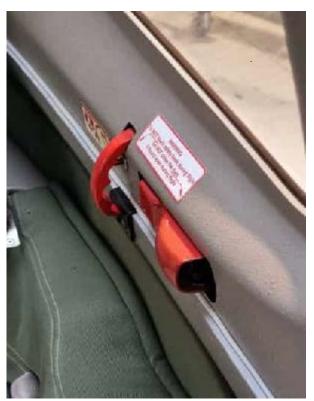
- 32. If MÄM 40-139 is not installed (old latching mechanism, refer to step 14), install placard (item 5) on the top surface of the inner passenger handle. Refer to Figure 28.
- NOTE: The placard can be self-fabricated in accordance with Appendix B.
 - a) Clean the inner passenger door handle from dirt and grease.
 - b) Close and latch the passenger door.
 - c) Mark the line on the passenger door handle where it is visible when observed from the pilot's perspective over the LH shoulder.
 - d) Unlatch the passenger door.
 - e) Align the placard with the marked line.
 - f) Trim the placard on the edges of the passenger door handle, if necessary.
 - The placard must completely disappear with the passenger door latched when observed from the pilot's perspective over the LH shoulder. Refer to Figure 28, latch closed.
