MANDATORY SERVICE BULLETIN

MSB 42MNG-006

Type: DA 42 M-NG

Installation of an additional wire for the alternator fail relay.

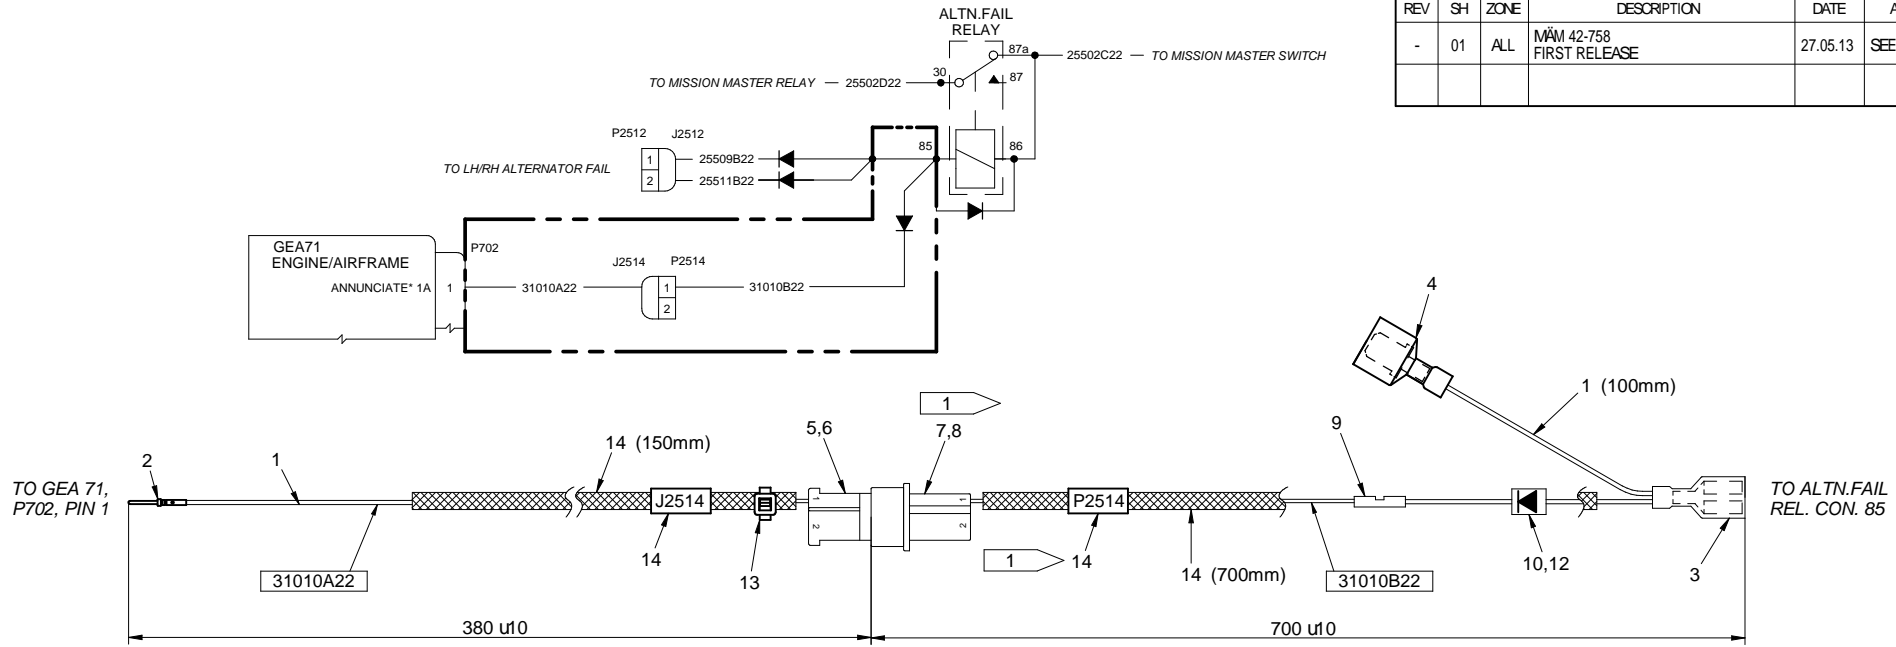
The Garmin G1000 incorporates an output of the GEA 71 to activate the alternator fail relay, if either alternator fails. The secondary configuration card Garmin P/N 010-12074-02 adds this additional trigger.

1	Disconnect the main battery for maintenance in accordance with AMM Section 24-31.
2	Remove the left baggage compartment rear cover.
3	Remove the instrument panel cover in accordance with AMM Section 25-10.
4	Remove the Garmin GEA 71 in accordance with AMM Section 31-40.
5	Disconnect the wires 25509B22 and 25511B22 (including two diodes) from the alternator fail relay. Refer also to drawing D62-2510-97-00-SB.
6	Connect faston tab side of D62-2510-97-00-SB to the wire (diodes) disconnected above.
7	Connect the faston connector of D62-2510-97-00-SB to the alternator fail relay.

8	<p>If the airplane is <u>not</u> equipped with an oxygen system, replace one hole plug with the grommet P/N 5616632.</p> <p>If the airplane is equipped with an oxygen system, drill a hole diameter 8,5 mm adjacent to the existing holes (see Figure 1) and protect edges with the grommet P/N 5616632.</p> <div data-bbox="384 508 1326 1111" data-label="Image">A photograph showing the interior of an aircraft's instrument panel area. A large, black, braided flexible conduit is routed across the panel. Below it, a busbar assembly is visible with a yellow label that reads 'BUSS' and '100A'. To the right, a blue grommet is already installed in a hole. A red dot and arrow point to a location on the panel surface adjacent to the existing holes, indicating where a new hole should be drilled.</div>
9	Route wire 31010B22 of D62-2510-97-00-SB through the grommet into the instrument panel.
10	Install the label P2514 onto the wire and insert the pin of wire 31010B22 into the connector position 1. Refer also to drawing D62-2510-97-00-SB.
