# MANDATORY SERVICE BULLETIN

## NO. MSB 42NG-018/1

#### I.5 Subject

This Service Bulletin prescribes the replacement of the possibly non conforming turbo connector assy D64-8122-20-00 by a conforming part of an improved design.

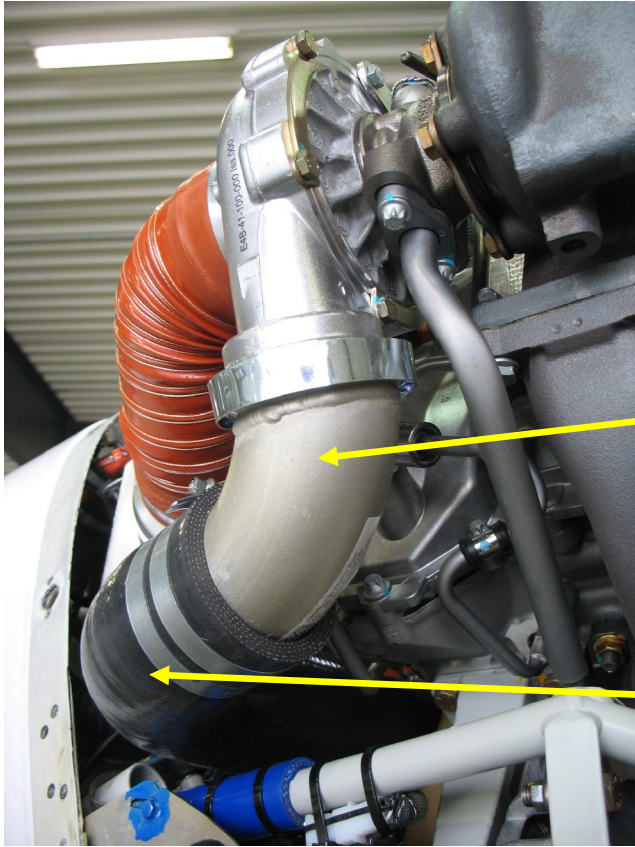
1	Remove the engine cowlings in accordance to AMM, chapter 71.
2	Remove the turbo connector assy. P/N D64-8122-20-00.

3	Check the O-ring on the new charge air tube assy P/N D64-8126-10-00 for correct position.
4	Install the charge air tube assy P/N D64-8126-10-00 to the turbo charger.  <p>Note: Do not tighten the V-Clamp.</p>
