**MANDATORY SERVICE BULLETIN**  
**MSB 42-099/1**  
**MSB 42NG-035/1**  
supersedes MSB 42-099 & MSB 42NG-035

Type: DA 42, DA 42 M, DA 42 NG, DA 42 M-NG

Inspection / replacement of spherical rod end bearing and safety washer of nose landing gear (NLG) actuator, P/N X11-0006/2 with S/N 0155 and below.

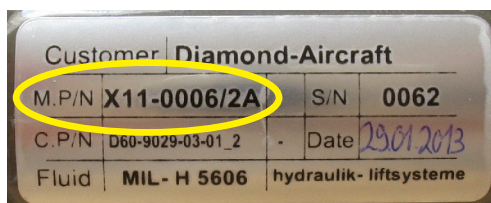
rod end bearing

NOTE: NLG actuators with P/N X11-0006/2A are not affected by this Service Bulletin.

| 2 | If NLG actuator has P/N X11-0006/2 and S/N is 0156 or higher, proceed with item 12. |
| 3 | <p>If NLG actuator has P/N X11-0006/2 and S/N is 0155 or lower remove NLG actuator from the aircraft in accordance with AMM, section 32-20.</p> <p>NOTE: It is not necessary to remove the actuator completely from the aircraft. The following work can be done with the actuator remaining connected to the NLG brace assembly and to the hydraulic system.</p> |
