RECOMMENDED SERVICE BULLETIN RSB 42-139 RSB 42NG-081

Replacement of rudder T-yoke axle with improved design.

WORK INSTRUCTION WI-RSB 42-139 WI-RSB 42NG-081

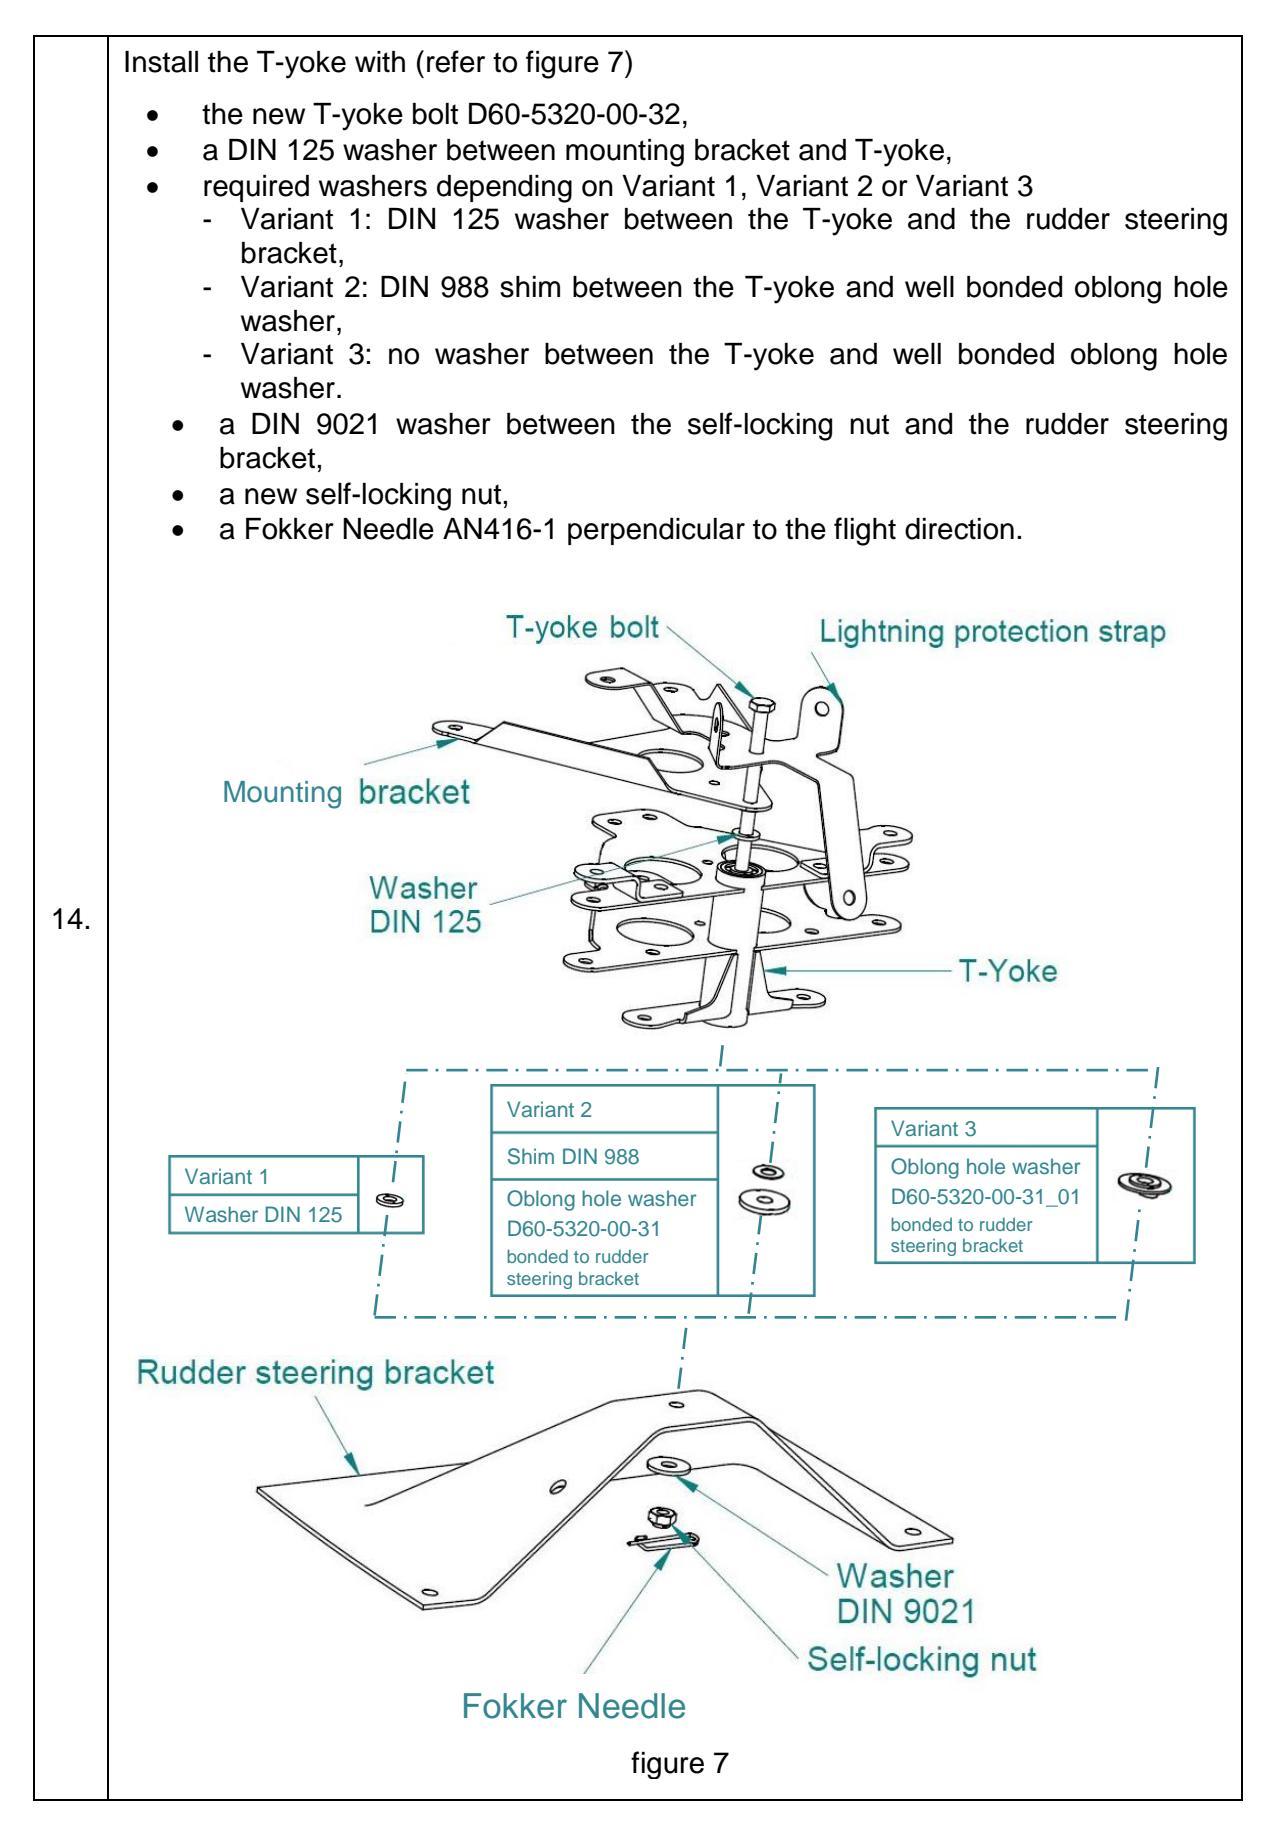
12.	If an oblon check if the	g hole washer (variant 2 or 3) is installed to the rudder steering bracket, e oblong hole washer is well bonded to the rudder steering bracket.
10	If the bondi has failed,	ng between oblong hole washer (variant 2 or 3) and rudder steering bracket repair the bonding in accordance with Section III.2.

13.	Note:	If loose oblong hole washer is D60-5320-00-31 (variant 2), replace it with oblong hole washer D60-5320-00-31_1 (variant 3).
