MANDATORY SERVICE BULLETIN

MSB 42-143/1

MSB 42NG-086/1

Inspection of hole position and condition in the rudder steering bracket.

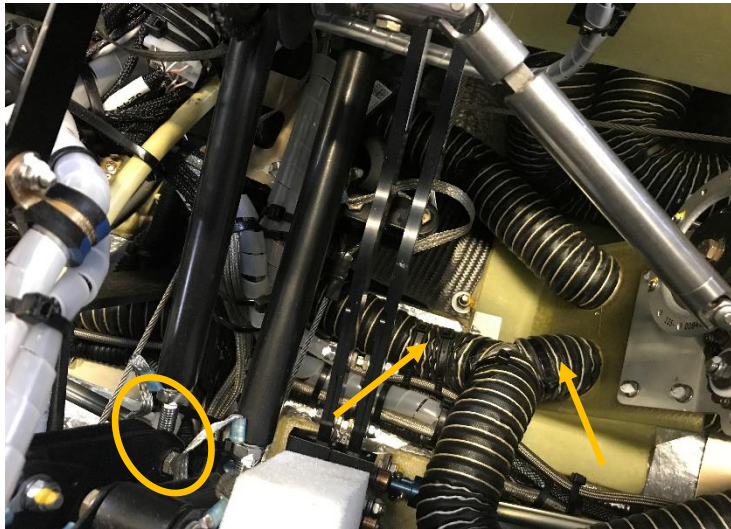
1.	Insert AMM-TR-MÄM-42-1213 into the AMM or use an AMM revision, in which AMM-TR-MÄM-42-1213 has been incorporated.
2.	Remove the pilot and co-pilot seat in accordance with AMM Section 25-10.
3.	Remove the middle tunnel front cover in accordance with AMM Section 25-10.
4.	<p>Remove components for better access to the rudder steering bracket:</p> <ul style="list-style-type: none"> Remove the two heating hoses, that are indicated in the picture by the arrows, from the aluminum Y-connector, pull out the heating hose, that is routed along the rudder steering bracket, disconnect the short aileron push rod from the main spar lever as indicated by the circle.

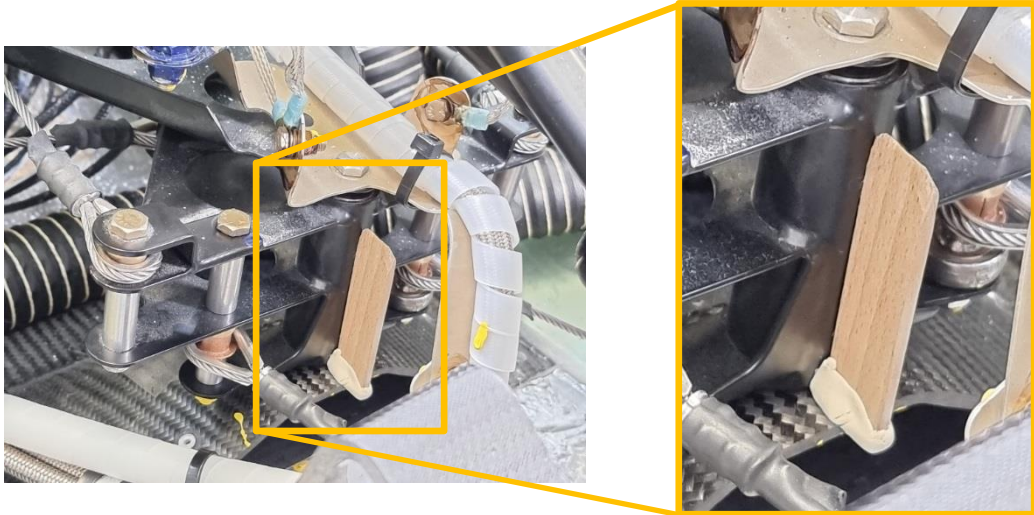
1.	<p>Use a wooden strip (cross-section e.g. 15 mm x 3 mm) and a piece of modeling clay to determine distance d.</p> <ul style="list-style-type: none">• Put a small piece of modeling clay to the end of a wooden strip.• Hold the wooden strip to the metal tube of the rudder bell crank.• Move the wooden strip down, so that the modeling clay is pressed onto the rudder steering bracket. <p>Note: Make sure there is no modeling clay between the wooden strip and the metal tube of the rudder bell crank.</p> <p>Note: For illustration, this step is shown on an airplane with removed components in the area of the rudder steering bracket.</p> <div data-bbox="323 1462 1362 1975">

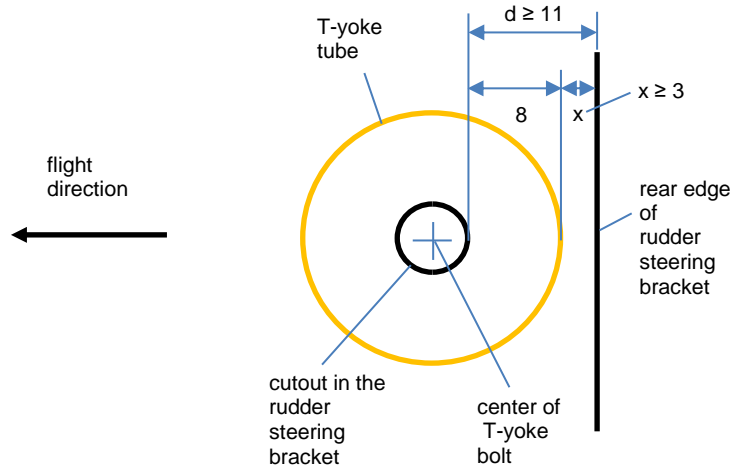
4.	<p>Check, if an oblong hole washer has been installed to the rudder steering bracket in accordance with MSB 42-087 / MSB 42NG-016:</p> <ul style="list-style-type: none"> • Obtain information from the maintenance logs, • Slightly lift off the T-yoke and use an inspection mirror to check, if an oblong hole washer is installed to the rudder steering bracket. <p>CAUTION: Make sure, the washer between the T-yoke and the rudder steering bracket does not get lost.</p>

5. If no oblong hole washer installed, distance **d** is at least 11 mm. Return to section III.

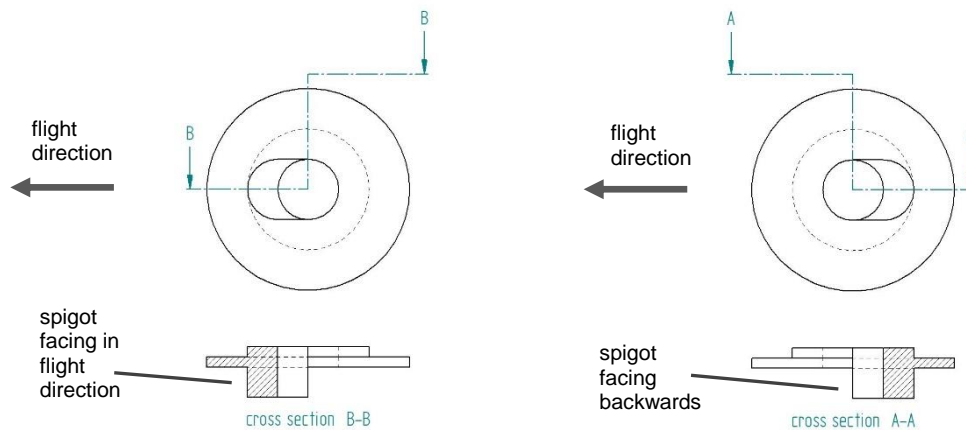
6. If an oblong hole washer is installed to the rudder steering bracket, determine the orientation of the oblong hole washer.

- Use an inspection mirror and inspect the bottom side of the rudder steering bracket.
