MANDATORY SERVICE BULLETIN

MSB 42-143/1

MSB 42NG-086/1

Inspection of hole position and condition in the rudder steering bracket.

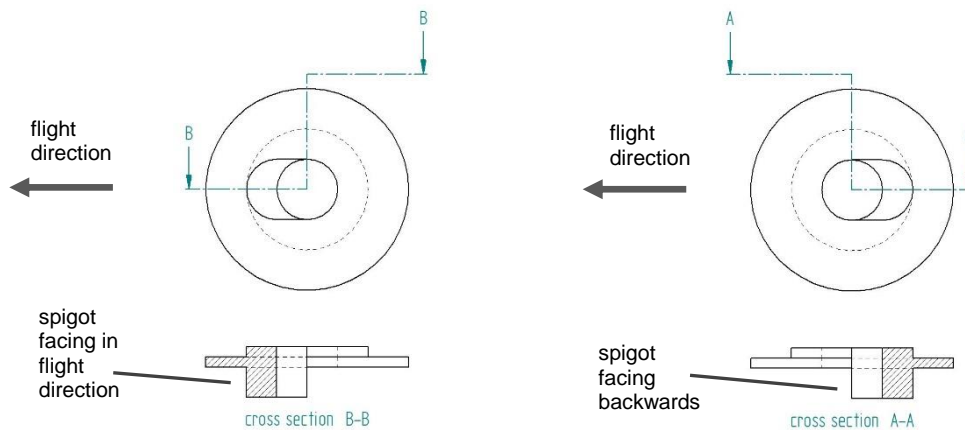
6. If an oblong hole washer is installed to the rudder steering bracket, determine the orientation of the oblong hole washer.

- Use an inspection mirror and inspect the bottom side of the rudder steering bracket.

7. If an oblong hole washer is installed to the rudder steering bracket with the spigot facing in flight direction, distance **d** is at least 11 mm. Return to section III.
