MANDATORY SERVICE BULLETIN

MSB 42-149

MSB 42NG-095

Actions to prevent Passenger Door Separation: Installation of Placards, AFM Procedure update and Inspection/Data Gathering.

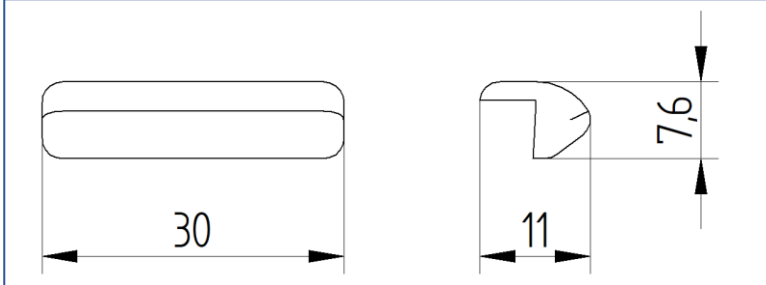
DA4-5200-00-69 (Small)

9	<p>If Retaining Bracket DA4-5200-00-69 is installed (refer to step 8.):</p> <ul style="list-style-type: none"> • Replace the Retaining Bracket according to MSB 42-083/MSB 42NG-014 (refer also to EASA AD 2010-0235). • Record replacement of the retaining bracket on the execution report in Appendix B.
10	<p>Examine the Retaining Bracket for signs of wear, corrosion and poor condition.</p> <ul style="list-style-type: none"> • There must be no corrosion on the Retaining Bracket. • Wear at the inner sides of the Retaining Bracket: maximum 0.5 mm per side. • The engaging surface of the Retaining Bracket and the edge of the engaging surface facing the Retaining Bracket must be free from steps and ridges. • Scratches or uniform wear of surface protection are permitted.

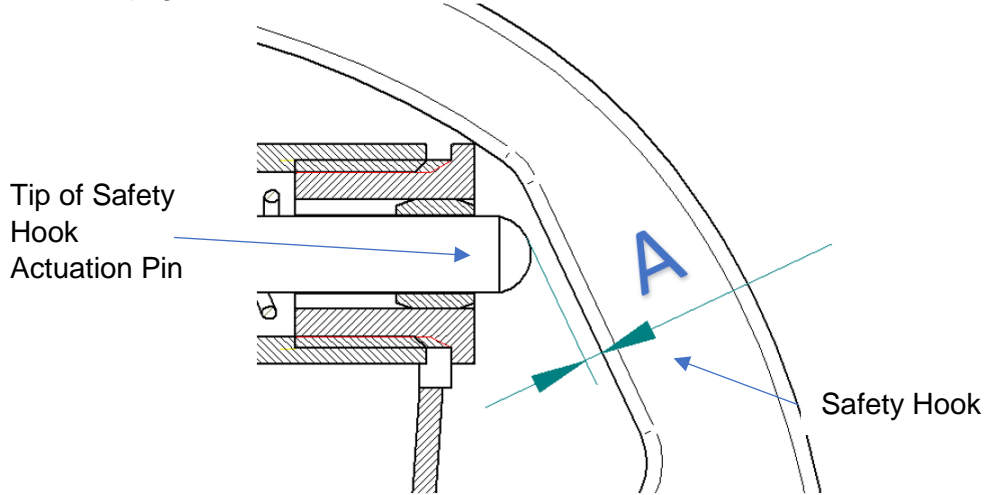
- Close and latch the Passenger Door.
- Record the measurements on the execution report in Appendix B.
 - Dimension A: distance of Actuation Pin to Safety Hook in resting position (e.g. with a feeler gauge).

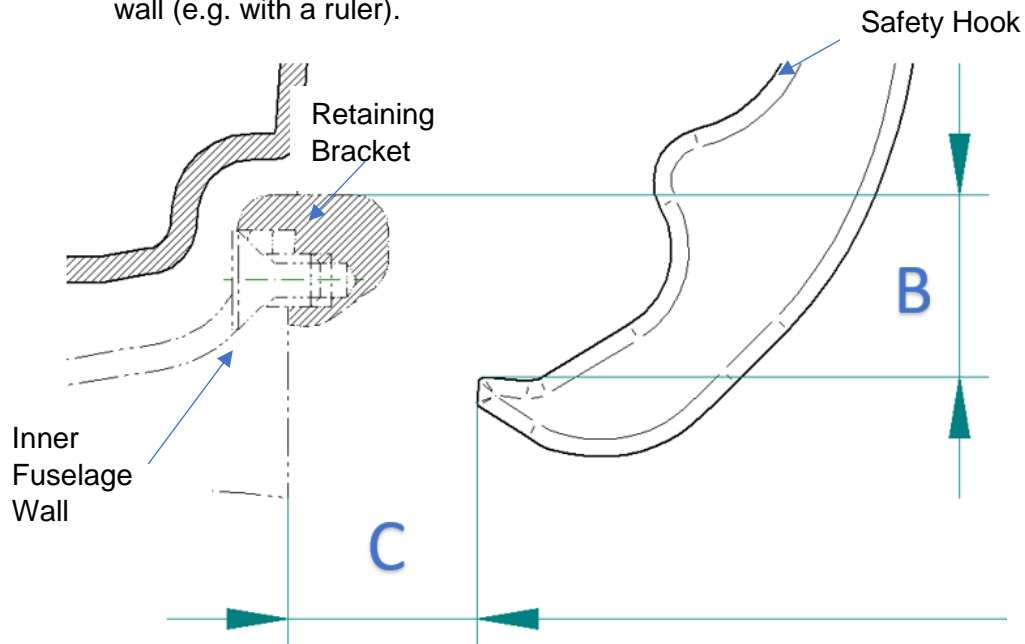
- Dimension B: distance between top surface of the Retaining Bracket to top surface of engaging section of Safety Hook in resting position of Safety Hook (e.g. with a ruler).
- Dimension C: horizontal distance between tip of Safety Hook and fuselage wall (e.g. with a ruler).

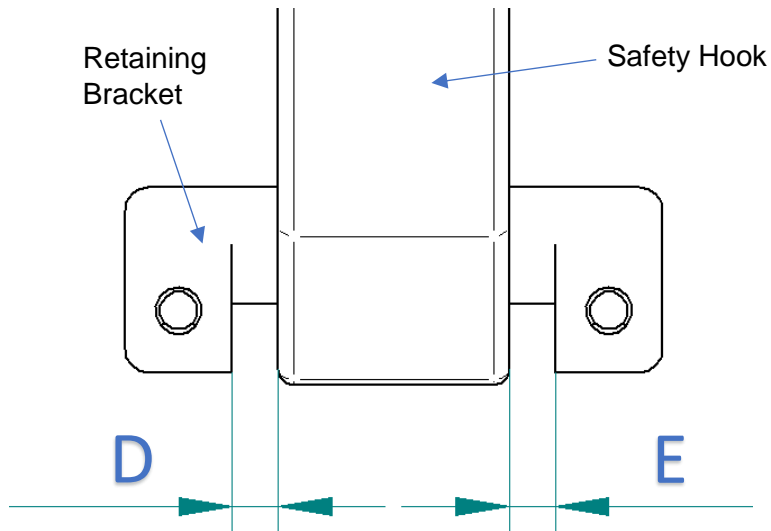
- Unlatch the Passenger Door and push the Passenger Door open, engaging the Safety Hook into the Retaining Bracket, apply slight pressure to the Passenger Door to keep the Safety Hook engaged during the measurement.
- Record the measurements on the execution report in Appendix B.
 - Dimension D (e.g. with a ruler).
 - Dimension E (e.g. with a ruler).

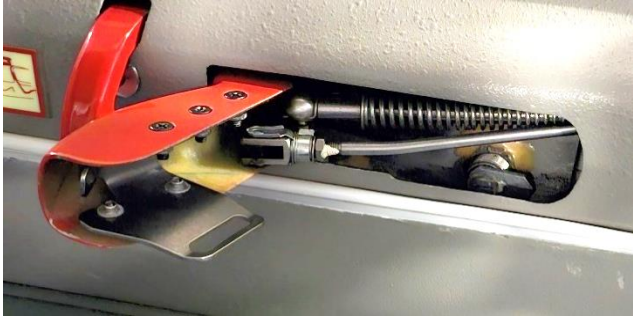
<p>Record the version of the Passenger Door latching mechanism on the execution report in Appendix B.</p>
<p>16</p>	<p>If the old Passenger Door latching mechanism is installed (refer to step 15): Visually inspect the spring.</p> <ul style="list-style-type: none"> • Move the Passenger Door Handle to the unlatched position. • Visually inspect the spring. <ul style="list-style-type: none"> ○ Look especially for a broken winding, replace the spring if found broken. • Record any findings on the execution report in Appendix B.

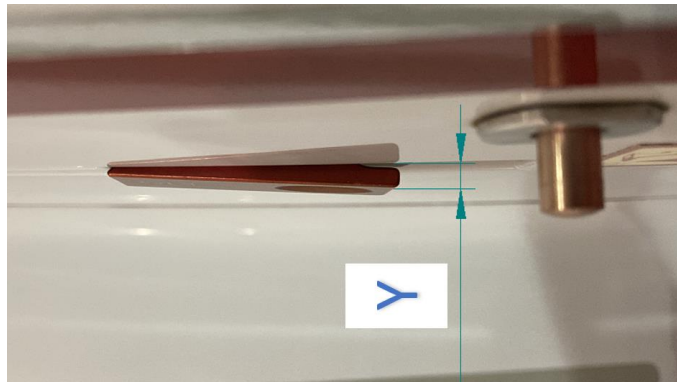
Protrusion Measurement

- Close the Passenger Door.
- Press the outside Passenger Door handle into the latched position until a distinct stop is reached.
- Examine if the Passenger Door Handle is recessed, flush or protruding over the Passenger Door surface. Record the condition on the execution report in Appendix B.
- If the handle protrudes from the surface of the Passenger Door, measure the protrusion.
- Record the measurement on the execution report in Appendix B.

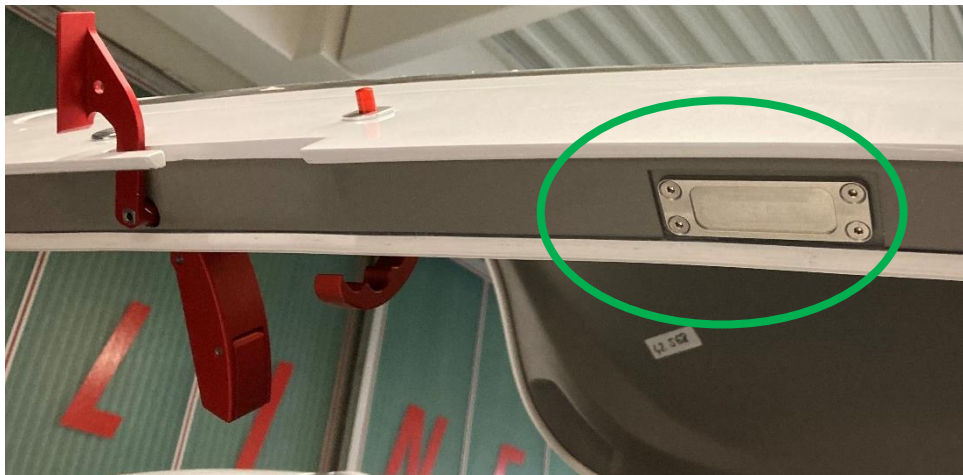
Note: Aid for identification: There is a metal plate bolted to the lower surface of the Passenger Door if MÄM 42-687 is installed. Refer to picture below.

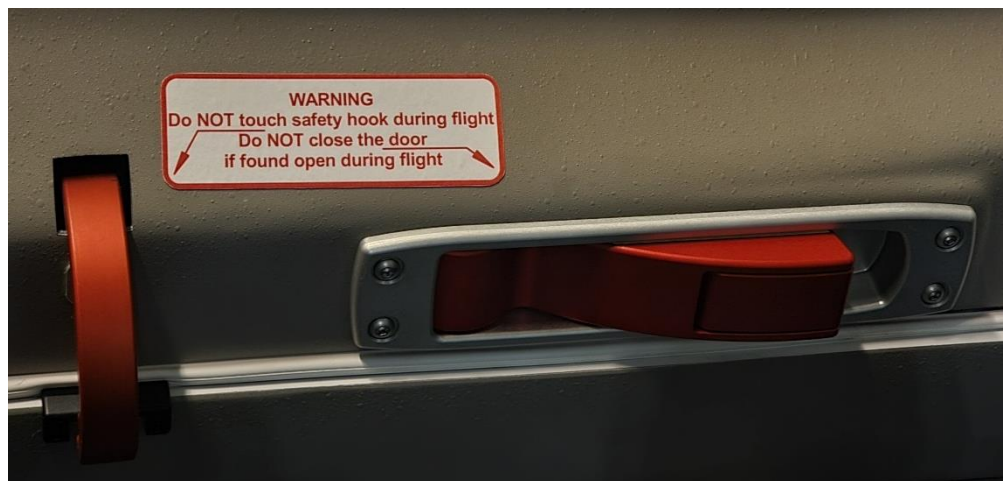
New latching mechanism – MÄM 42-097 installed (refer to step 15)

- Clean the area where the placard will be attached from dirt and grease.
- Position the placard approximately 10 mm forward of the Safety Hook cut-out in the Passenger Door and approximately 10 mm above the Passenger Door Handle.
