MANDATORY SERVICE BULLETIN

MSB 42-149

MSB 42NG-095

Actions to prevent Passenger Door Separation: Installation of Placards, AFM Procedure update and Inspection/Data Gathering.

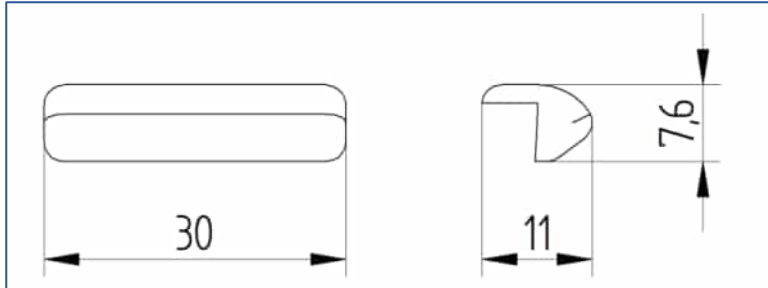
DA4-5200-00-69 (Small)

| 9 | <p>If Retaining Bracket DA4-5200-00-69 is installed (refer to step 8.):</p> <ul style="list-style-type: none"> • Replace the Retaining Bracket according to MSB 42-083/MSB 42NG-014 (refer also to EASA AD 2010-0235). • Record replacement of the retaining bracket on the execution report in Appendix B. |

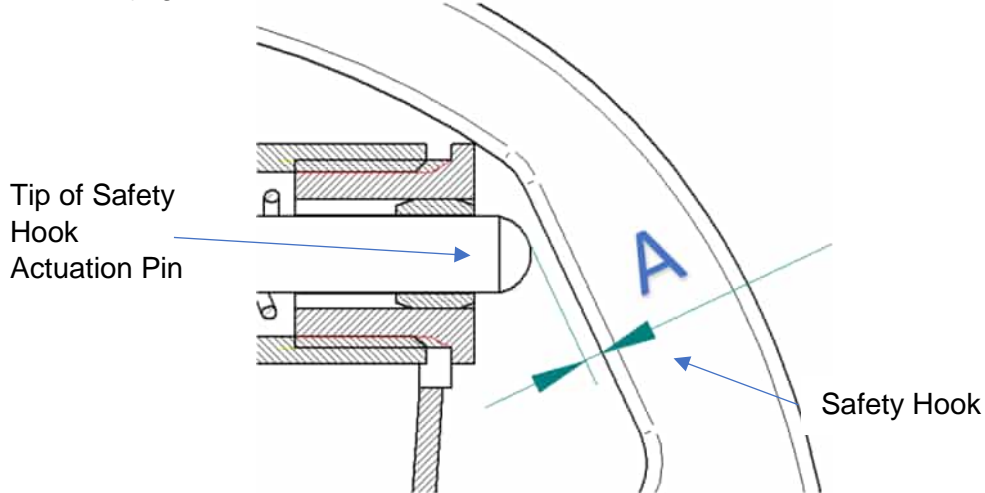
- Close and latch the Passenger Door.
- Record the measurements on the execution report in Appendix B.
 - Dimension A: distance of Actuation Pin to Safety Hook in resting position (e.g. with a feeler gauge).

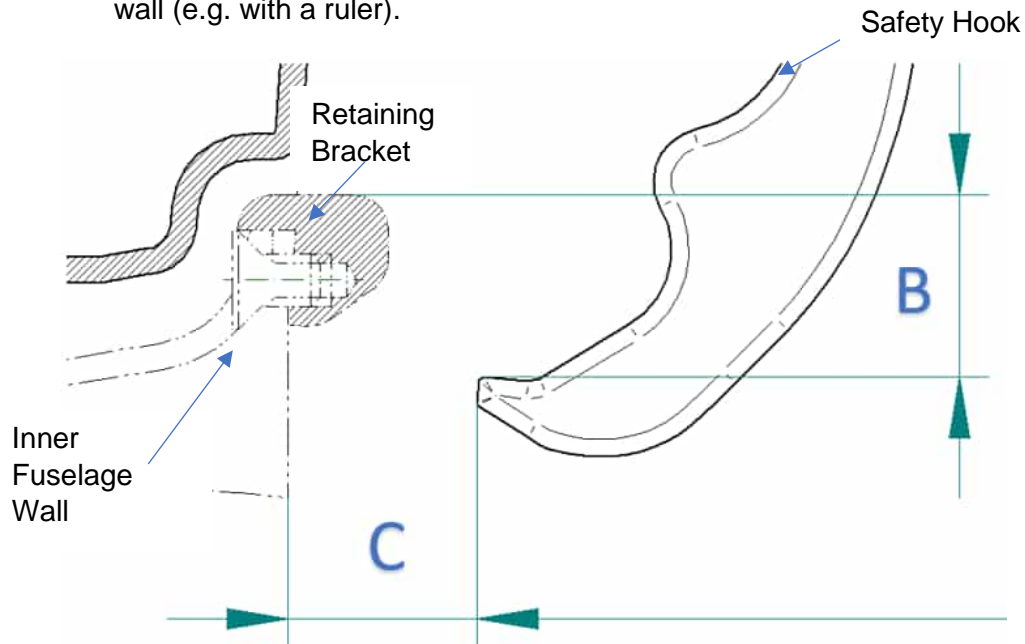
- Dimension B: distance between top surface of the Retaining Bracket to top surface of engaging section of Safety Hook in resting position of Safety Hook (e.g. with a ruler).
- Dimension C: horizontal distance between tip of Safety Hook and fuselage wall (e.g. with a ruler).

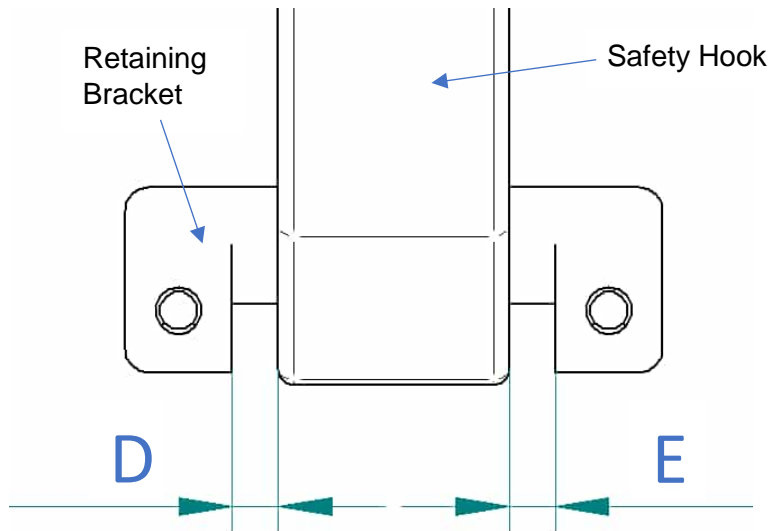
- Unlatch the Passenger Door and push the Passenger Door open, engaging the Safety Hook into the Retaining Bracket, apply slight pressure to the Passenger Door to keep the Safety Hook engaged during the measurement.
- Record the measurements on the execution report in Appendix B.
 - Dimension D (e.g. with a ruler).
 - Dimension E (e.g. with a ruler).

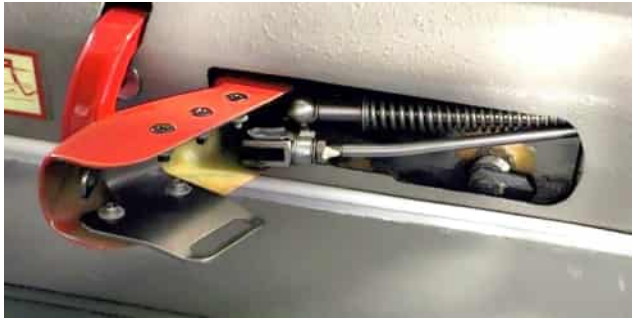
| <p>16</p> | <p>If the old Passenger Door latching mechanism is installed (refer to step 15): Visually inspect the spring.</p> <ul style="list-style-type: none"> • Move the Passenger Door Handle to the unlatched position. • Visually inspect the spring. <ul style="list-style-type: none"> ○ Look especially for a broken winding, replace the spring if found broken. • Record any findings on the execution report in Appendix B. |

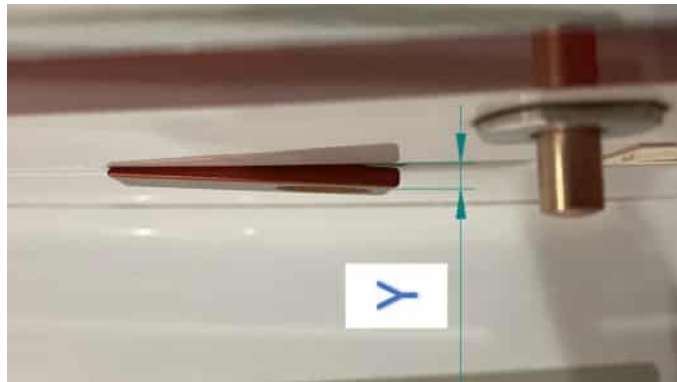
Protrusion Measurement

- Close the Passenger Door.
- Press the outside Passenger Door handle into the latched position until a distinct stop is reached.
- Examine if the Passenger Door Handle is recessed, flush or protruding over the Passenger Door surface. Record the condition on the execution report in Appendix B.
- If the handle protrudes from the surface of the Passenger Door, measure the protrusion.
- Record the measurement on the execution report in Appendix B.

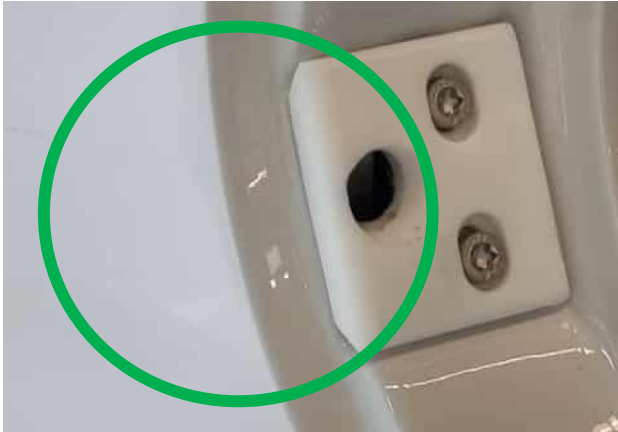
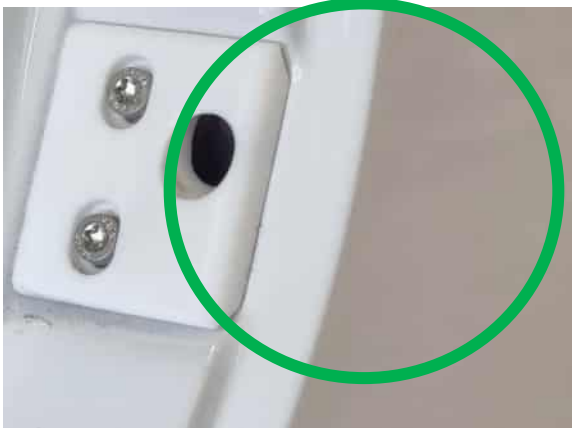
| 24 | <p>Data Collection: Inspect the door frame in the area around the front and rear latching bolts for damage.</p> <p>Record any damage on the execution report in Appendix B.</p> <div style="text-align: center;"> <p>Front</p> <p>Rear</p> </div> |
