# MANDATORY SERVICE BULLETIN

## MSB 42-099/1

## MSB 42NG-035/1

Inspection / replacement of spherical rod end bearing and safety washer of nose landing gear (NLG) actuator, P/N X11-0006/2 with S/N 0155 and below.

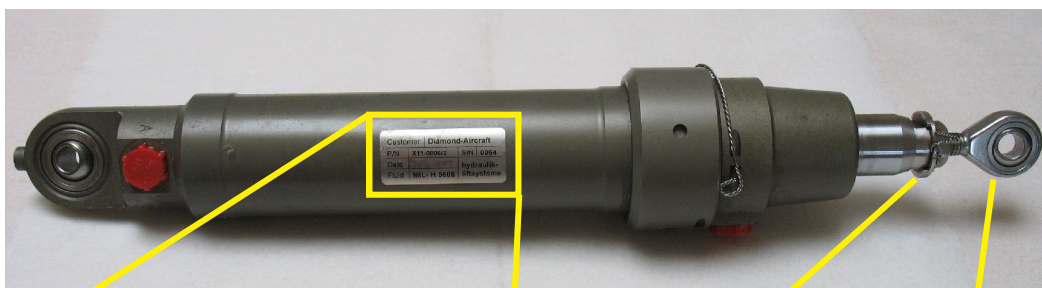
1

Identify part number (P/N) and serial number (S/N) of nose landing gear (NLG) actuator (use inspection mirror).

safety washer

rod end bearing

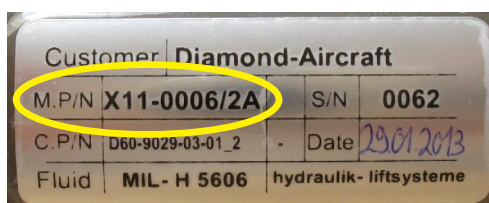
2	If NLG actuator has P/N X11-0006/2 and S/N is 0156 or higher, proceed with item 12.
3	<p>If NLG actuator has P/N X11-0006/2 and S/N is 0155 or lower remove NLG actuator from the aircraft in accordance with AMM, section 32-20.</p> <p>NOTE: It is not necessary to remove the actuator completely from the aircraft. The following work can be done with the actuator remaining connected to the NLG brace assembly and to the hydraulic system.</p>
4	Remove spherical rod end bearing from the NLG actuator piston in accordance with AMM, section 32-30. Discard spherical rod end bearing.
5	<p>Measure diameter of safety washer.</p> <p>Possible diameters are:</p> <ul style="list-style-type: none"> <li>- 27 mm (old design, picture on the left)</li> <li>- 24 mm (P/N X11-0006-00-00.02, Rev B, new design, picture on the right).</li> </ul>

6	If diameter of safety washer is 27 mm replace it with one of the new design with 4 holes for lock wire and with reduced diameter of 24 mm, P/N X11-0006-00-00.02, Rev B.
