MANDATORY SERVICE BULLETIN

MSB 42-149

MSB 42NG-095

Actions to prevent Passenger Door Separation: Installation of Placards, AFM Procedure update and Inspection/Data Gathering.

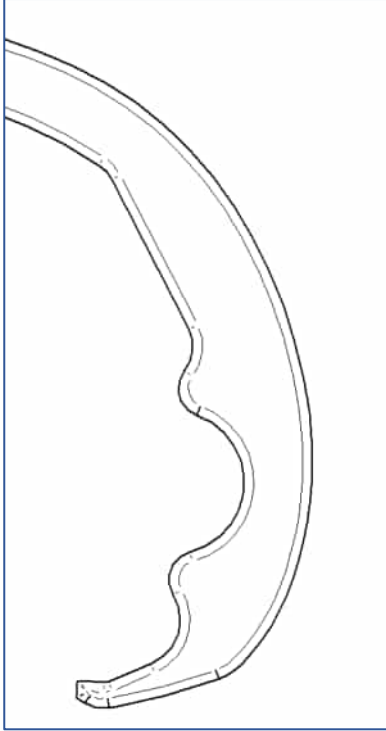
DA4-5221-00-52_1 (Straight Bottom)

- 6 Examine the Safety Hook for signs of wear, corrosion and poor condition:
- Record the finding on the execution report in Appendix B.
 - There must be no deformation or cracks.
 - Pay particular attention to the contact area of the Actuation Pin.
 - Grooves in the Safety Hook must be less than 2 mm deep.

Replace Safety Hook, if

- any of the Safety Hook dimensions measured in this step are not within the given tolerances, or
- corrosion is found, or
- deformation, grooves, ridges or steps.

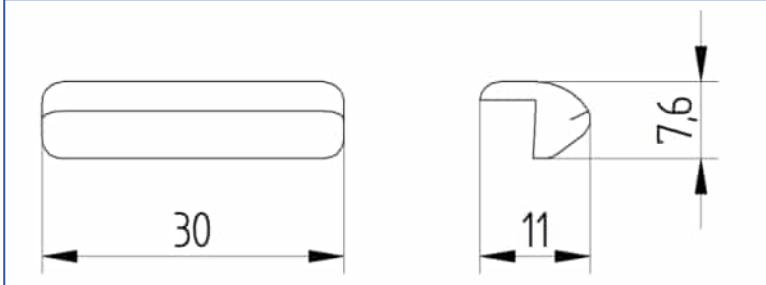
DA4-5200-00-69 (Small)

9	<p>If Retaining Bracket DA4-5200-00-69 is installed (refer to step 8.):</p> <ul style="list-style-type: none"> • Replace the Retaining Bracket according to MSB 42-083/MSB 42NG-014 (refer also to EASA AD 2010-0235). • Record replacement of the retaining bracket on the execution report in Appendix B.
10	<p>Examine the Retaining Bracket for signs of wear, corrosion and poor condition.</p> <ul style="list-style-type: none"> • There must be no corrosion on the Retaining Bracket. • Wear at the inner sides of the Retaining Bracket: maximum 0.5 mm per side. • The engaging surface of the Retaining Bracket and the edge of the engaging surface facing the Retaining Bracket must be free from steps and ridges. • Scratches or uniform wear of surface protection are permitted.

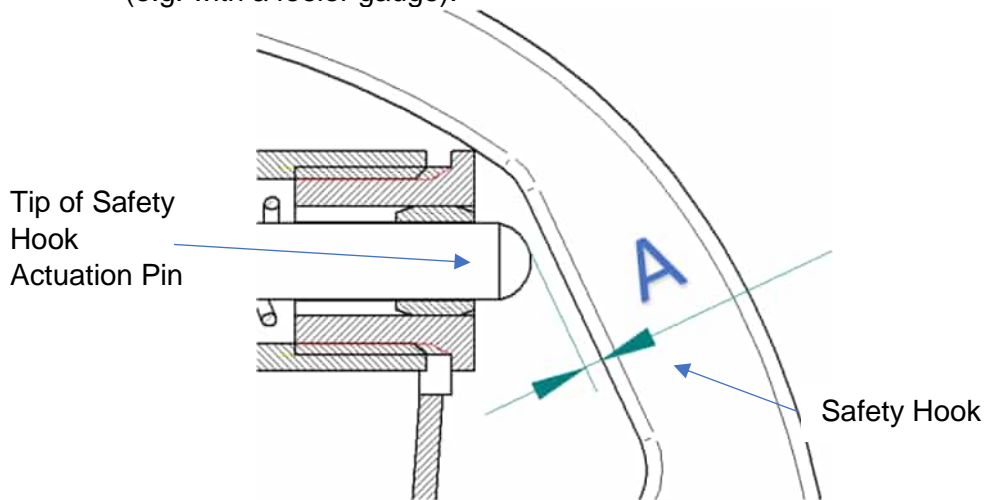
- Close and latch the Passenger Door.
- Record the measurements on the execution report in Appendix B.
 - Dimension A: distance of Actuation Pin to Safety Hook in resting position (e.g. with a feeler gauge).

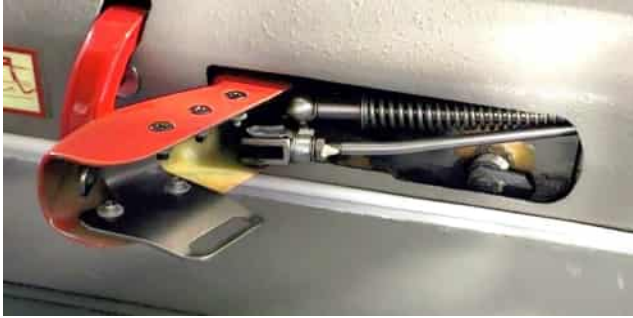
<p>Record the version of the Passenger Door latching mechanism on the execution report in Appendix B.</p>
<p>16</p>	<p>If the old Passenger Door latching mechanism is installed (refer to step 15): Visually inspect the spring.</p> <ul style="list-style-type: none"> • Move the Passenger Door Handle to the unlatched position. • Visually inspect the spring. <ul style="list-style-type: none"> ○ Look especially for a broken winding, replace the spring if found broken. • Record any findings on the execution report in Appendix B.

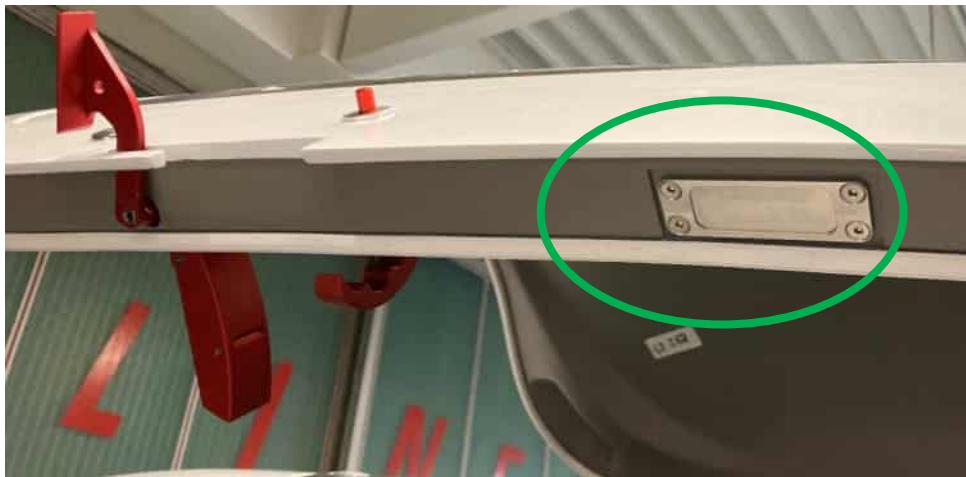
Note: Aid for identification: There is a metal plate bolted to the lower surface of the Passenger Door if MÄM 42-687 is installed. Refer to picture below.
