SERVICE INFORMATION NO. SI 42-073

GARMIN Service Bulletin No. 0713 Rev. D
FAA Airworthiness Directive 2008-02-06, dated 26-Feb-2008
ATA-Code: 22-10

NO.: 0713 Revision D

SUBJECT: GSM 85 Inspection Procedure

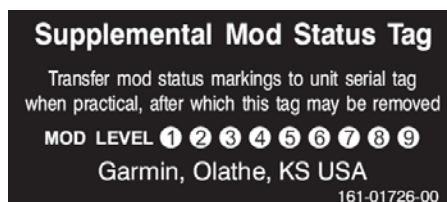
Figure 4-2

If the serial tag is not accessible (for marking mod status) on an installed GSM 85, a Supplemental Mod Status Tag (Figure 4-2), P/N 161-01726-00 (or equivalent that provides all of the same information) can be marked Mod 1 or Mod 3 per Step 4.7 and placed on an accessible surface of the GSM 85.

The serial tag shall be marked with the mod status from the Supplemental Mod Status Tag during the next regular service that allows access to the serial tag. The supplemental tag should be removed from the GSM 85 servo gearbox.
