## SERVICE INFORMATION NO. SI 42-088

GARMIN – Service Alert No. 0824 Rev. B  
ATA-Code: 34-00

NO.: 0824 Rev B

**TO:** All G1000/G900X/G950 Owners and Operators  
**DATE:** 4 August 2008  
**SUBJECT:** GDU 104X CRS/BARO Knob Interference  
**REVISION B:** Removed the GDU 1045 (011-00819-04) and added a list of affected serial numbers

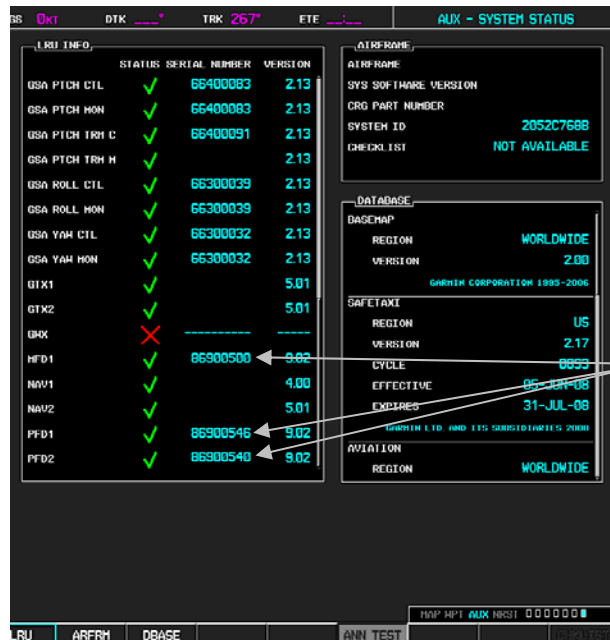
GDU 104X installations with GDU software version 3.02 and later can view unit serial numbers on the AUX – SYSTEM STATUS page. Refer to Figure 1 for an example.

Example  
GDU 104X  
Serial Numbers
