SERVICE INFORMATION NO. SI-42-110

EASA Airworthiness Directive No. 2009-0151
Thielert Aircraft Engines Service Bulletin TM TAE 125-1009 P1
ATA-Code: 61-20

<u>Technische Mitteilung Nr. / Datum:</u>	TM TAE 125-1009 P1, Erstausgabe / 07.07.2009
<u>Service Bulletin No. / Date:</u>	TM TAE 125-1009 P1, Initial Issue / July 07, 2009
<u>Betrifft:</u>	Constant Speed Unit – Schwingungsdämpfer
<u>Subject:</u>	Constant Speed Unit – Vibration Isolator
<u>Betroffenes Luftfahrtgerät:</u>	TAE 125-02-99 (CENTURION 2.0)
<u>Type affected:</u>	TAE 125-02-99 (CENTURION 2.0)
<u>Betroffene Geräte-Nr.:</u>	Alle DA42 Installationen
<u>Models affected:</u>	All DA42 installations
<u>Einstufung:</u>	Kategorie P1 – Sicherheit
<u>Classification:</u>	Category P1 – Safety
<u>Ausführung bis:</u>	Maßnahmen sind innerhalb der nächsten 100 Flugstunden oder mit der nächsten Inspektion durchzuführen, maßgebend ist das ersteintreffende Ereignis.
<u>Time of Compliance:</u>	Measures have to be accomplished within the next 100 flight hours or with the next inspection, whichever occurs first.
<u>Grund:</u>	Mögliche Motorausfälle, welche durch ein Versagen des Proportional-druckreduzierventils aufgrund von Vibrationen veru

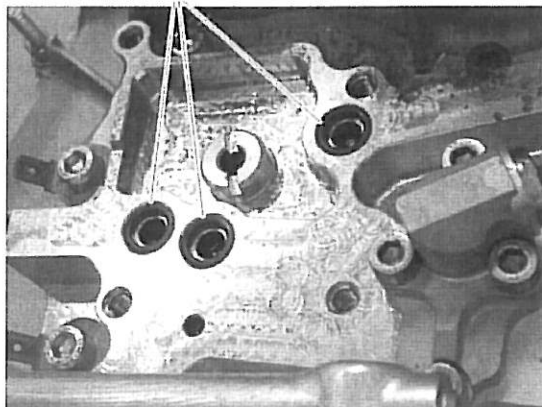
Bild 4

■ ACHTUNG: Die Oberfläche der Basisplatte darf beim Entfernen der O-Ringe auf keinen Fall beschädigt werden oder Kratzer bekommen.
Die Oberfläche der Basisplatte auf Kratzer überprüfen.
Wenn Kratzer auf der Oberfläche der Basisplatte gefunden werden, MUSS Thielert Aircraft Engines GmbH benachrichtigt werden.

4. Die drei O-Ringe auf der Basisplatte sehr vorsichtig entfernen und entsorgen. Siehe Bild 4.
