## SERVICE INFORMATION NO. SI 36-115

All H 36 and HK 36 with Limbach engines

SLICK Service Bulletin No. SB1-15A

**SUBJECT:** Potential decreased service life of Slick 4-cylinder magneto distributor gear assemblies. **Based on process and component improvements following the initial release of this service bulletin, the serial number range is being extended in this revision. Magnetos previously returned for compliance to SB1-15 must be returned or inspected for compliance to this revision SB1-15A.**

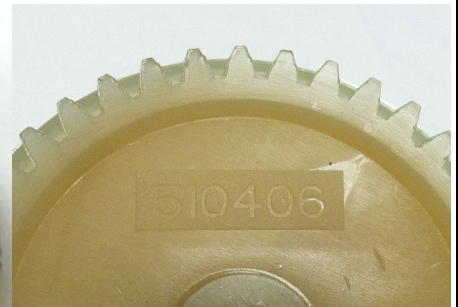
The initial release of SB1-15 was based on a limited number of field reports and product returns, Champion Aerospace has identified a possible condition in the distributor gear assemblies of 4-cylinder magnetos that can lead to decreased service life. Some of the returned products contained distributor gears exhibiting loosening of the electrode finger. This condition was observed in magnetos with a varying number of service hours. Typical symptoms are unusual RPM drop during magneto check, difficulty starting, and/or rough running engines.

**Figure 3. Affected K3008 Distributor Gear With Copper Electrode**

**COMPLIANCE:** REMOVE affected distributor gear assembly in subject magnetos and REPLACE with replacement distributor gear assembly, K3008, as soon as possible, not to exceed the next 50 hours. Document Service Bulletin compliance as written entry in applicable Aircraft and/or Engine logbook.
