# SERVICE BULLETIN

**Service Bulletin No.:** D42L-34-04 Rev 1

**Title:** G1000 System Software Version 1054.03  
Update for DA42 L360 Aircraft

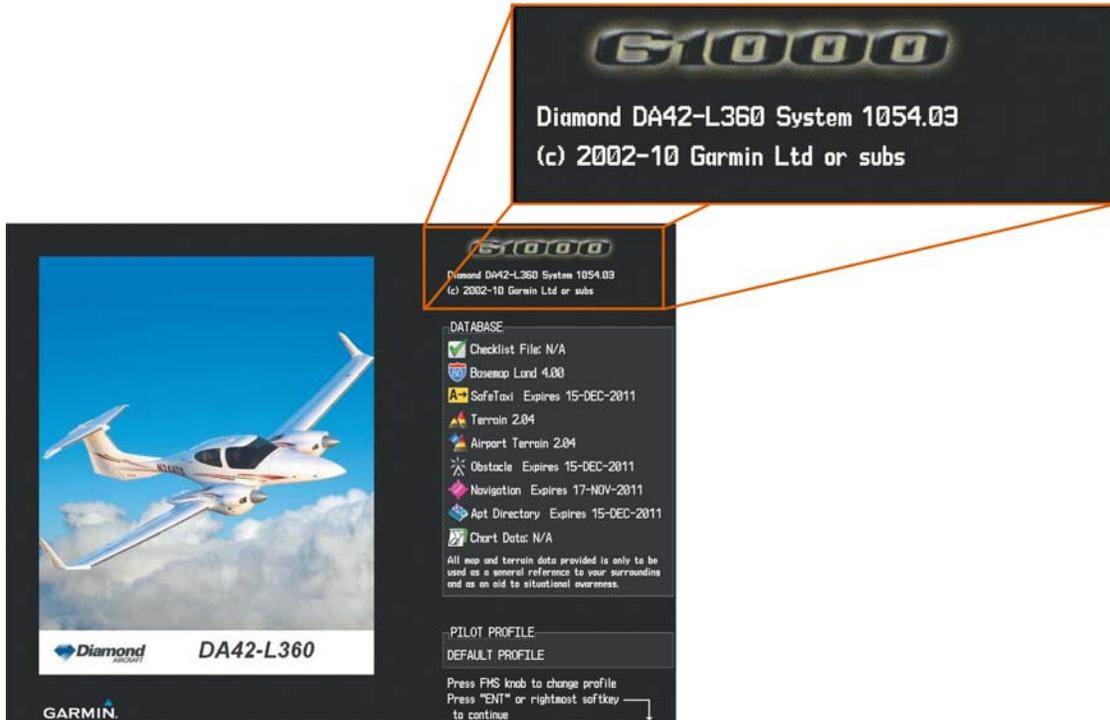
1. In the aircraft, turn the aircraft Electrical Master switch on.
2. Look at the MFD power-up screen (see following figure). In the upper right corner, the display shows 'Diamond DA42-L360 System XXXX.XX' .

3. This 'System' number is the System Software Version. It correlates to the G1000, DA42-L360 SW Loader Image. For example:

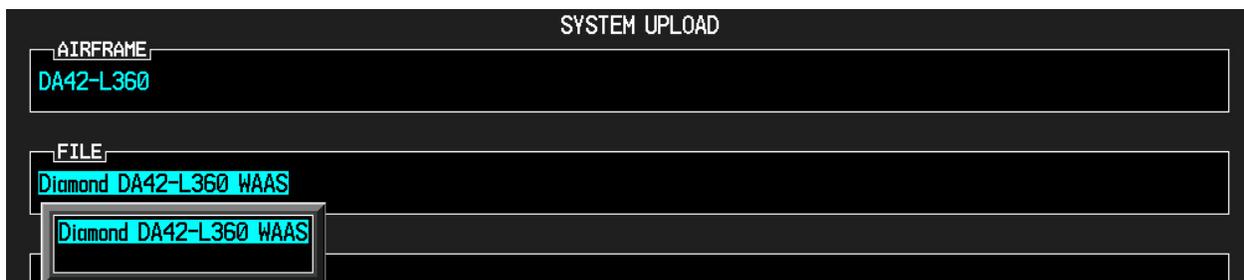
Loading WAAS software in a non-WAAS-equipped G1000 system, may result in a corrupted GIA, making cause for unit replacement.

6. Once the correct file has been selected, press the ENT key.

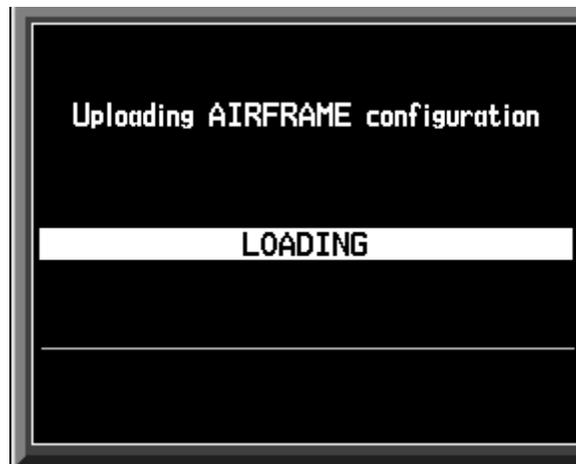
8. Monitor the status of the upload process.

- Once all files have been successfully loaded, press the ENT key to acknowledge the Upload Complete prompt.

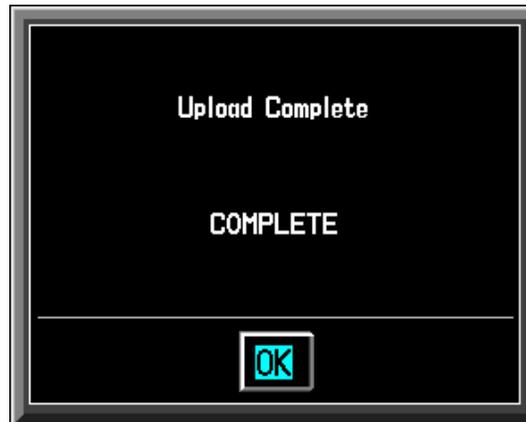
- Press the UPDT CFG softkey.
- Use the FMS knob to select YES.

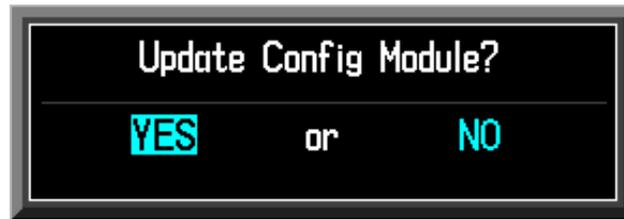
- Allow the config module update to complete.

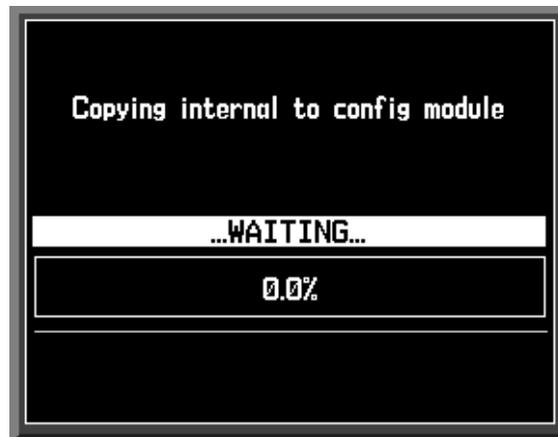
- When the configuration module update is completed, re-enter the configuration settings as noted in Section 2.2 Step 23 of this bulletin.
- Refer to the DA42-L360 Airplane Maintenance Manual Section 31-40 for instructions on manually setting other configuration settings.
- Proceed to Section 2.4.

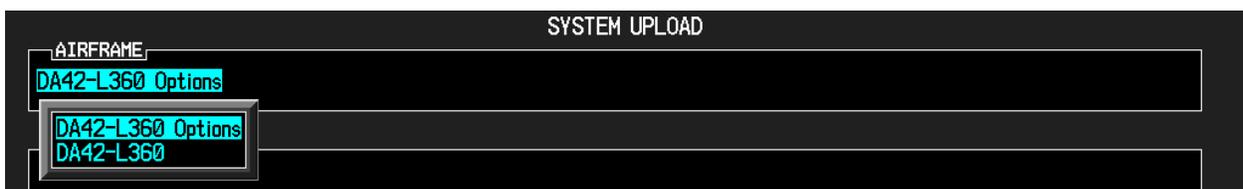
1. Go to the SYSTEM UPLOAD page using the FMS knob.
2. Activate the cursor and highlight the AIRFRAME field.
3. Using the FMS knob, select DA42-L360 Options.

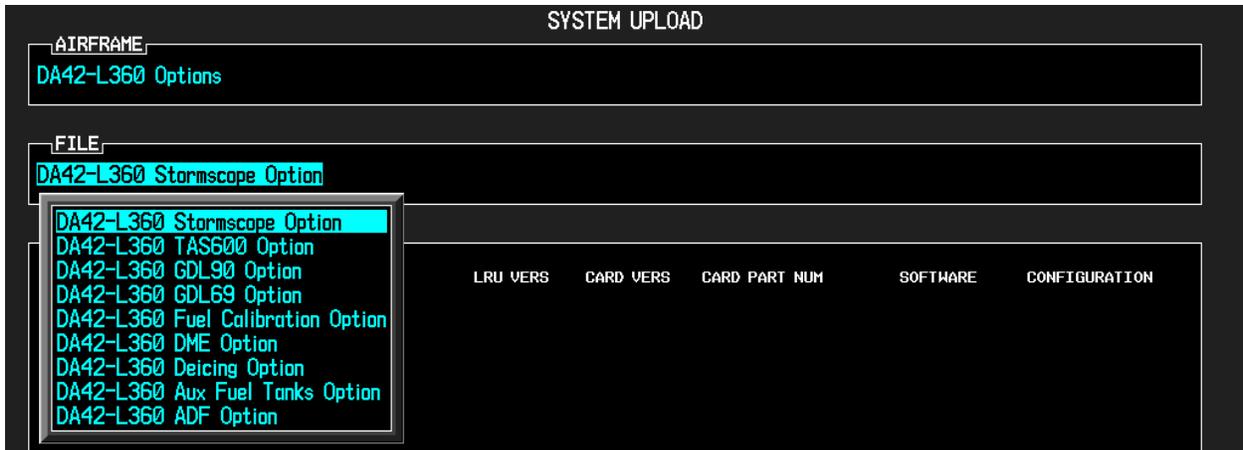
- Using the FMS knob, select the appropriate option and press the ENT key.

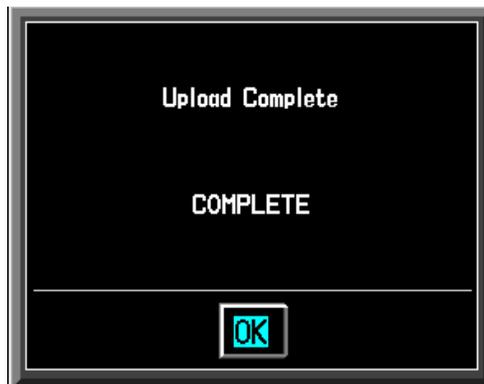
- Press the LOAD softkey to begin the software and configuration loading process.
- Press the ENT key to acknowledge the Upload Complete prompt.

- View the SUMMARY field and ensure that all items are "COMPLETED".
- Repeat steps 5 through 8 to load any other equipped options.
- Check the configuration settings as noted in Section 2.2 Step 23 of this bulletin and update to the original values if changed.
- Refer to the DA42-L360 Airplane Maintenance Manual Section 31-40 for instructions on manually setting other configuration settings.
- Once all software and configuration files have been loaded, turn off the G1000 system.
- Proceed to Section 2.5 of this bulletin.

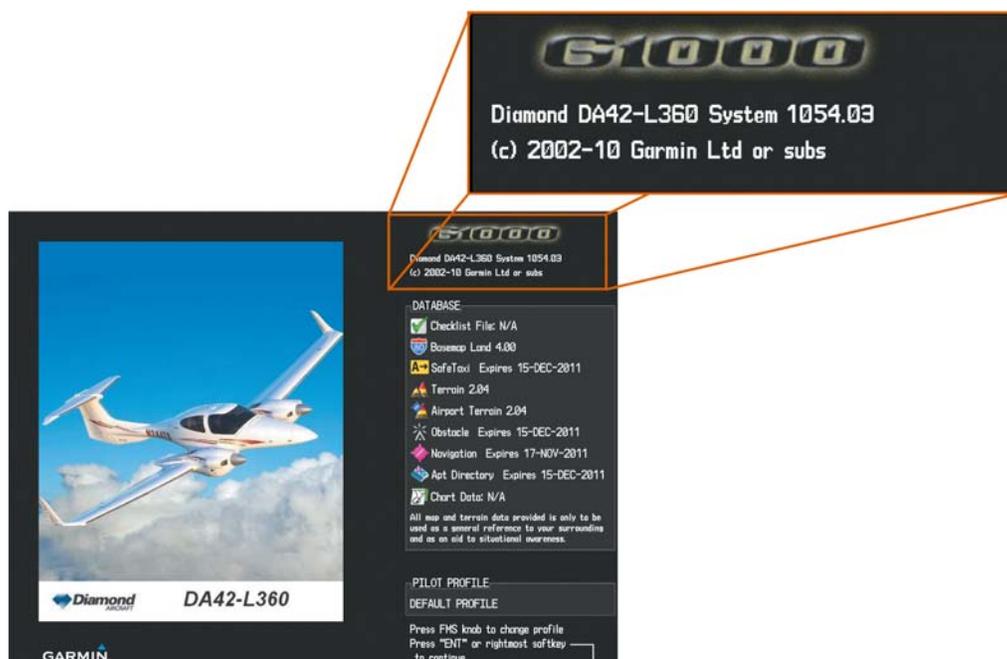
7. Look at the upper right corner of the MFD power-up screen, the display shows 'Diamond DA42-L360 System XXXX.XX':

8. This 'System' number is the System Software Version. It correlates to the G1000 SW Loader Image used to load the software to the system:

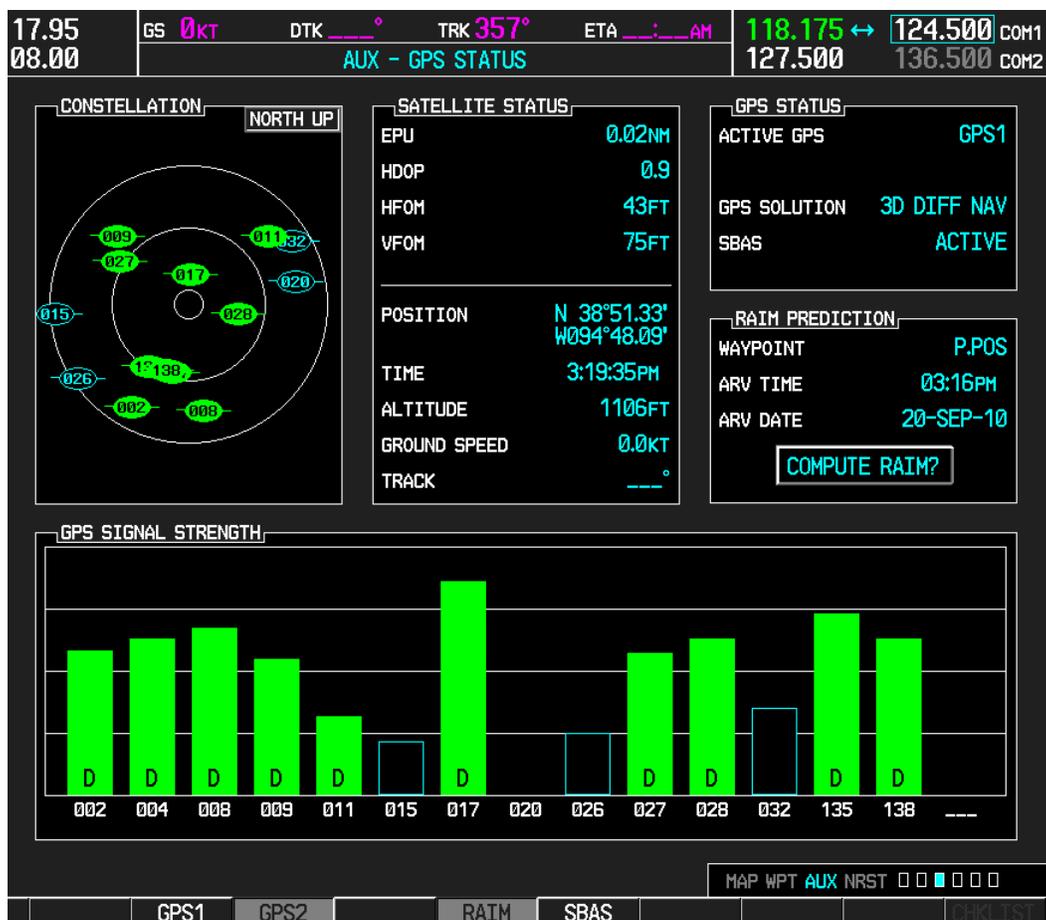
18. De-activate reversion mode by pushing the DISPLAY BACKUP button again.

19. The GIA 63(W) units should normally acquire a 3D GPS navigation solution within 5 to 10 minutes of startup, provided the aircraft is outside (or indoors with a GPS repeater). Select the AUX – GPS STATUS Page on the MFD. Two softkeys on the bottom of the display allow the user to toggle between GPS 1 and GPS 2. Verify that both receivers show ‘3D NAV’ or ‘3D DIFF NAV’ in the GPS STATUS box for GPS SOLUTION.

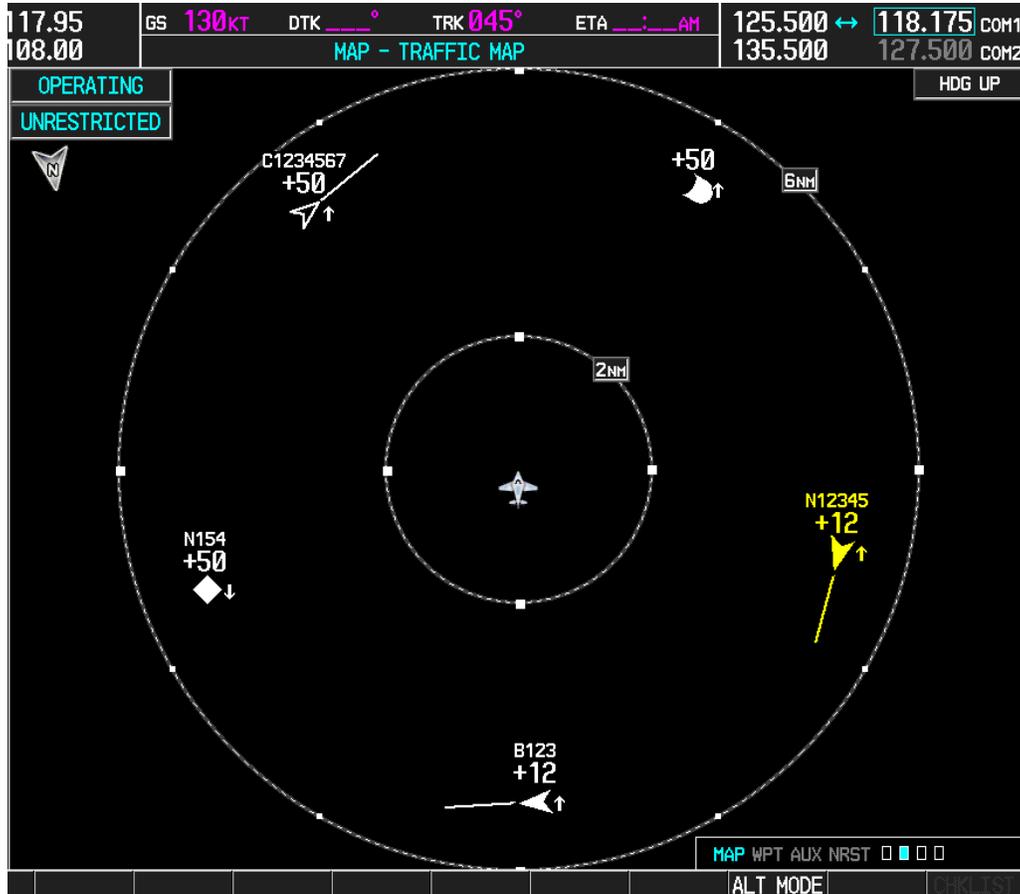
1. Using the small FMS knob, verify the Map – Traffic Map page can be displayed on the MFD.

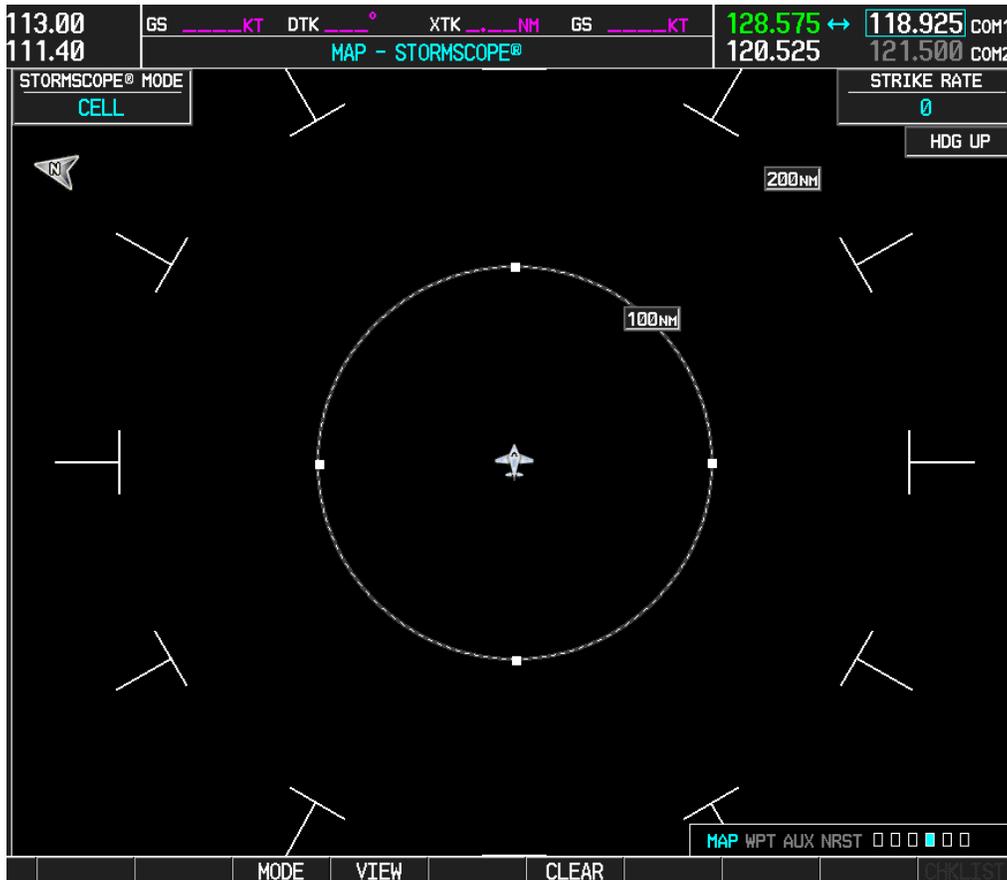
1. Using the small FMS knob, verify the Map – Stormscope page can be displayed on the MFD.

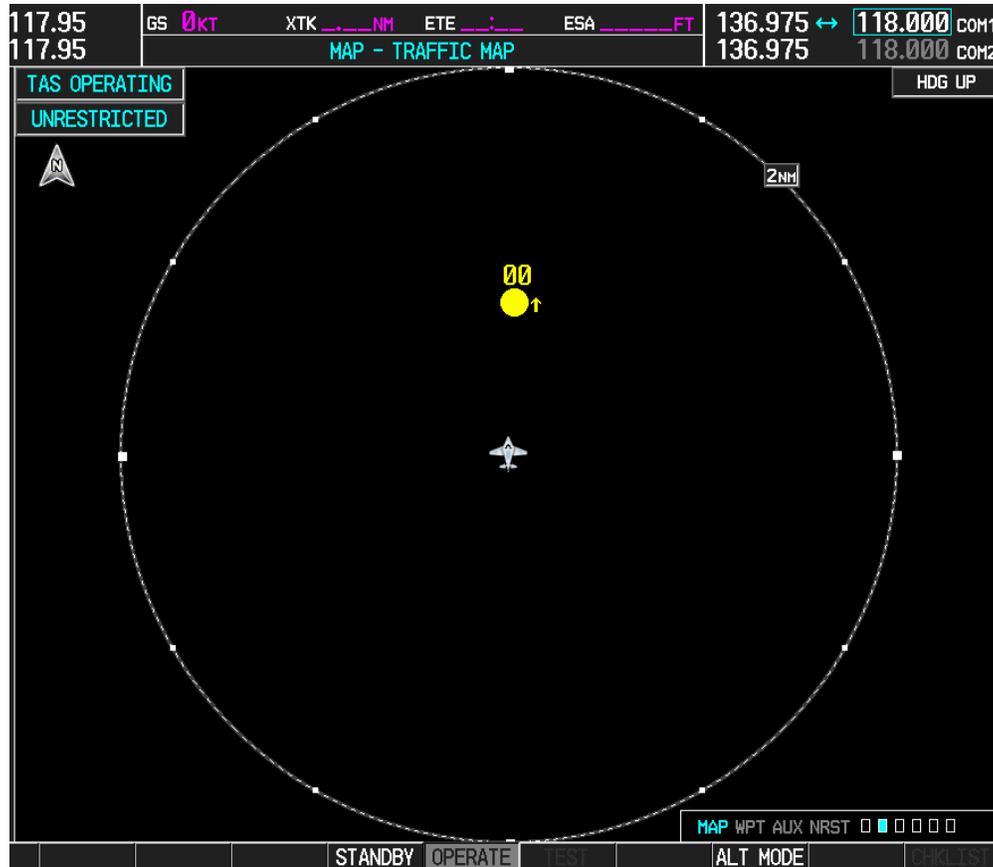
1. Using the small FMS knob, verify that the upper left corner of the Map – Traffic Map page on the MFD displays “TAS OPERATING”.

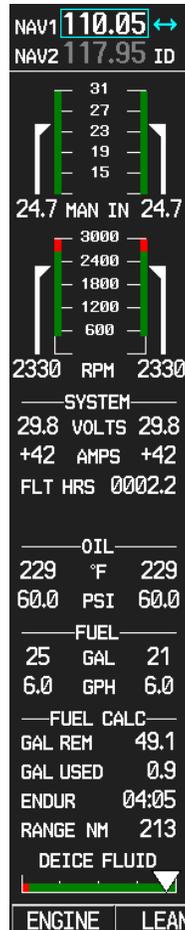
1. For aircraft with the Deicing system installed, verify that the lower left corner of the System Display on the MFD displays "DEICE FLUID".
