# SERVICE BULLETIN

**Service Bulletin No.:** D42L-34-08 Rev 0

**Title:** G1000 System Software version 1054.04  
Update for DA42 L360 Aircraft

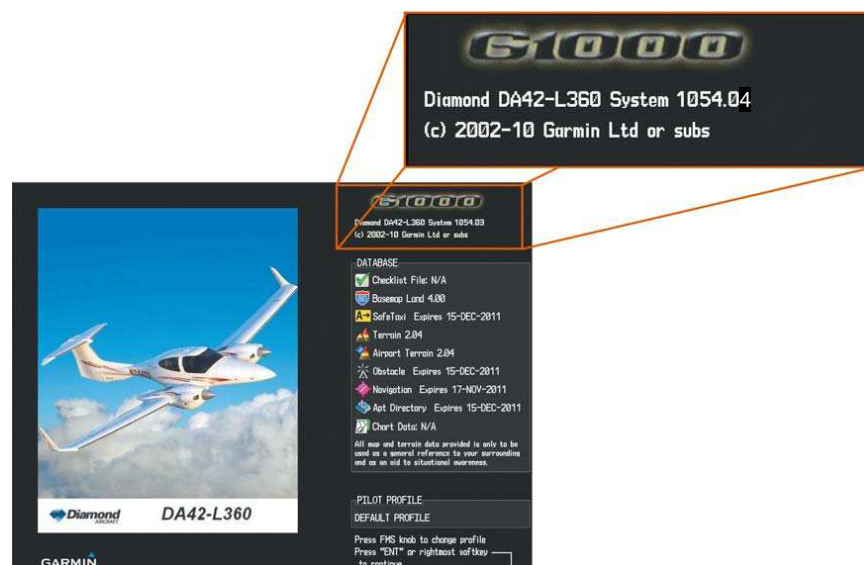
1. In the aircraft, turn the aircraft Electrical Master switch on.
2. Look at the MFD power-up screen (see following figure). In the upper right corner, the display shows 'Diamond DA42-L360 System 1054.04'.

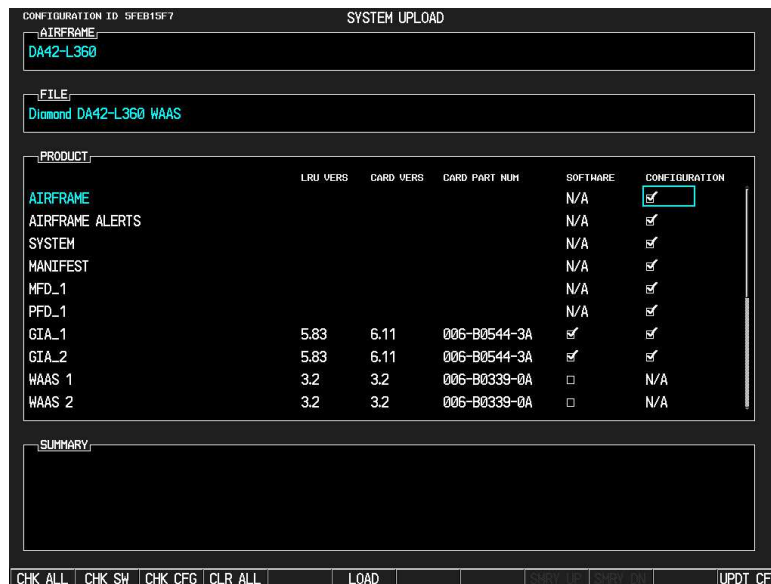
- Once the correct file has been selected, press the ENT key.
- Press the LOAD softkey to begin the software and configuration loading process.

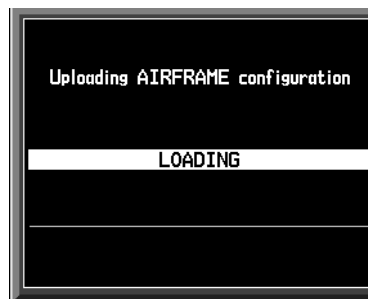
- Monitor the status of the upload process.

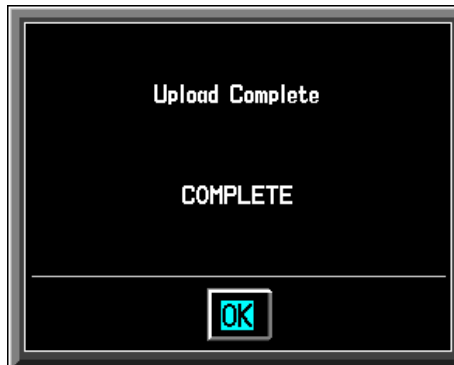
9. Once all files have been successfully loaded, press the ENT key to acknowledge the Upload Complete prompt.

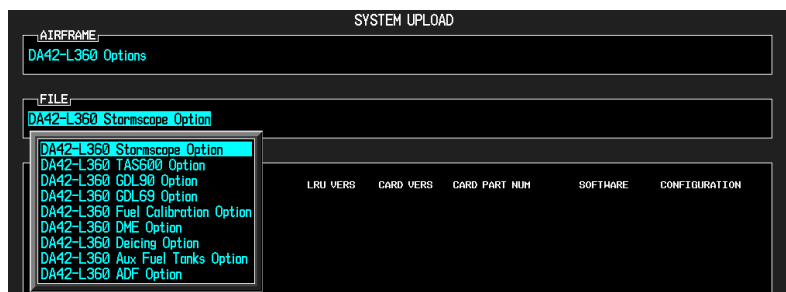
4. Press the ENT key.
5. Using the FMS knob, select the appropriate option and press the ENT key.

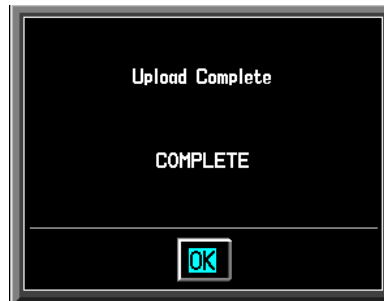
6. Press the LOAD softkey to begin the software and configuration loading process.
7. Press the ENT key to acknowledge the Upload Complete prompt.

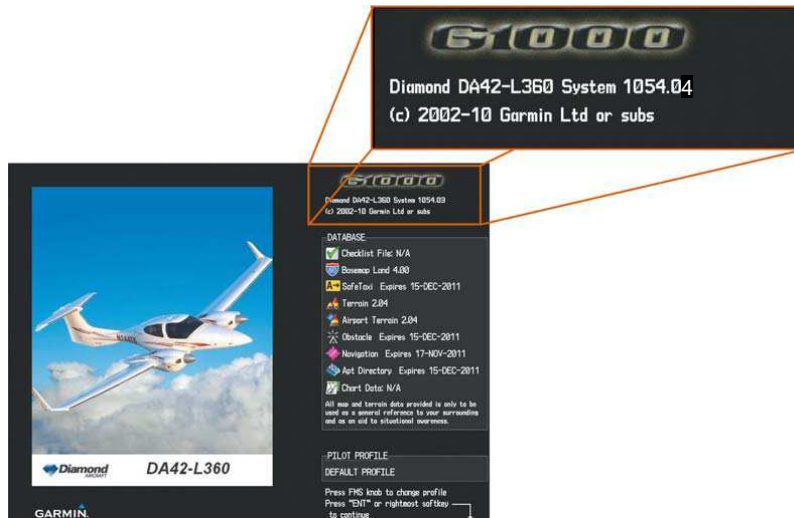
7. Look at the upper right corner of the MFD power-up screen, the display shows 'Diamond DA42-L360 System 1054.04':

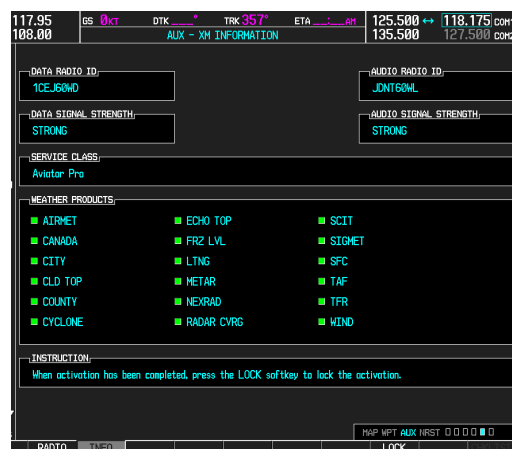
1. Using the small FMS knob, verify the AUX – XM INFORMATION page can be displayed on the MFD.

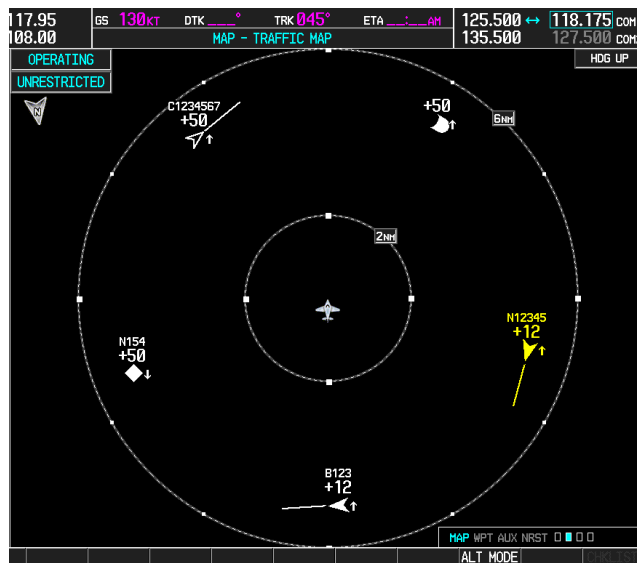
1. Using the small FMS knob, verify the Map – Traffic Map page can be displayed on the MFD.
