SERVICE INFORMATION NO. SI 20E-013

BRP-Rotax GmbH & Co KG Service Bulletin SB-912 i-014

Exchange of propeller shaft on ROTAX. Engine type 912 / 914 (Series) and 912 i (Series)

ATA System: 72-10-00 Propeller gear assy.

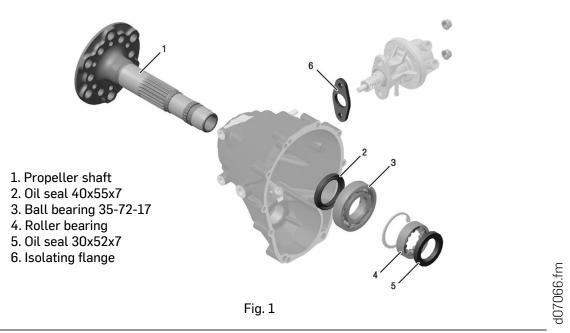
Parts requirement in case of replacement:

Part no.	Qty/engine	Description	Application
937047	1	Propeller shaft	Version 2
832587	1	Ball bearing 35-72-17	Gearbox side
950470	1	Oil seal 40x55x7	Gearbox side
232246	1	Roller bearing	Crankcase side
950200	1	Oil seal 30x52x7	Crankcase side
950228	1	Isolating flange	Fuel pump (912 Series)

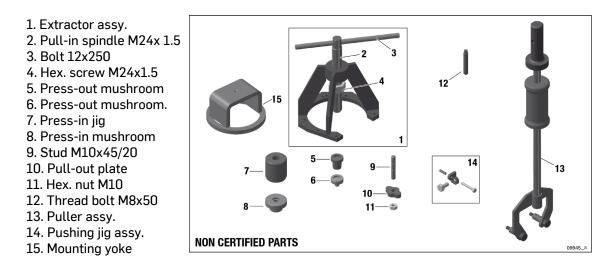
2.6) Special tooling/lubricants- /adhesives- /sealing compounds

Description	Qty/engine	Part no.	Application
EXTRACTOR ASSY.	1	877615	Roller bearing 25x25x15, oil seal 30x52x7
PULL -IN SPINDLE M24x1.5	1	877580	Extractor assy.
BOLT 12x250	1	276155	Extractor assy.
HEX. SCREW M24x1.5 - 19 MM	1	842585	Extractor assy.
PRESS-OUT MUSHROOM	1	877605	Prop shaft (Version 2)
PRESS-IN JIG	1	877594	Oil seal 30x52x7 (Version 2)
PRESS-IN MUSHROOM	1	877590	Roller bearing 25x52x15
STUD M10x45/20	1	941180	Roller bearing 25x52x15, oil seal 30x52x7
PULL-OUT PLATE	1	877561	Roller bearing 25x52x15, oil seal 30x52x7
HEX. NUT M10	1	242092	Roller bearing 25x52x15, oil seal 30x52x7
THREAD BOLT M8x50	1	240880	Crankshaft locking screw
PUSHING JIG ASSY.	1	877540	Gearbox
PULLER ASSY.	1	877660	Gearbox
MOUNTING YOKE	1	876885	To compress dog gear
LOCTITE 243 BLUE	as required	897651	Hex. screw M7x16
LOCTITE ANTI SEIZE 8151	as required	297434	Propeller shaft at ball bearing
LOCTITE 5910	as required	899791	Flange sealant

See Fig. 2.
