RECOMMENDED SERVICE BULLETIN

RSB 40-082/1
RSB D4-102/1
RSB F4-035/1
RSB 40NG-041/1

I.5 Subject

Inspection of NLG elastomer pack center tube

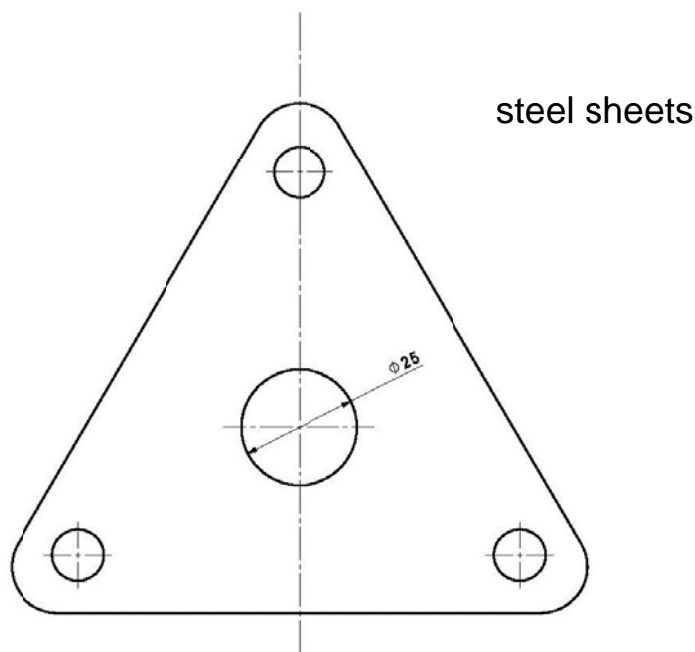
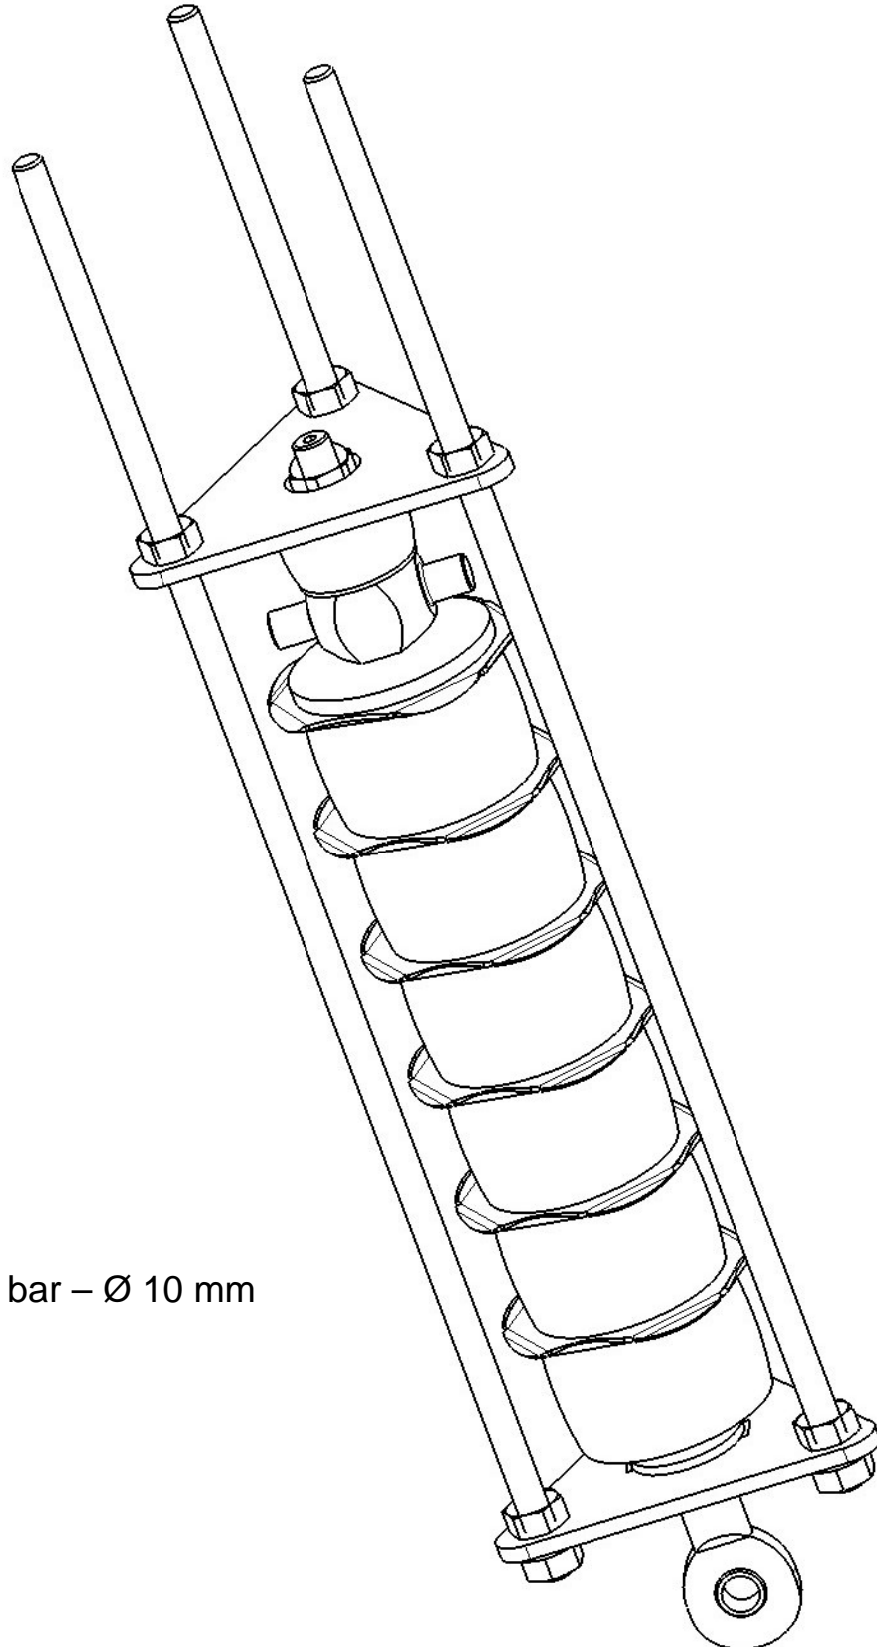
IV APPENDIX A

Note: Appendix A provides sketches for building a tensioning tool for easier assembly of the NLG damper.

threaded bar – Ø 10 mm
