SUPPLEMENT A02 TO THE AIRPLANE FLIGHT MANUAL

DA 40 NG GARMIN G1000 NXI AVIONICS SYSTEM

Doc. No.

: 6.01.15-E

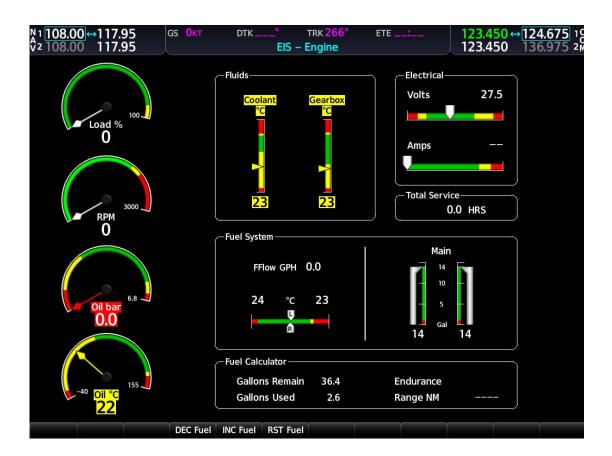
Default page, engine.

Displayed after pushing the ENGINE button.

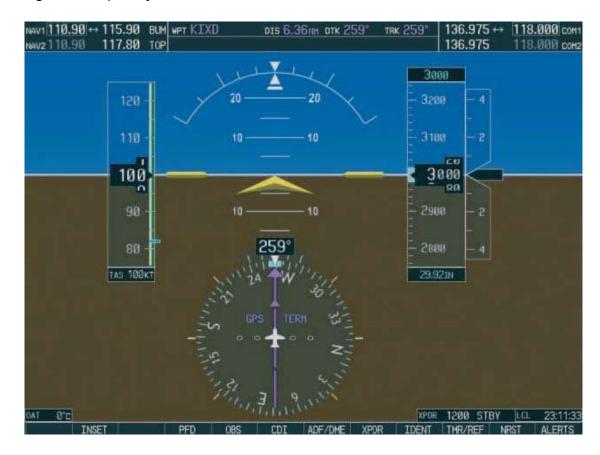
- * Communications frequency volume and squelch knob
- Communications frequency set knobs

- * Communications frequency transfer button
- * Altimeter setting knob (baro set)
- * Course knob
- Map range knob and cursor control
- * FMS control buttons and knob
- * PFD softkey buttons, including master warning/caution acknowledgment
- * Navigation frequency set knobs
- * Navigation frequency volume and identifier knob

The PFD displays the crew alerting (annunciator) system. When a warning or caution message is received, a warning or caution annunciator will flash on the PFD, accompanied by an aural tone. A warning is accompanied by a repeating tone, and a caution is accompanied by a single tone. Acknowledging the alert will cancel the flashing and provide a text description of the message. Refer to AFM Chapter 3 - EMERGENCY PROCEDURES, 4B - ABNORMAL OPERATING PROCEDURES, and Section 7.10.3 - WARNING, CAUTION, AND ADVISORY MESSAGES of this supplement.
