## SERVICE INFORMATION NO. SI 40-041

DA 40 with Garmin G1000 EASA STC.IM.A.S.01023 (FAA STC SA01254WI) installed, with less than 50 hrs total time

EASA AD No.: 2006 – 0295-E for  
Engine – Contamination of the Engine Fuel System – Inspection  
ATA-Code: 72

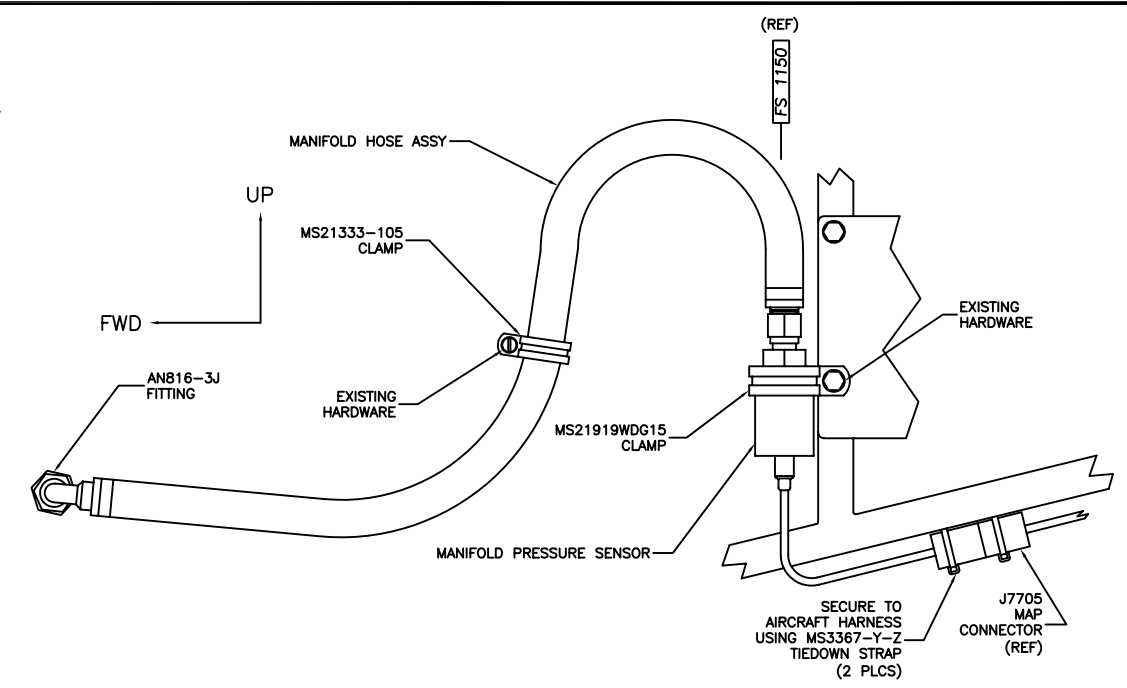
**MANIFOLD PRESSURE SENSOR**  
(VIEW LOOKING RT)

WIRE COLOR	P7705 PIN
RED	1
BLUE	2
BLACK	3

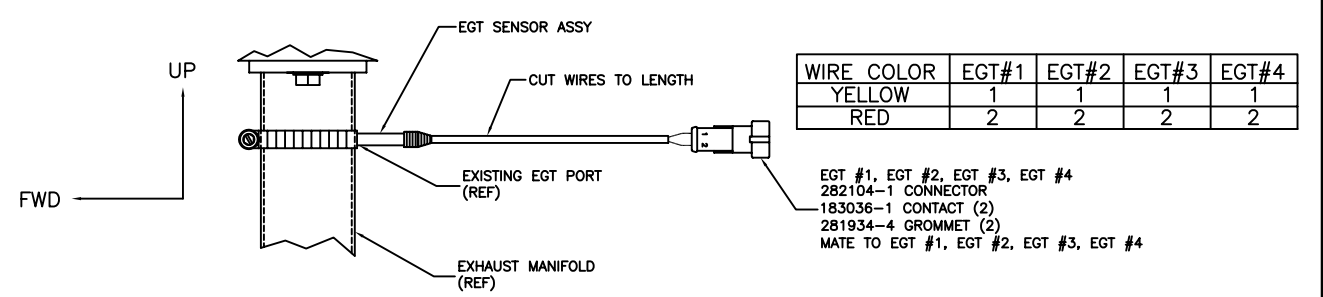
**EGT SENSOR**  
(TYP 4 PLCS)

**DETAIL H**  
**ENGINE COMPARTMENT SENSORS**  
◆ DA 40 ONLY (REF NOTE 20)
