MANDATORY SERVICE BULLETIN MSB 42-092

MSB 42NG-022

Center Wing - Skin to Spar Bond

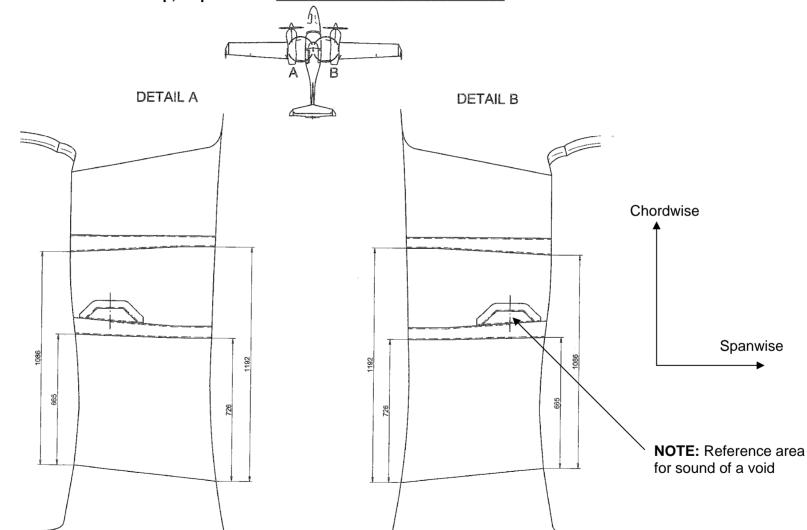
Void Map, Airplane S/N:

NOTE: Dimensions are for reference only. Determine exact location of spars by tap testing.

NOTE: Dimensions are specified in millimeters. Refer to AMM for conversion to inches.

3.	Mark voids, fill in Void Map (Appendix A) and file with DAI (Fax: +43 - 2622 - 26700 - 1369, Email: airworthiness@diamond-air.at).
	The Void Map is attached to this WI. A sample Void Map which explains how to use the form is also attached.
	NOTE: Keep records of voids (copy of void map, pictures,) to find back for repair.
