## SERVICE INFORMATION NO. SI-42NG-007

GARMIN Software Service Bulletin No. 0945, Revision A  
ATA-Code: 34-00

NO.: 0945, Revision A

**SUBJECT:** G1000 System Software Version 0670.03 Update for G1000-equipped  
Diamond DA42NG Aircraft

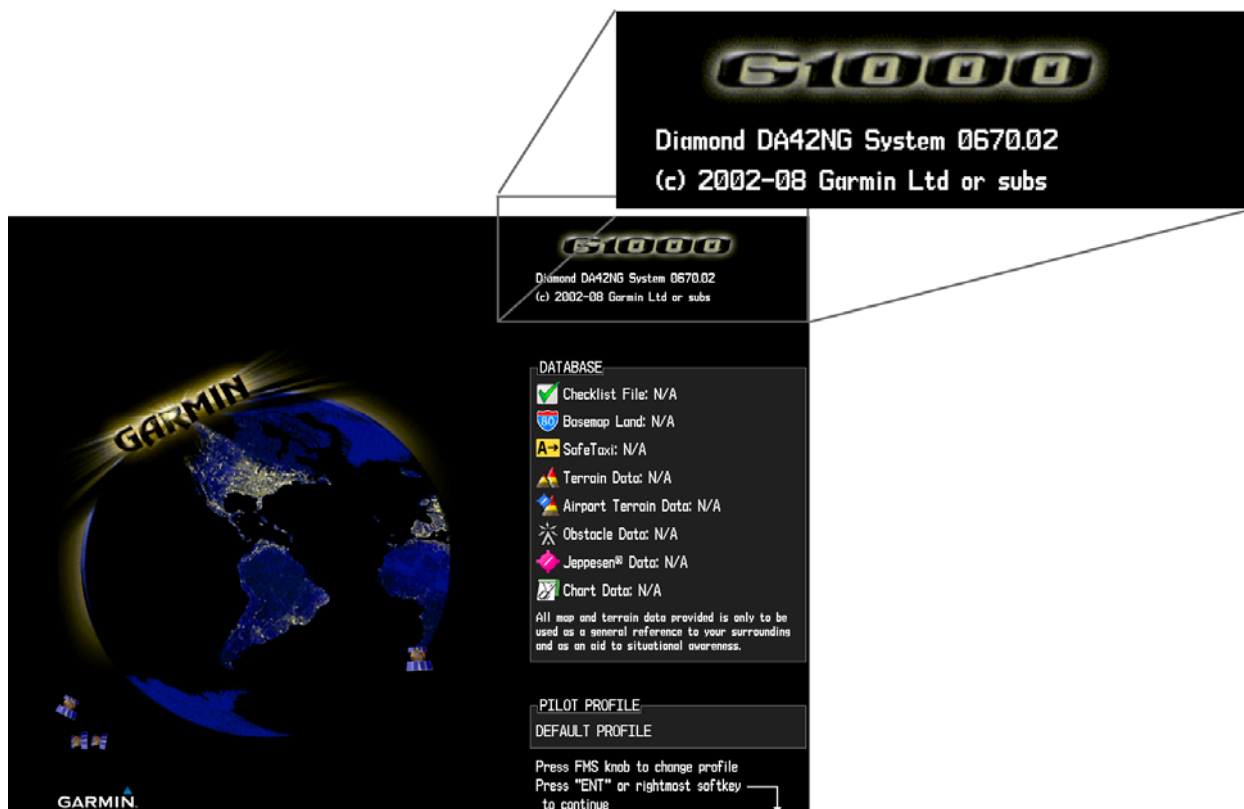
- ❑ To identify what G1000 System Software version is installed, do the steps that follow:
1. In the aircraft, turn the aircraft ELECT. MASTER switch on.
  2. Look at the MFD power-up screen (see following figure). In the upper right corner, the display shows 'Diamond DA42NG System XXXX.XX'.

3. This 'System' number is the System Software Version. It correlates to the G1000 SW Loader Card used to load the software to the system. For example:

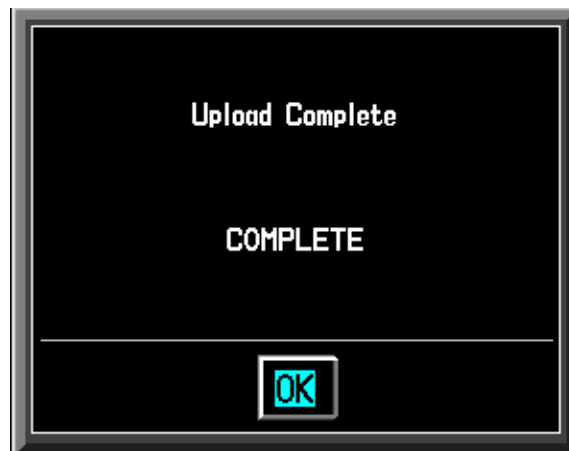
9. Once all files have been successfully loaded, press the ENT key to acknowledge the Upload Complete prompt.

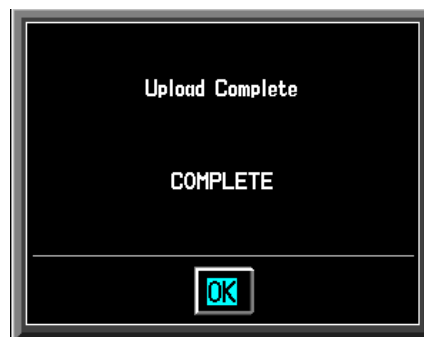
6. Press the LOAD softkey, to begin the software and configuration loading process.
7. Press the ENT key to acknowledge the Upload Complete prompt.

8. View the SUMMARY field and ensure that all items are "COMPLETED".
9. Repeat steps 5 through 8 to load any other equipped options.
10. Re-enter the configuration settings as noted in Section 2.1 Step 20 of this bulletin.
11. Refer to the DA 42 NG Airplane Maintenance Manual Section 31-40-00 for instructions on manually setting other configuration settings.
12. Proceed to Section 3 of this bulletin.

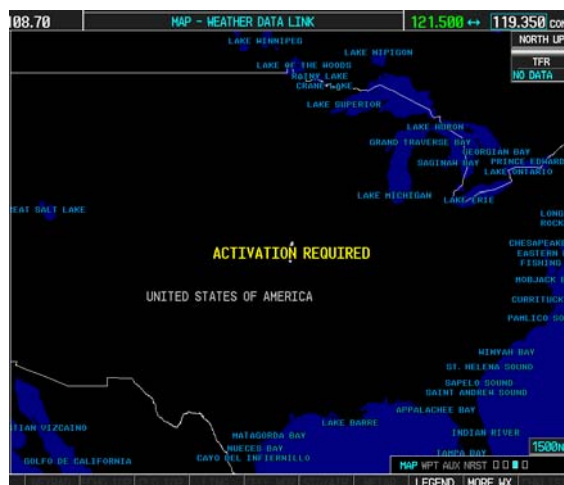
This check verifies that the GDL69-to-G1000 interface operates correctly. This check is required for DA42NG aircraft with the GDL 69 installed.

1. Using the small FMS knob, verify the Map – Weather Data Link page can be displayed on the MFD.

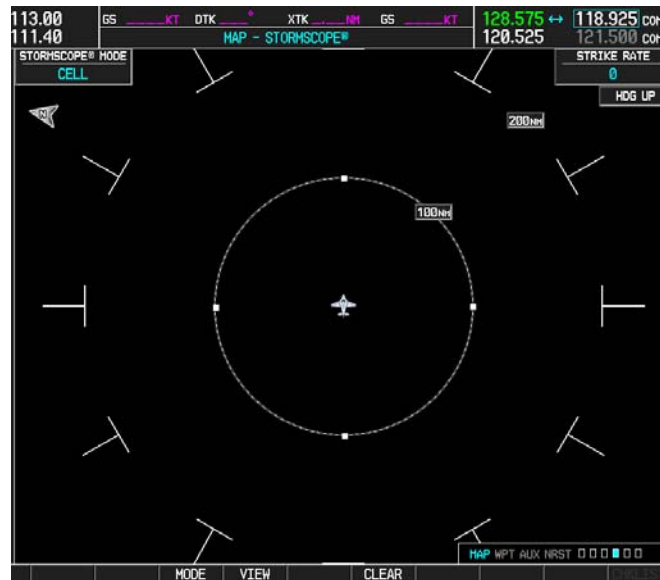
This check verifies that the L-3 Communications Stormscope® interface operates correctly. This check is required for DA42NG aircraft with the Stormscope installed.

1. Using the small FMS knob, verify the Map – Stormscope page can be displayed on the MFD.

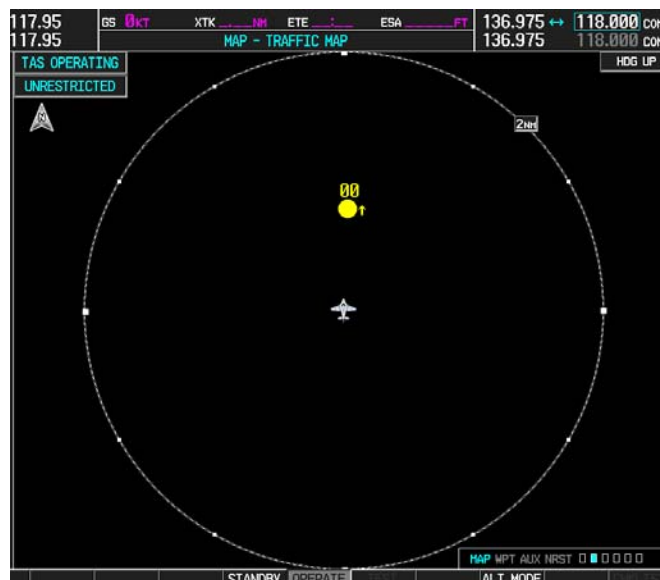
This check verifies that the KTA870 TAS-to-G1000 or TAS600-to-G1000 interface operates correctly. This check is required for DA42NG aircraft with the KTA870 TAS or TAS600 installed.

1. Using the small FMS knob, verify that the upper left corner of the Map – Traffic Map page on the MFD displays “TAS OPERATING”.

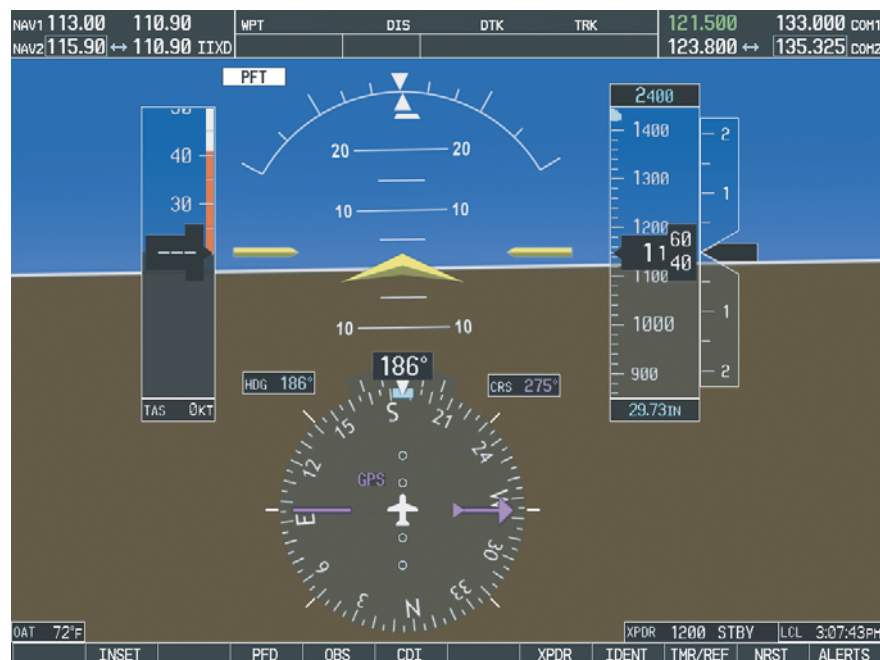
A red 'AFCS' ( AFCS ) annunciation will be displayed until both GIAs, the AHRS, and the autopilot servos are online. The red 'AFCS' annunciation will then be replaced by a white 'PFT' annunciation.

2. Verify that a white 'PFT' annunciation is displayed on the PFD, as shown in the following figure.

3. Upon successful completion of the pre-flight test, an aural alert will sound and the 'PFT' annunciation will clear. Continue to Step 3.8.2.

If the 'PFT' annunciation turns red, the test has failed and additional troubleshooting will have to be performed prior to continuing with the test.

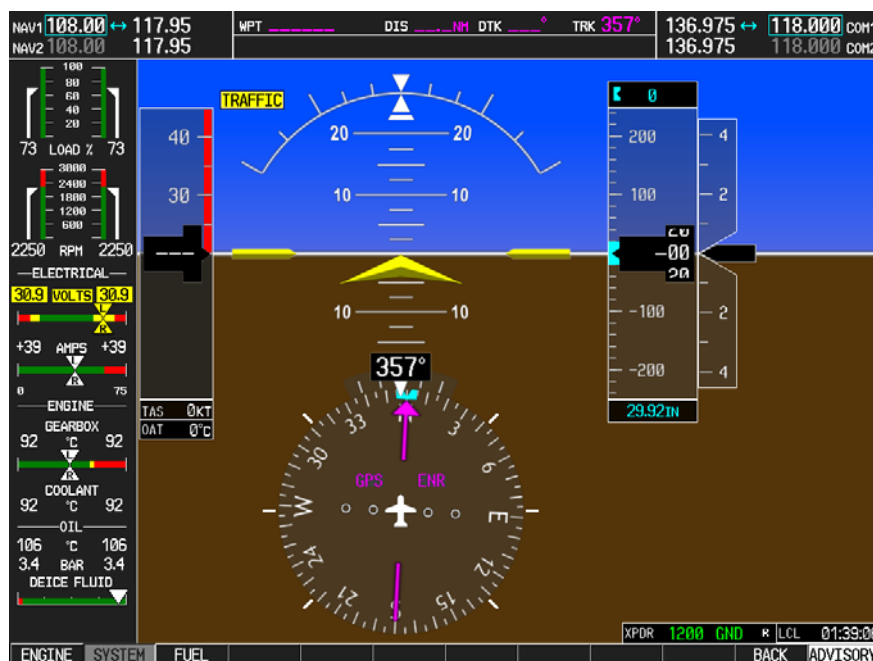
This check verifies that the Deicing system interfaces operate correctly. This check is required for DA42NG aircraft with the Deicing option installed.

1. For aircraft with the Deicing system installed, verify that the lower left corner of the System Display on the PFD displays "DEICE FLUID".
