OPTIONAL SERVICE BULLETIN NO. OSB-42-050/1

I.4 Subject

Installation of additional ECU Backup Batteries to supply electric power solely to the ECU in the course of high transient causing a short term voltage drop in case of insufficient main battery power. The ECU Backup Battery capacity is sufficient for at least 30 minutes engine operation.

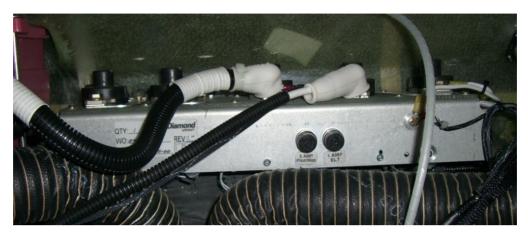
Figure 1

If the installed relay panel looks like the figure below, proceed with the instructions given in section III.2.

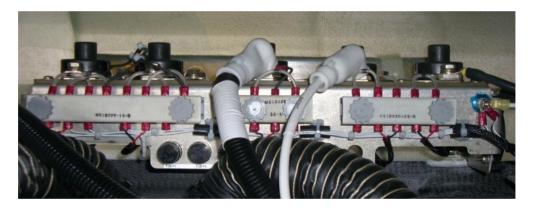
Figure 2

If the installed relay panel looks like the figure blow, proceed with the instructions given in section III.3.

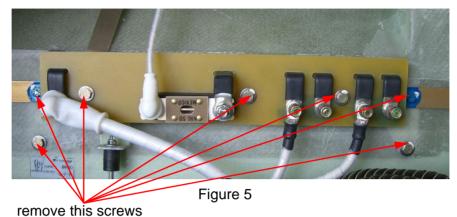
5 Remove the 7 screws of the relay panel on the instrument panel side, as shown below.

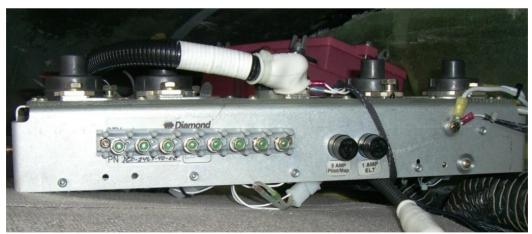
Figure 6

If the airplane if equipped with an oxygen system remove the relay panel clear of the airplane.
- 8 Modify the relay panel according the steps below.
- Install the terminal block (P/N MS27212-1-8) 6 cm (2.4 ") from the right edge (as shown below), using the hardware MS35206-216 (screw), AN960-C4 (washer) and MS21083B04 (locknut). Two holes (3.0mm) must be drilled into the relay panel first. The two most outboard mounting holes of the terminal block should be used for mounting.

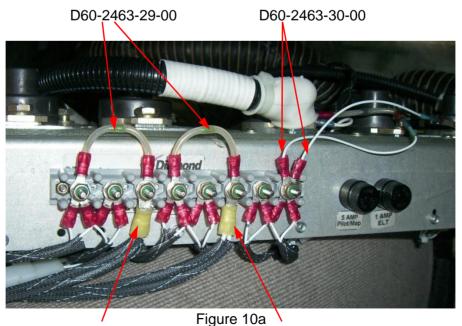
14 Connect the ring terminals of the 6 adapter harnesses (D60-2463-31-00-SB and D60-2463-32-00-SB), the fuse assemblies (D60-2463-29-00), the wire 24317A14 (D60-2463-24-00x01), the wire 24318A14 (D60-2463-25-00x01) and the cable, diode assemblies (D60-2463-30-00) to the terminal block as shown below.

24317A14

24318A14

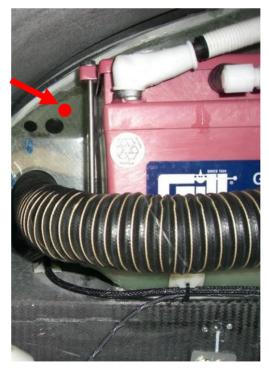
Figure 12

If the airplane is equipped with an oxygen system, drill a hole diameter 8,5 mm adjacent to the existing holes (see Figure 12) and protect edges with grommet dm 6 mm (P/N 5616632).

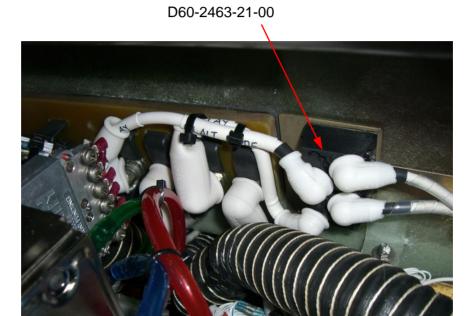
Figure 13

Re-install the relay panel including the diode assy D60-2463-21-00 on the right side of the front landing gear spar (instrument panel side) as shown below, using the two mounting bolts of the relay panel.

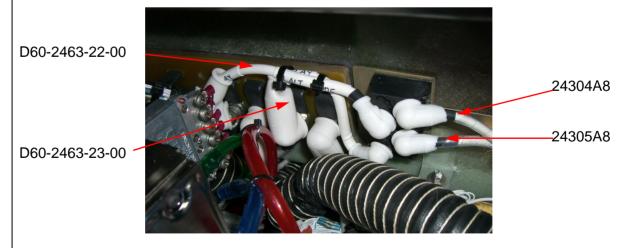
Figure 14

- Disconnect the cables 24304A8 and 24305A8 at the LH and RH alternator relays respectively.
- Install the cables D60-2463-22-00 (LH relay) and D60-2463-23-00 (RH relay), which are part of the diode assembly D60-2463-21-00, onto the above mentioned terminals of the alternator relays, including the insulating boots P/N MS 25171-3S.

CAUTION: The cables D60-2463-22-00 and D60-2463-23-00 must have enough clearance to the canopy arm when in closed position.

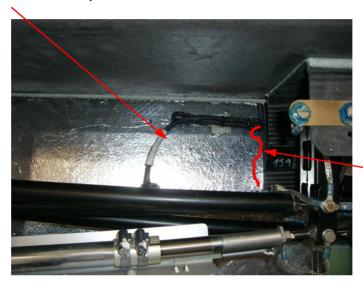
Figure 15

new routing

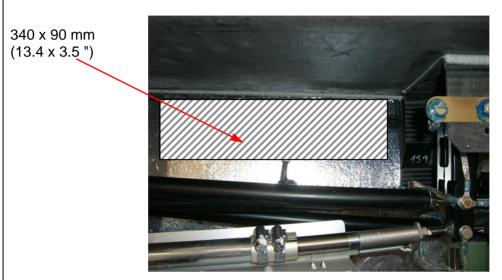
Figure 16a (LH)

Remove the aluminium foil at the positions shown below for mounting of the ECU Backup Batteries. Refer also to drawing D60-2467-50-00.

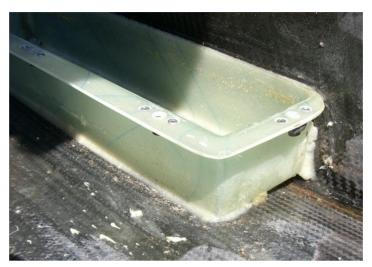
Figure 17

Bond the lower brackets (LH and RH) D60-2467-57-00 to the main structure using thickened resin according to AMM. Refer also to drawing D60-2467-50-00.

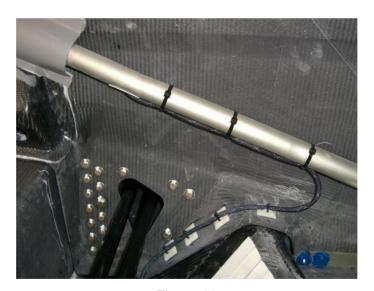
Figure 18

Route the wires 24315A14 (D60-2467-11-00) and 24316A14 (D60-2467-12-00) through the right hand lightning protection conduit to the instrument panel, along with the wires for the roll servo of the autopilot.

NOTE: Older serial numbers of the DA 42 can have a braid installed instead of the conduit.

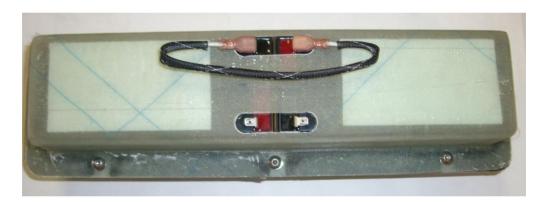
Figure 20

30 Install the batteries serial connection cable D60-2463-26-00x01, to gain 24V.

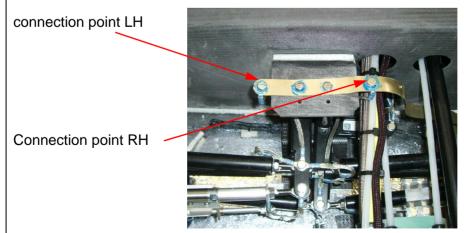
Figure 21

Install the batteries ground cables D60-2463-27-00x01 to the negative poles of the backup batteries and connect them to the lightning protection strap as shown below.

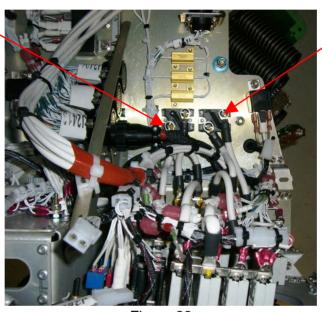
Figure 22

- 32 Crimp the supplied ring terminals (part of D60-2463-24-00x01 and D60-2463-25-00x01) onto the wires 24315A14 / 24317A14 and 24316A14 / 24318A14, part of D60-2467-11-00 / D60-2463-24-00x01 and D60-2467-12-00 / D60-2463-25-00x01, prior routed from the fuselage to the instrument panel and through the front landing gear spar (step 18).
- Connect the wires 24315A14 / 24317A14 and 24316A14 / 24318A14 to the two diodes installed on the bottom of the instrument panel sheet metal. Refer also to figure 22. **CAUTION:** Attention should be paid to the polarity of the diodes.

24315A14 / 24317A14

24316A14 / 24318A14

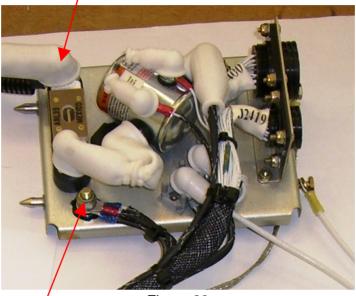
Figure 23

Connect the Fuse Assembly, USense, D60-2407-33-00 to the top terminal of the fuse holder. Refer also to figure 23.

LH shown, RH mirrored

Connect the ring terminal of the cable here

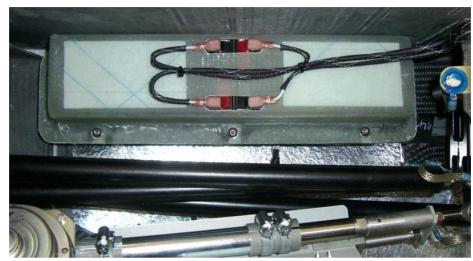
Figure 24 (LH shown)

Connect the battery fuse assemblies (part of D60-2467-11-00 LH and D60-2467-12-00 RH) to the positive pole of the backup batteries.

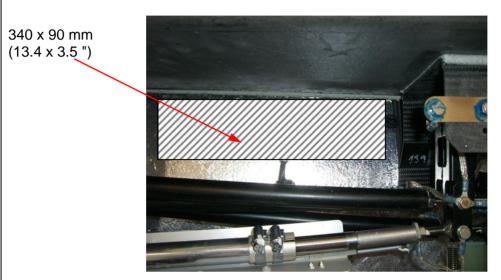
Figure 26a (LH)

2 Remove the aluminium foil at the positions shown below for mounting of the ECU Backup Batteries. Refer also to drawing D60-2467-50-00.

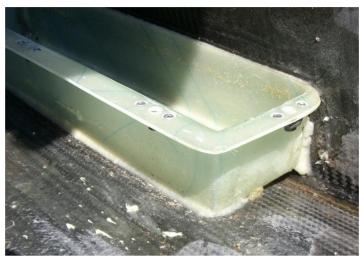
Figure 27

Bond the lower brackets (LH and RH) D60-2467-57-00 to the main structure using thickened resin according to AMM. Refer also to drawing D60-2467-50-00.

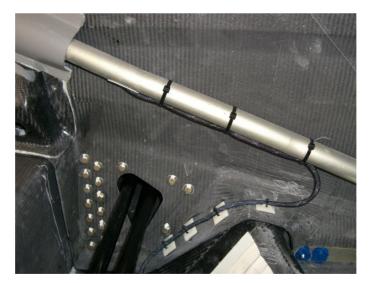
Figure 28

- 5 Remove the instrument panel cover in accordance with the AMM.
- Route the wires 24315A14 (D60-2467-11-00) and 24316A14 (D60-2467-12-00) through the right hand lightning protection conduit to the instrument panel, along with the wires for the roll servo of the autopilot.

NOTE: Older serial numbers of the DA 42 can have a braid installed instead of the conduit.

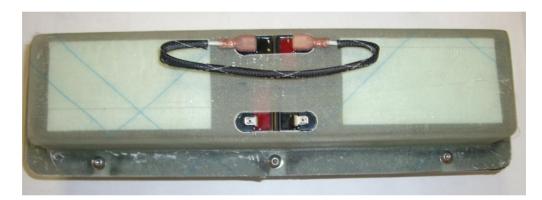
Figure 30

8 Install the batteries serial connection cable D60-2463-26-00x01, to gain 24V.

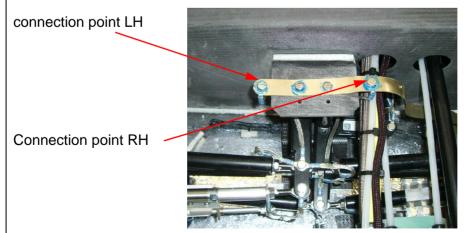
Figure 31

Install the batteries ground cables D60-2463-27-00x01 to the negative poles of the backup batteries and connect them to the lightning protection strap as shown below.

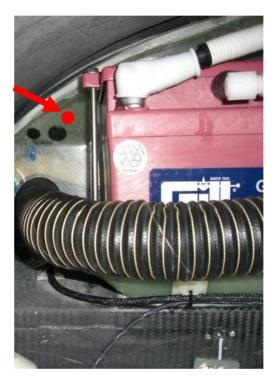
Figure 32

If the airplane is equipped with an oxygen system, drill a hole diameter 8,5 mm adjacent to the existing holes (see Figure 32) and protect edges with grommet dm 6 mm (P/N 5616632).

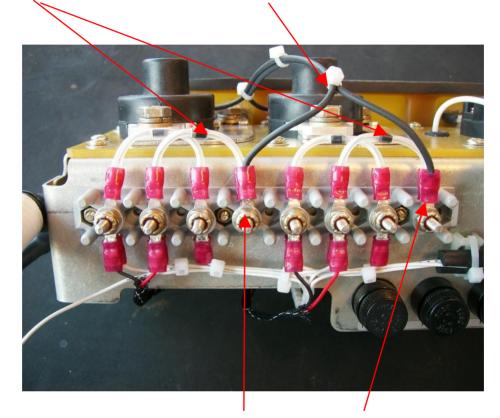
Disconnect the two wires connected to the alternator relay power side and sealed them with appropriate heatshrink. Replace the diode assemblies with the fuse assemblies D60-2463-29-00. Connect wires 24317A14 (D60-2463-24-00x01) and 24318A14 (D60-2463-25-00x01). Refer also to Figure 34

Replace diode assy's

Disconnect and seal wires

Connect wires 24318A14 and 24317A14

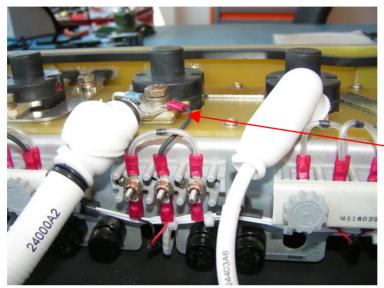
Figure 35

Replace the positive coil connection of the battery relay with the "Cable, diode assembly" D60-2463-30-00. Note the polarity of the diode. Refer to drawing D60-9224-30-03 and also to figure 35.

Replace cable with D60-2463-30-00

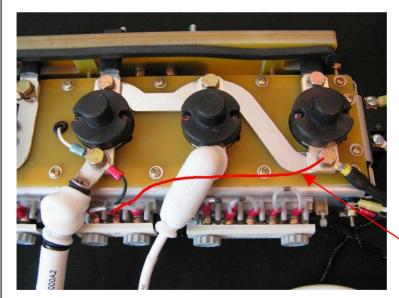
Figure 36

Install the second "Cable, diode assembly" D60-2463-30-00 between the battery bus and the positive coil connection of the battery relay. Note the polarity of the diode. Refer to drawing D60-9224-30-02_02 and also to figure 36.

Install D60-2463-30-00

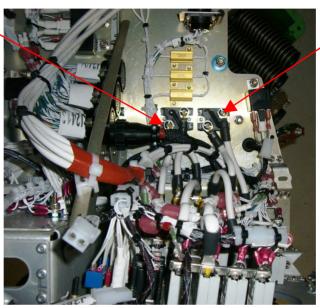
Figure 37

17 Connect the wires 24315A14 / 24317A14 and 24316A14 / 24318A14 to the two diodes installed on the bottom of the instrument panel sheet metal. Refer also to figure 37. **CAUTION:** Attention should be paid to the polarity of the diodes.

24315A14 / 24317A14

24316A14 / 24318A14

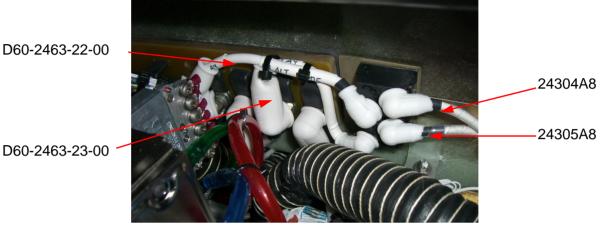
Figure 39

Install the cables D60-2463-22-00 (LH relay) and D60-2463-23-00 (RH relay), which are part of the diode assembly D60-2463-21-00, onto the above mentioned terminals of the alternator relays, including the insulating boots P/N MS 25171-3S.

CAUTION: The cables D60-2463-22-00 and D60-2463-23-00 must have enough clearance to the canopy arm when in closed position.

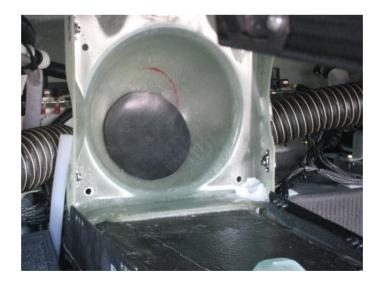
Figure 40

- Connect the cable 24304A8 (including insulating boot) to the positive side (marked "+") of the diode, installed on the top of the bracket. Refer also to drawing D60-2463-21-00.
- Connect the cable 24305A8 (including insulating boot) to the positive side (marked "+") of the diode, installed on the bottom of the bracket. Refer also to drawing D60-2463-21-00.
- If the airplane is equipped with an oxygen system, install the supplied rubber D60-3553-41-02 onto the hole prior drilled into the oxygen bottle mounting bracket.

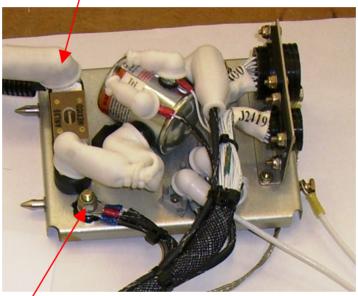
Figure 41

- 27 Disconnect the connectors mentioned above and seal them by appropriate heatshrink.
- Connect the LH USense cable D60-2407-31-00, including Fuse Assembly, USense, D60-2407-33-00 to the voltage sense connector of the alternator harness in the left nacelle.
- Connect the RH USense cable D60-2407-32-00, including Fuse Assembly, USense, D60-2407-33-00 to the voltage sense connector of the alternator harness in the left nacelle.
- Connect the Fuse Assembly, USense, D60-2407-33-00 to the top terminal of the fuse holder. Refer also to figure 41.

LH shown, RH mirrored

Connect the ring terminal of the cable here
